Subject: "TCU MALFUNCTION. HAVE THE VEHICLE INSPECTED." MESSAGE AND DTC B1252:87 AND U0198:00 STORED	Service Alert No.: SA-060/25
	Last Issued : 12/16/2025

2025-2026 Mazda3
2025-2026 CX-30
2025-2026 CX-50
2025-2026 CX-50 HYBRID
2025-2026 CX-70
2025-2026 CX-90

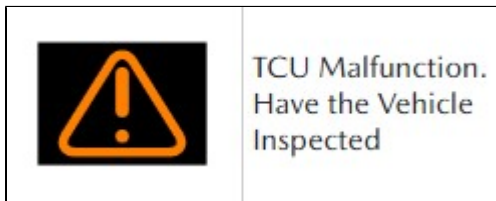
Some customers may experience a message "TCU Malfunction. Have the Vehicle Inspected" in the instrument cluster.
