<b>Subject:</b>  <b>ELECTRICAL CONCERN AND/OR MULTIPLE DTC'S DUE TO AFTERMARKET DEVICE</b>	<b>Service Alert No.: SA-061/25</b>
	<b>Last Issued : 12/17/2025</b>

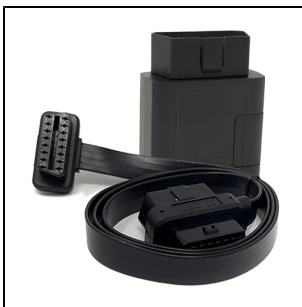
- Battery discharge. The device may disrupt the CAN system battery saver mode.
- IDS/MMDS will not communicate with the vehicle due to poor DLC-2 connection. The aftermarket device may cause DLC-2 female terminals to spread open.
- DTCs
  - B1041:54 - ADAPTIVE FRONT LIGHTING SYSTEM (AFS) CONTROL MODULE
  - B108E:04 - CENTER DISPLAY INTERNAL MALFUNCTION
  - C0061:54 - DSC HU/CM
  - C1001:92 - FORWARD SENSING CAMERA (FSC)
  - C1001:97 - FORWARD SENSING CAMERA (FSC)
  - U300A:62 - ELECTRIC PARKING BRAKE (EPB)
  - U3004:17 - ACC RELAY CIRCUIT MALFUNCTION
  - U0415:00 - MAZDA RADAR CRUISE CONTROL (MRCC)/SMART BRAKE SUPPORT (SBS)
  - U0420:00 - MAZDA RADAR CRUISE CONTROL (MRCC)/SMART BRAKE SUPPORT (SBS)
  - Multiple DTC's (U0XXX:00 COMMUNICATION ERROR)

**Note:** Some aftermarket devices may include a pig-tail connector or passthrough attached to the OBD-II port. Be sure to check for any extensions, splitters, or other port adapters (see example image below).

- If an aftermarket device is found connected to DLC-2, take a photo and attach it to the RO. Advise the customer to remove it.
- If you determine that no aftermarket devices have been installed, continue with normal MGSS diagnosis.

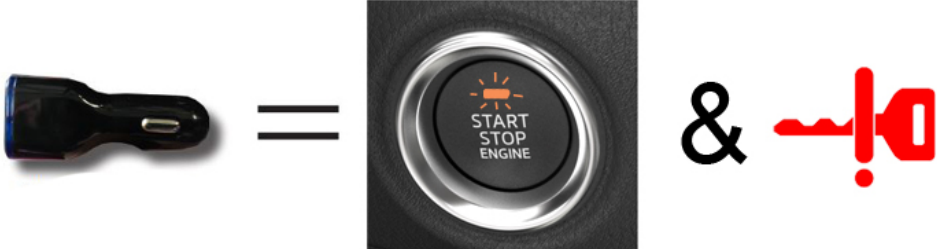
Some aftermarket cell phone chargers, accessories connected to the 12V outlet or key fob proximity to a cell phone may cause issues with the START/STOP button or rear view camera.

- Intermittent engine no start or unable to turn off
- Instrument cluster red security indicator light ON
- Engine Start/Start Button Amber indicator light flashing
- Battery discharge
- Electrical relay buzzing noise
- DTC B13D3:94 stored (Communication error with remote transmitter)
- DTC P1260:00 stored (Immobilizer system problem)
- Rear View Monitor Display is Blurry

Aftermarket Cell Phone Charger/Accessory connected to 12V outlet	Engine Start/Stop Button Amber Indicator Light Flashing	Key Warning Light (red)

For concerns where the vehicle power supply cannot be controlled adequately, such as an engine no start condition or the engine cannot be turned off, explain to the customer as follows: Due to the reverse power supply from electronic devices with internal batteries connected through the vehicle's accessory socket, the vehicle system may not be able to determine the vehicle electronic status. As a result, the vehicle power supply control fails. To overcome this situation, remove the electronic device with internal batteries from the accessory socket.

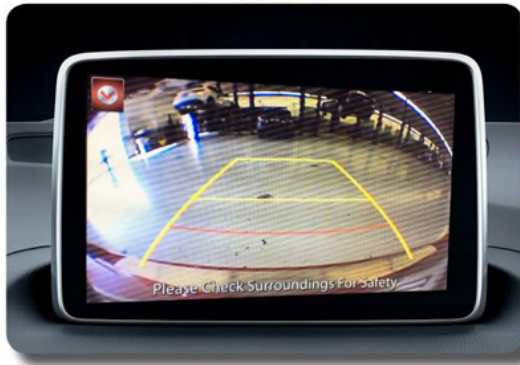
Blurry Display

With aftermarket cell phone charger connected to 12V outlet

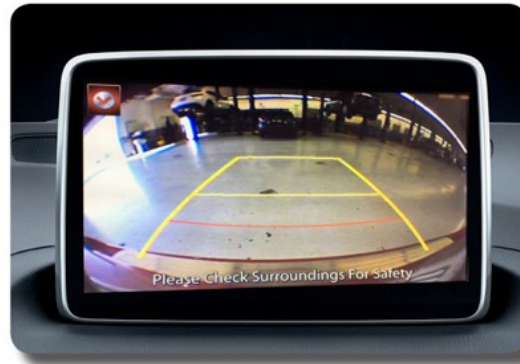
OK

Without aftermarket cell phone charger

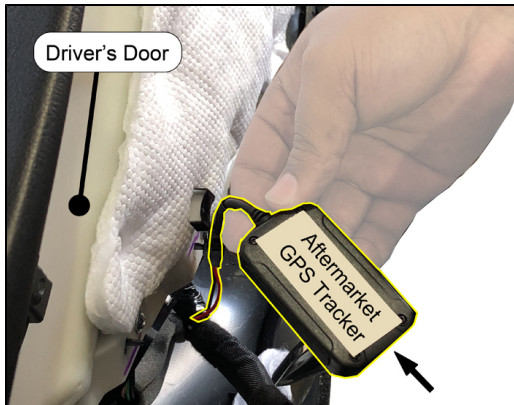
Below are examples of concerns due to an aftermarket GPS tracking device wired to the power window main switch:

- Engine no start
- Battery discharge
- Main relay buzzing

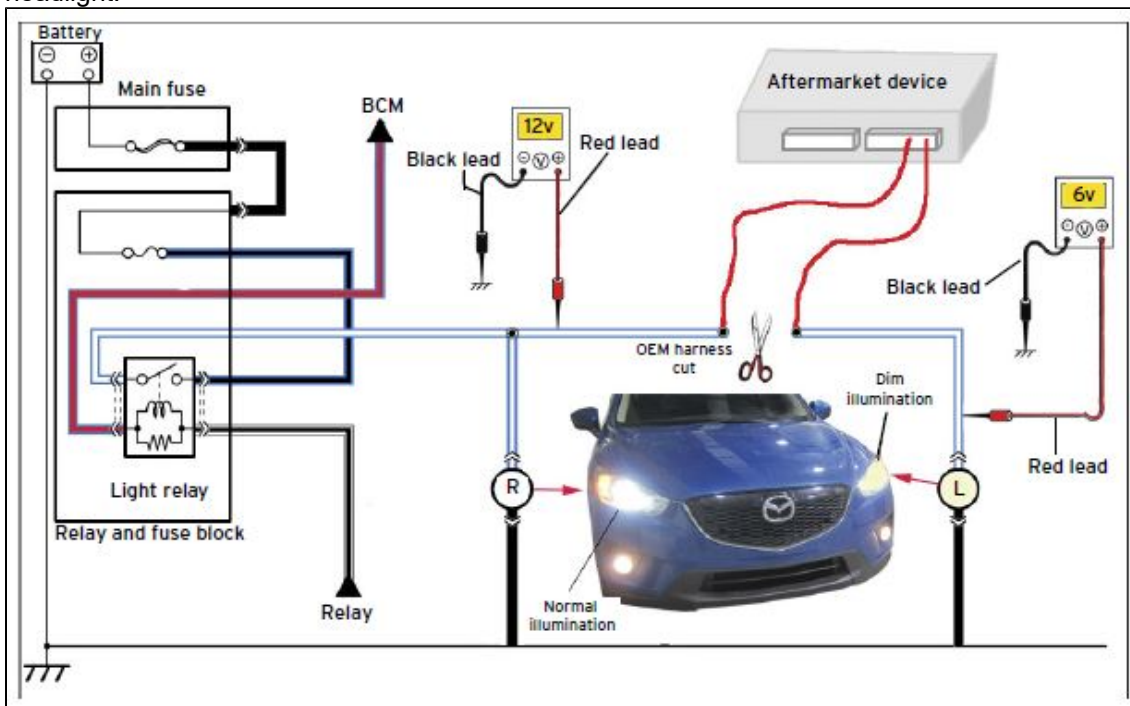
Below is an example of a dim headlight. The aftermarket device changed the headlight circuit resistance, causing a dim headlight.

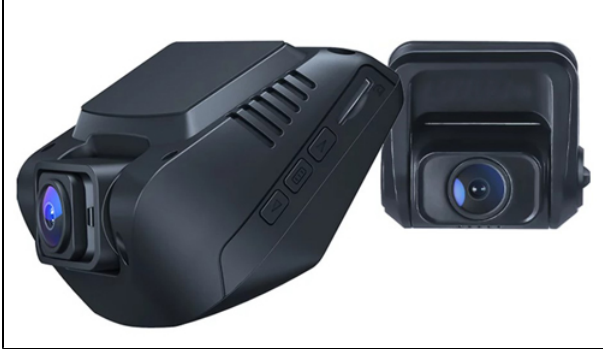
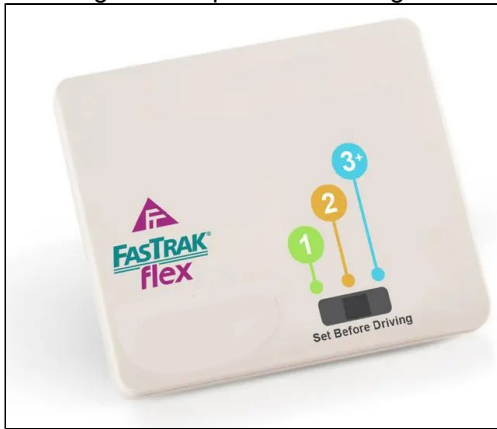
DTC B119F:01 (TEL antenna No.1 malfunction) stored. This may be caused by an aftermarket dash cam, radar detector and/or FasTrak device.

The aftermarket device may cause electrical noise disturbing the reception of GPS signals.

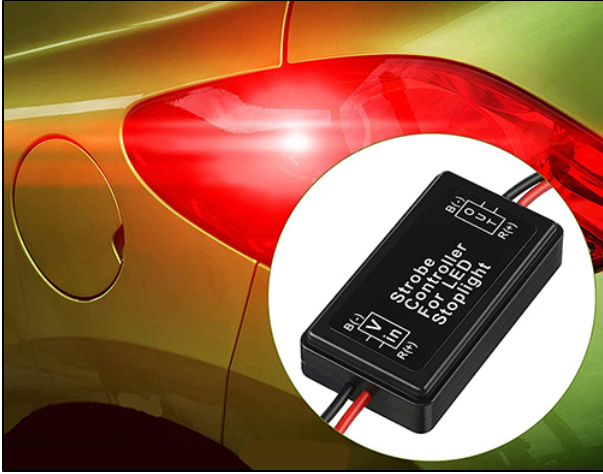
DTC C0023:14 (Brake light circuit malfunction) stored. This may be caused by an aftermarket brake light flasher.

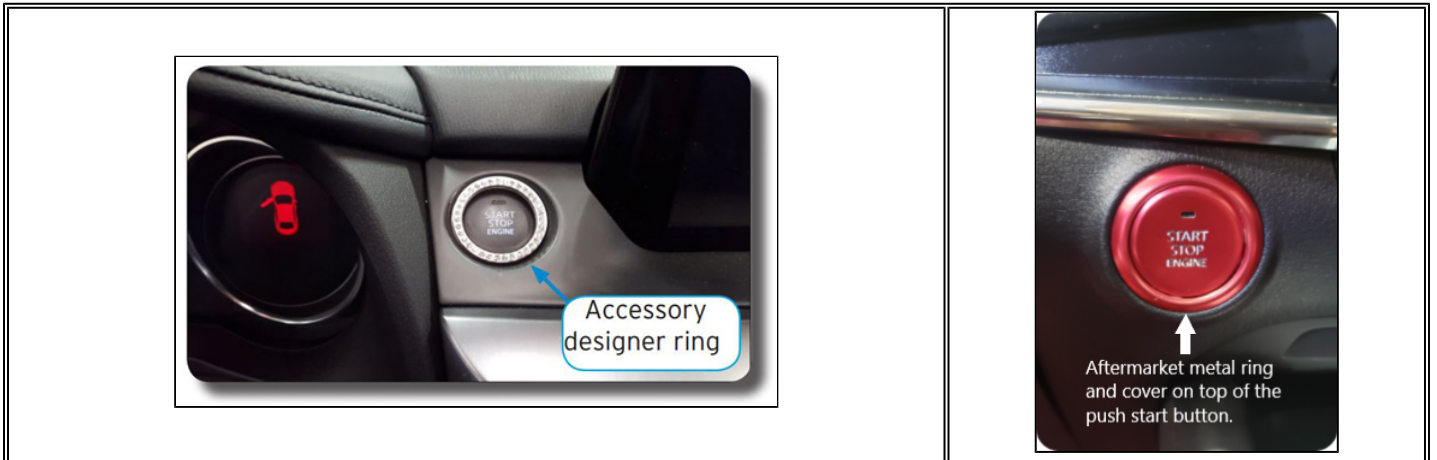
When programming a key or installing a Genuine Mazda Accessory Remote Engine Start system, you may encounter programming difficulty. This may be caused by a customer installed aftermarket decorative trim and/or cover on the START/STOP ENGINE button. The aftermarket accessory may create electrical interference, which may interfere with programming.
