# Service Bulletin

Bulletin No.: PIT5689M

**Subject: No Restart after an Auto Stop Event / No Crank / Dead Battery / Glow Plug / Transfer Case / SES MIL / DTC**

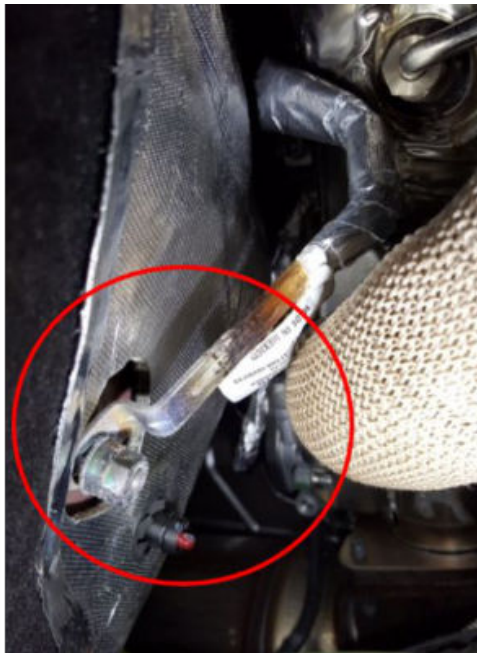
5748460

Shown above is ground G132 loose.

Inspect the engine to body ground cable/strap, G132 and G134. Tighten any loose ground connections or replace any damaged ground cable/strap. Ensure that the ground cable/strap is properly orientated to prevent damage to the ground cable/strap caused by powertrain movement.
