SIB 12 03 24

B48P AND B48R ENGINE: FC 034AEF EXHAUST COLD START, NOT CONTROLLABLE
2025-12-17

U11 X1 Sports Activity Vehicle
U10 X2 Sports Activity Vehicle

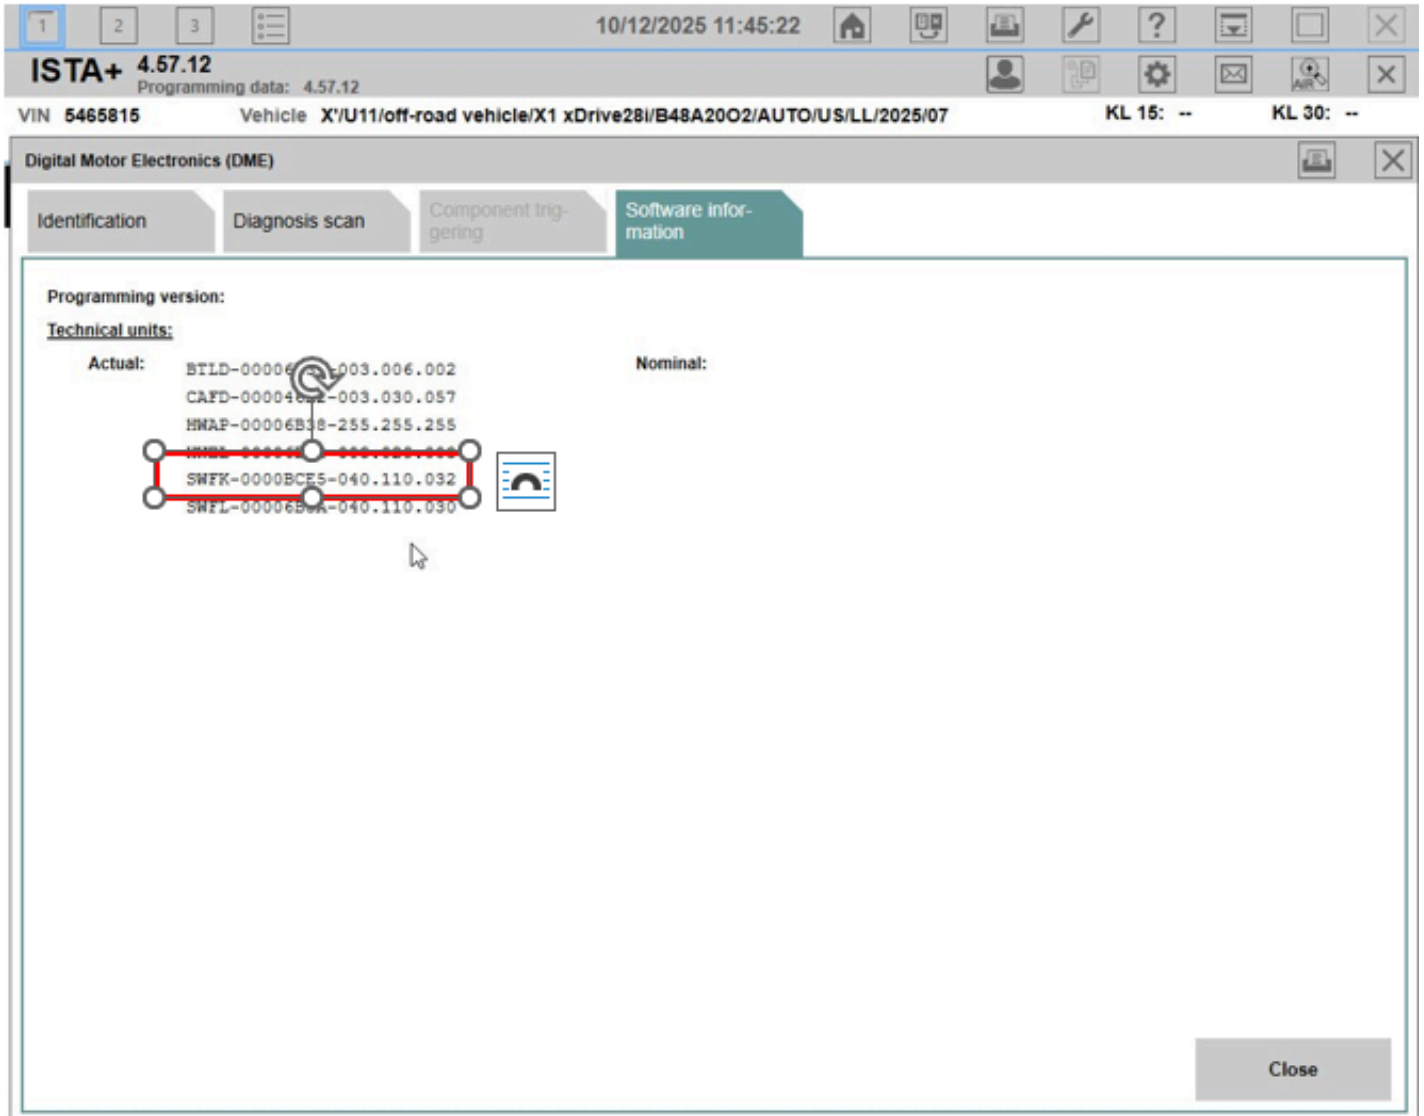
1. Check the vehicle's DME software identifier SWFK as shown in the example below.
Does your vehicle match one of the following software versions (9B85, A9D7, AC0A, AC09)?
 - a. Yes – Create a TSARA programming case titled "IRAP B4x VANOS" Prior to this make sure to follow **B09 02 16 for proper scheduling. See noted steps below that must be followed prior to IRAP being started.**
