MBUX multimedia system: The central display is dark, various other system complaints

| Topic number | LI82.85-P-071623 |
| Function group | 82.85 - Navigation and Communication systems |
| Validity | Model series 167 with code 548/549 |

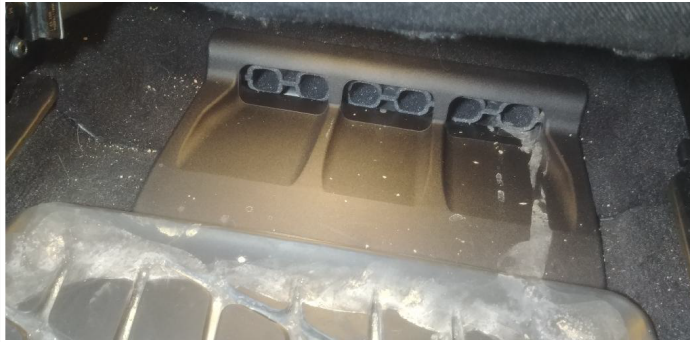
Water ingress through the air vent under the front passenger seat (see attached, note that the vents are facing the rear of the vehicle). As a result, the head unit (A26/17) may become damaged.

Inspect the MBUX multimedia system (A16/17) hardware, including all attached wiring and connectors, for traces of water and/or corrosion (see attached picture for example).

| Attachments | |
|---|---|
| <a href="#">MBUX control unit with visible traces of water intrusion.jpg</a> | An example of signs of liquid intrusion into passenger HVAC vent |

Avoid using rubber floor mats for the second row seats on which water can collect and subsequently enter the air vent under the front passenger seat.

An optimized cover is now available for the air vent under the front passenger seat (see parts note). To avoid a recurrence of water damage, install this cover.

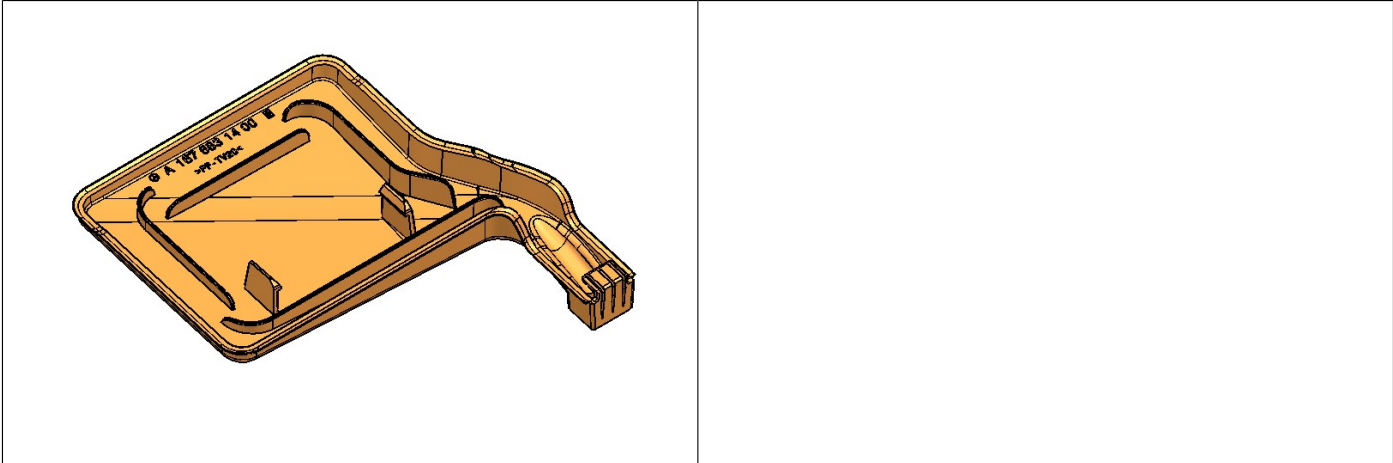
| File | Description |
|---|---|
| <a href="#">air vent cover A1676831400.jpg</a> | Optimized air vent cover |

| Part number | ES1 | ES2 | Designation | Quantity | Note | EPC |
|---|---|---|---|---|---|---|
| A 167 683 14 00 | | | Cover panel | 1 | Available as of approx. 04/2021 | X |
