SIB 63 09 25

FAILURE/MALFUNCTION OF THE AMBIENT LIGHTING
2025-12-18

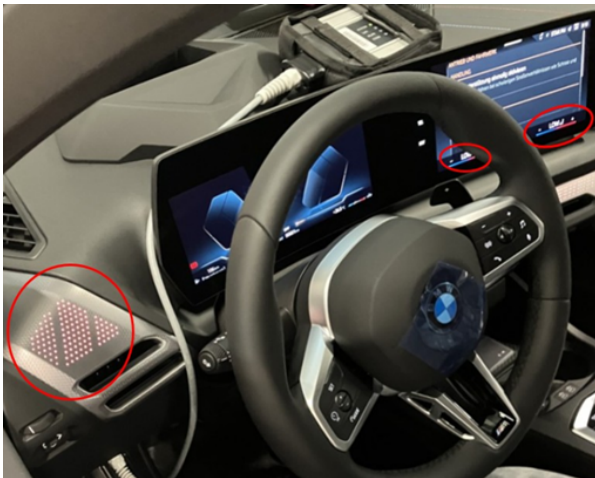
After programming the vehicle via ISTA/RSU to 25-07-5xx, some of the interior ambient lighting strips (examples circled) may no longer function properly.

- **804A38 – Interior lights layering (IL-LIN_3): versioning incorrect: LIN slave 5**
- **804A39 – Interior lights layering (IL-LIN_3): versioning incorrect: LIN slave 6**
- **804A3E – Interior lights layering (IL-LIN_3): versioning incorrect: LIN slave 11**

Unfavorable logic in the LED control unit hub.

Follow the test plan to encode the LED control unit hub.

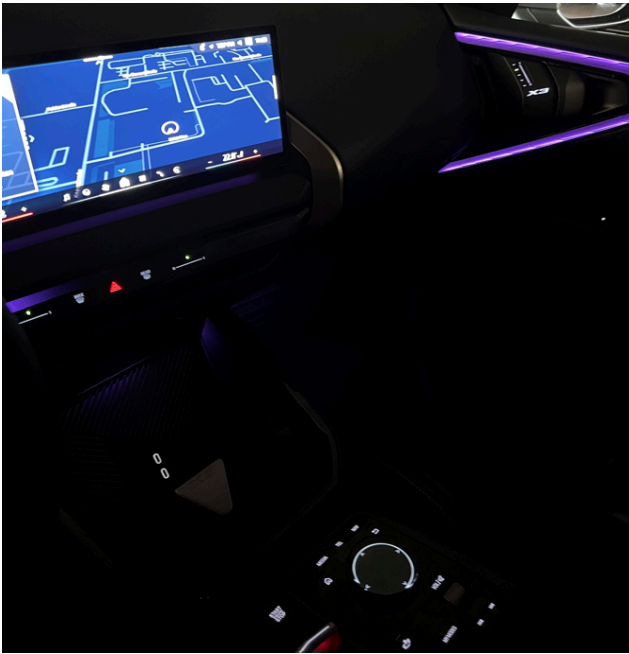
Possible fault codes entries for G45:

- **804A34 – Interior lights layering (IL-LIN_3): versioning incorrect: LIN slave 1**
- **804A35 - Interior lights layering (IL-LIN_3): versioning incorrect: LIN slave 2**
- **804A36 - Interior lights layering (IL-LIN_3): versioning incorrect: LIN slave 3**
- **804A37 - Interior lights layering (IL-LIN_3): versioning incorrect: LIN slave 4**
- **804A38 - Interior lights layering (IL-LIN_3): versioning incorrect: LIN slave 5**
- **804A3A - Interior lights layering (IL-LIN_3): versioning incorrect: LIN slave 7**
- **804A47 - Interior lights layering (IL-LIN_3): versioning incorrect: LIN slave 8**
- **804A48 - Interior lights layering (IL-LIN_3): versioning incorrect: LIN slave 9**
