SIB 66 13 23

CAMERA-BASED ADAS: CCM FOR RESTRICTED FUNCTION – KAFAS CAMERA HOOD DEFORMATION

2025-12-17

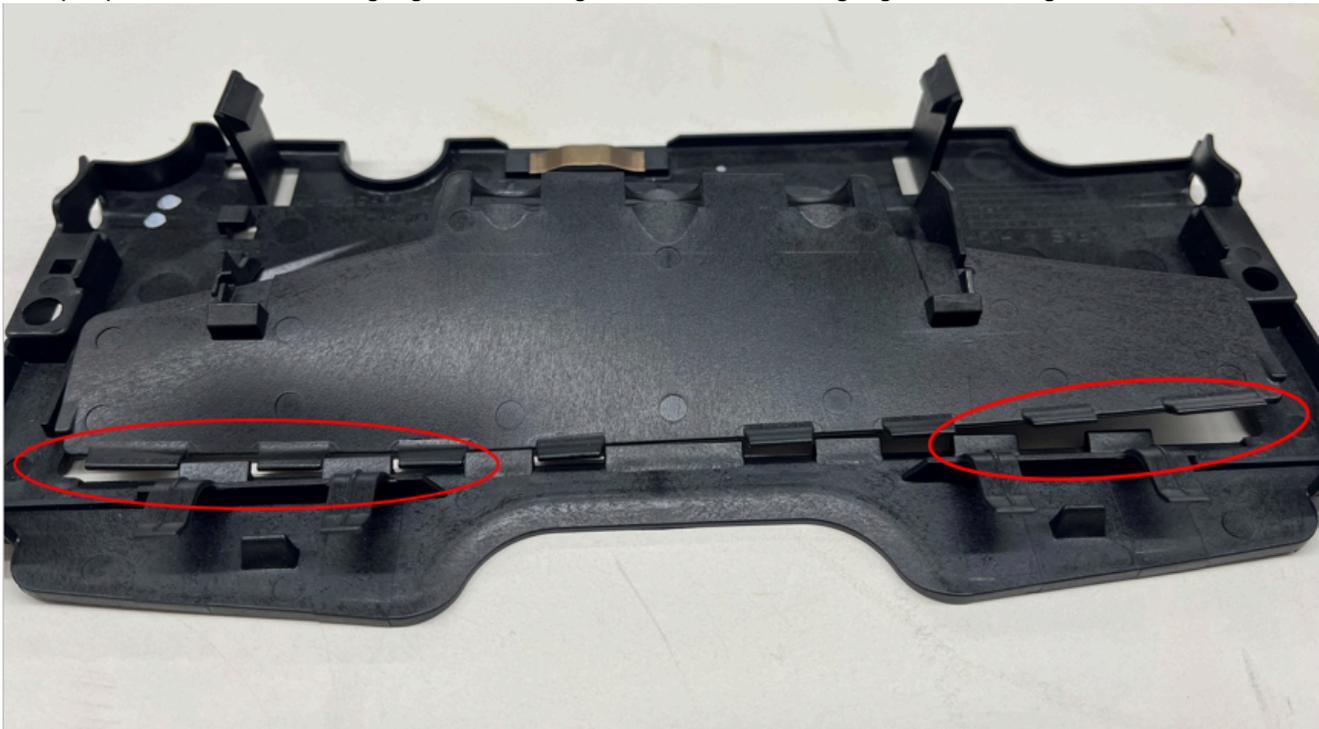
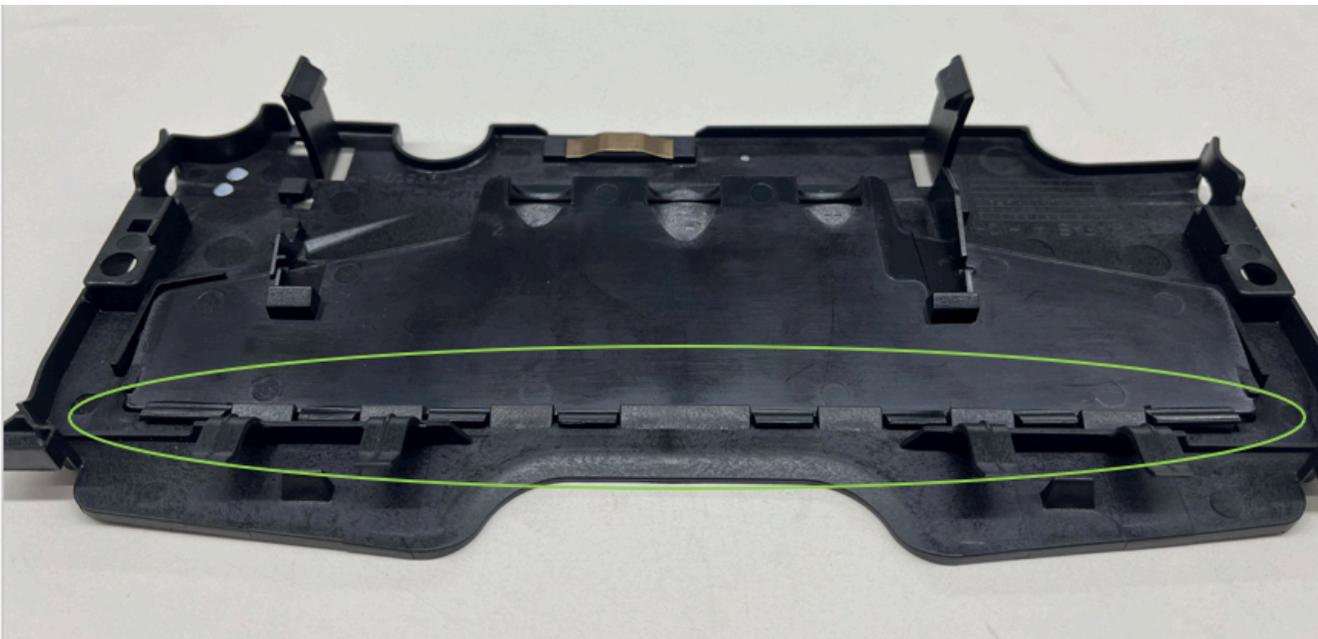
The KAFAS 4 High camera reaches temperatures that the KAFAS camera hood material cannot withstand. This results in deformation/distortion of the KAFAS camera hood.

2. When installed, check whether the KAFAS hood is in contact with the holder/mount all the way around. See example photos below. **Red** highlighted showing distortion. **Green** highlighted showing no defect.

If you find distortion, replace the KAFAS camera hood with part number 51 31 5A93179 for (F97 G01) front windscreen trim or part number 51 31 5A9A552 for (F98 G02). Then follow the below modification steps.

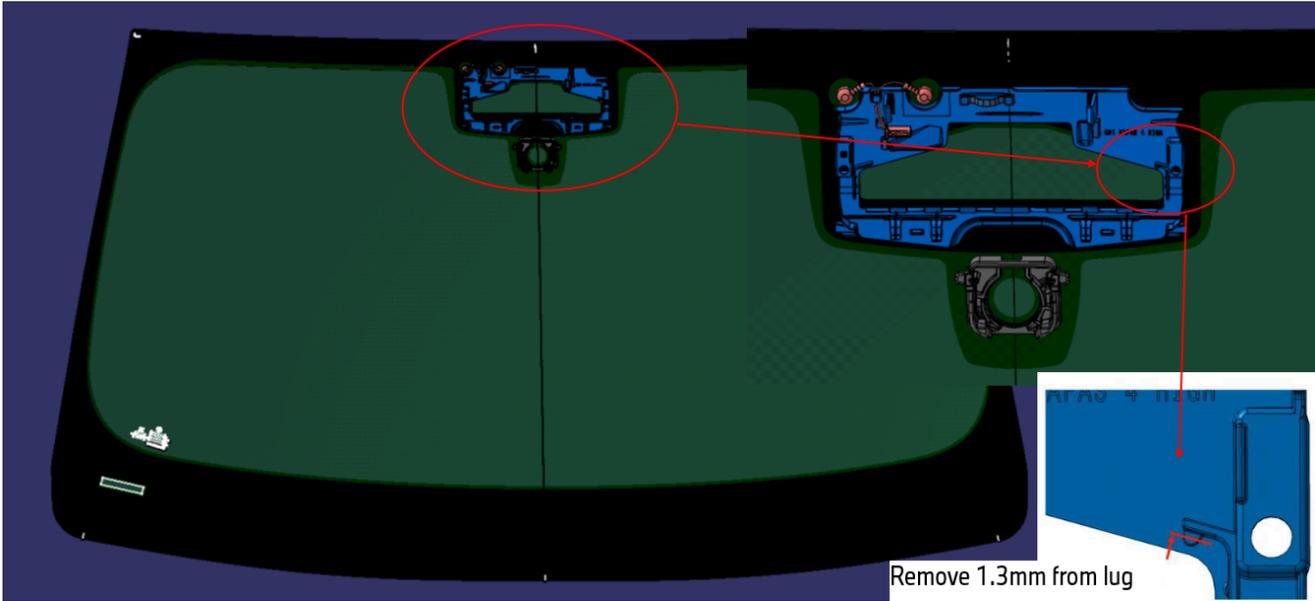
The mounting point for the KAFAS camera hood must be adjusted.

Using a grinding tool (for example Dremel®), shorten the entire surface of the retaining lug by 1.3 mm. See example photo with location for modification. Then deburr and clean it thoroughly, and remove the adhesive tape.

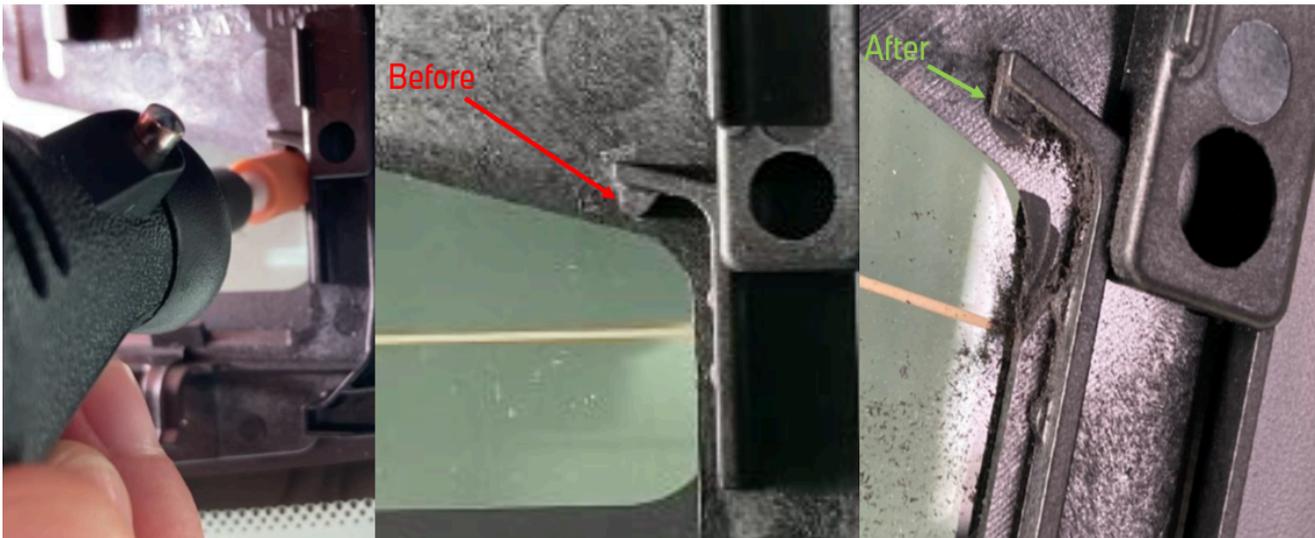
Before and after photos showing the modification below.

Mount the KAFAS camera hood. Make sure that it is in contact with the holder all the way around, especially in the modified retaining lug area.
