Technical Service Bulletin

GROUP	NUMBER
BODY ELECTRICAL	25-BE-017G
DATE	MODEL(S)
DECEMBER 2025	GV80 (JX1) GV80 COUPE (JX1)

SUBJECT: INOPERABLE HORN REPLACEMENT

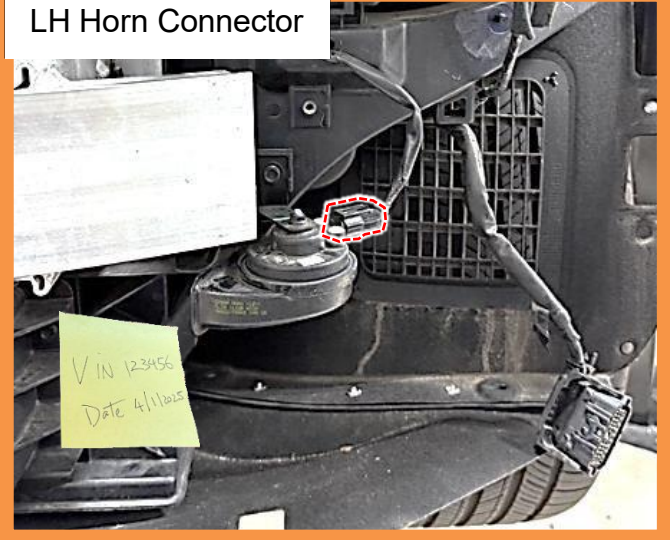
LH Horn Connector

Using the STUI camera function, take a photo of the original horizontally mounted LH horn.

2. Disconnect the horn connectors (A).
