**HYUNDAI**  
**Technical Service Bulletin**

GROUP <b>BODY</b>	NUMBER <b>25-BD-011H-1</b>
DATE <b>DECEMBER 2025</b>	MODEL(S) <b>SANTA CRUZ (NXT)</b>

**SUBJECT:** TONNEAU COVER INSPECTION & REPAIR GUIDE

**Description:** Some Santa Cruz (NXT) vehicles may have a tonneau cover that does not latch or unlatch, retract properly, and/or have a v-gap is present when closed. This may be due to a broken or missing clip on the underside of the tonneau cover. This bulletin provides instructions to inspect and, if necessary, repair the tonneau cover function using the Tonneau Cover Repair Kit or replacing the tonneau handle & latch assembly.

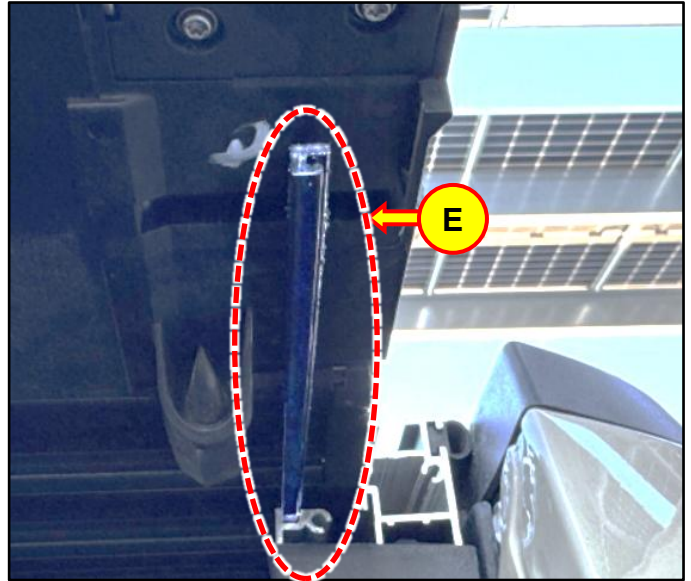
4. Visually inspect the plastic guide rails (E) under the tonneau cover for displacement.

Reinsert the plastic guide rail(s) into the track(s) if needed.

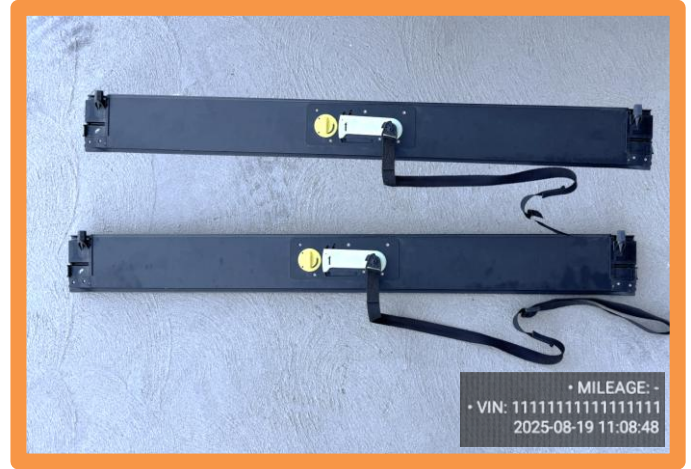
Using the STUI camera function, take a photo of the original latch assembly next to the replacement latch assembly.

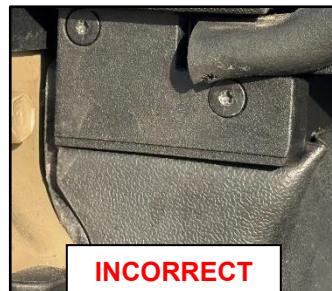
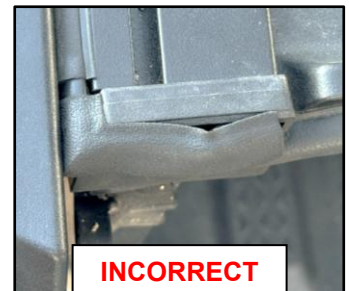
The lower seal **MUST** overlap the end cap, not be underneath.

The upper seal **MUST** be completely flush with the end caps.

9. Confirm the end caps seals are properly reassembled.

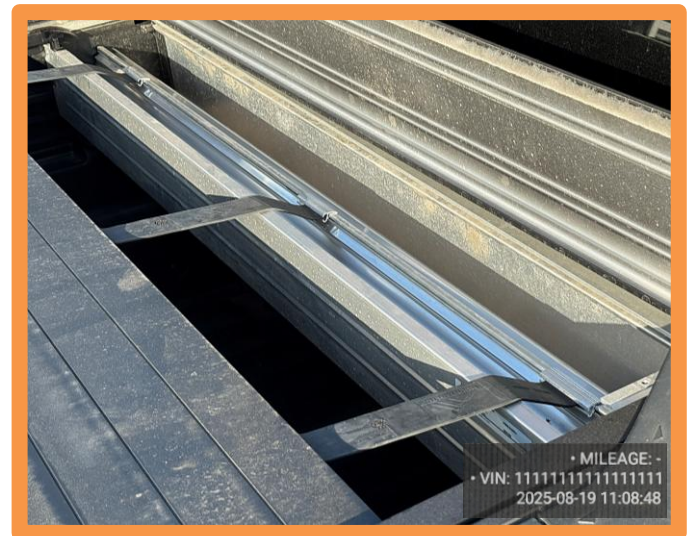
Using the STUI camera function, take a photo showing the 3 straps with metal connectors installed on the axle.

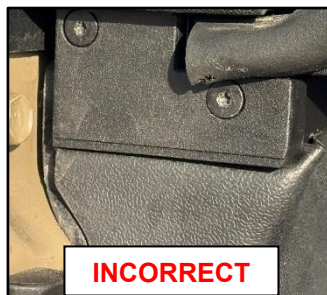
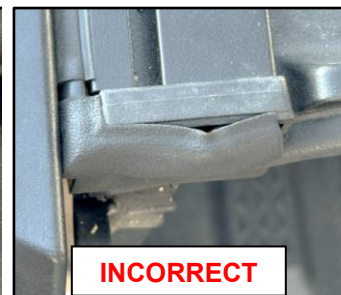
The lower seal **MUST** overlap the end cap, not be underneath.

The upper seal **MUST** be completely flush with the end caps.
