Technical Service Bulletin

GROUP	NUMBER
BODY ELECTRICAL	25-BE-025G
DATE	MODEL(S)
DECEMBER 2025	SEE BELOW

SUBJECT: AVN SOFTWARE UPDATE FOR INOPERABLE HEAD UNIT (PGEN6)

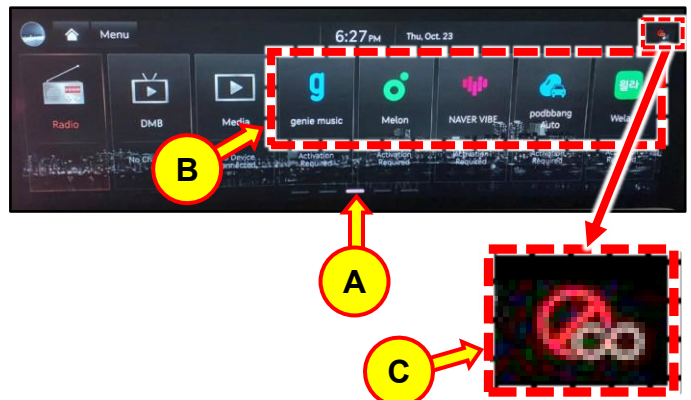
2. Confirm whether any of the pages (A) of the home screen is showing apps **NOT** intended for the U.S. market (B), and if communication features such as Genesis Connected Services are **NOT** functioning properly (C).

- **FAIL:** If conditions above are present, proceed to the next step.
- **PASS:** If the menu screen is **OK**, and communication features operate normally, the update in this TSB does **NOT** apply.

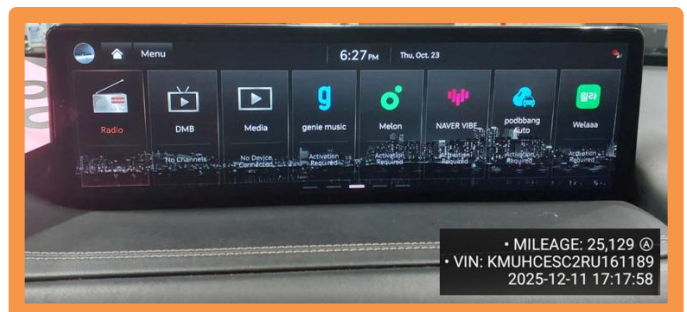
Using the STUI camera function, take a photo of the menu screen showing the incorrect Apps.
