SERVICE BULLETIN

APPLICABILITY: 2019-21MY Crosstrek PHEV **NUMBER:** 09-82-23R

SUBJECT: DTC P0452 EVAP System (CPC) Pressure Sensor/Switch Circuit Low **DATE:** 10/02/23

Design Changes to Fuel Tank Assembly & Vent Tubes

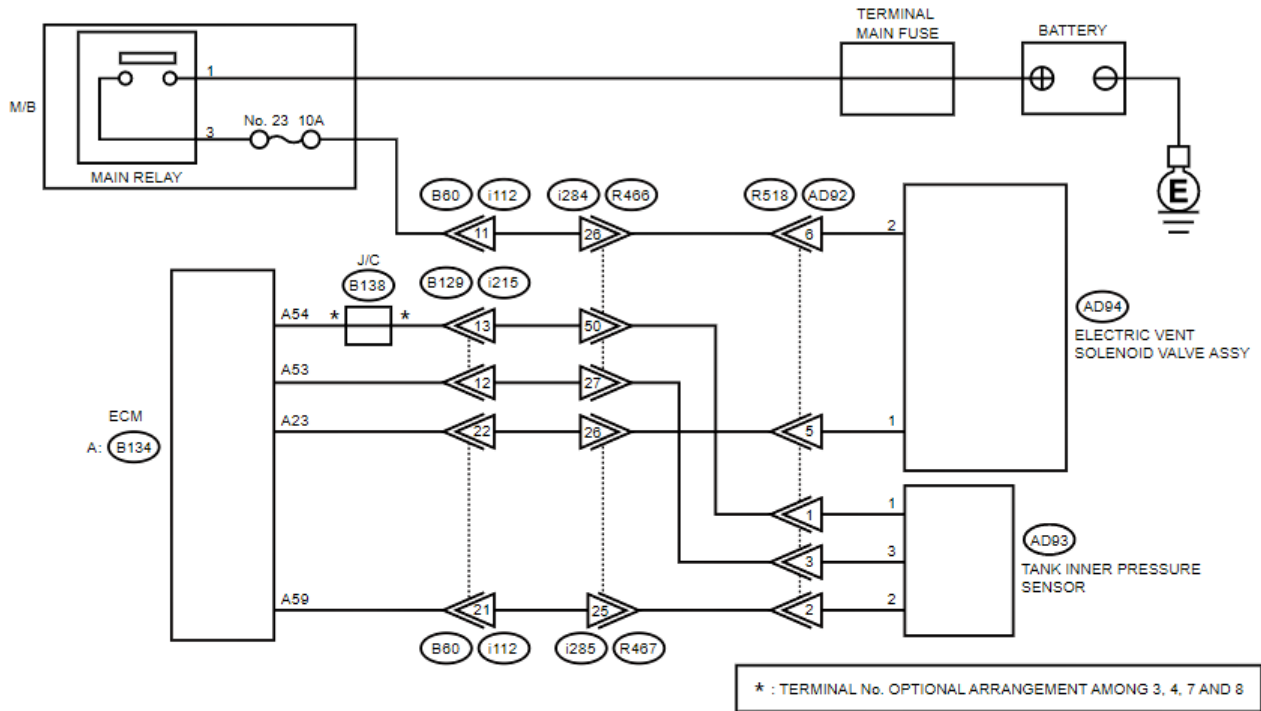
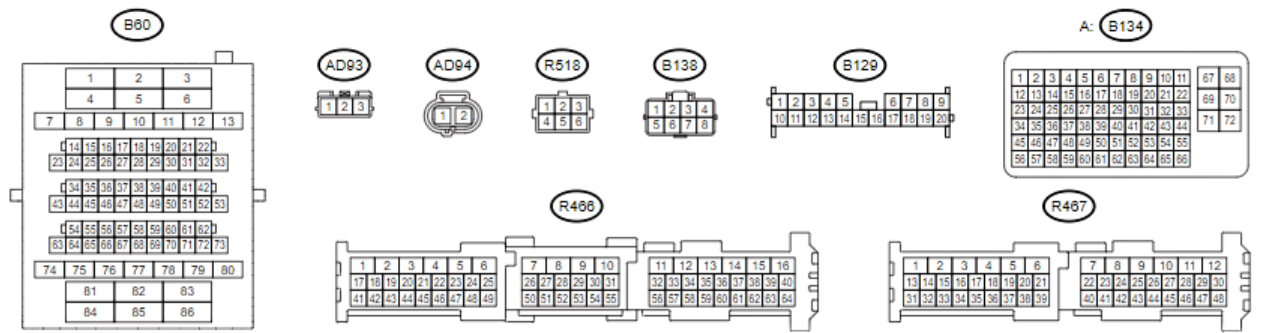
Wiring Diagram:

Check the Tank Pressure Sensor power supply for short to ground (see wiring diagram provided below).

Connector & Terminal (AD93) No. 3 (+) – Chassis Ground (-):
Is the voltage 4.5 Volts or more?

Connector & Terminal (B134) No. 59 (+) – Chassis Ground (-):
