**SERVICE BULLETIN**

**APPLICABILITY:** 2022-25MY WRX

**NUMBER:** 05-92-25R

**SUBJECT:** Click/Crack Sound from Front Lower Control Arm

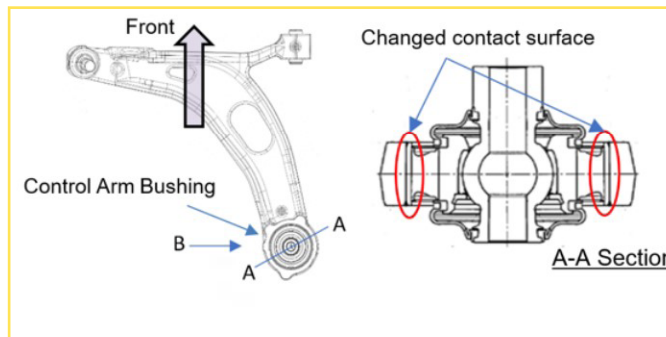
**DESCRIPTION OF DESIGN CHANGE:**

This bulletin announces the design change made to the front lower control arms developed to address cases of a click or cracking type sound heard when moving forward or backward at low speed with the steering wheel fully turned position. This is caused by the coarse surface of the lower arm allowing slight movement of the outer portion of the bushing. The new arms have a smooth finish on the contact surface providing an increased fixed positioning of the bushing. If this is reported by a customer and can be duplicated, replace the affected lower control arm using the part information supplied in this bulletin.

The new control arm assemblies have been incorporated into vehicle production as per starting VIN **R9814013**.

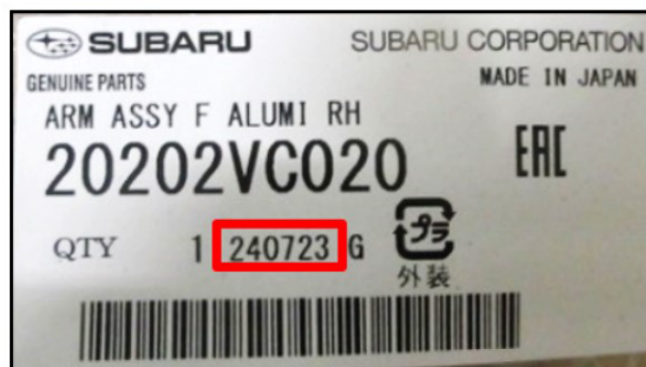
The design change was implemented on parts with a production date code of 240723 (July 23, 2024) and after. The production date code can be located on the part number label. See the example below.
