Technical Service Bulletin

Topic	Bentayga V8 Kovomo - DTC P310B00 with Symptom Code 2638 - Check Engine Lamp - Fuel Pressure Regulation
Market area	Bentley: worldwide (2WBE)
Brand	Bentley
Transaction No.	2058484/14
Level	EH
Status	Released for publishing
Release date	Dec 10, 2025

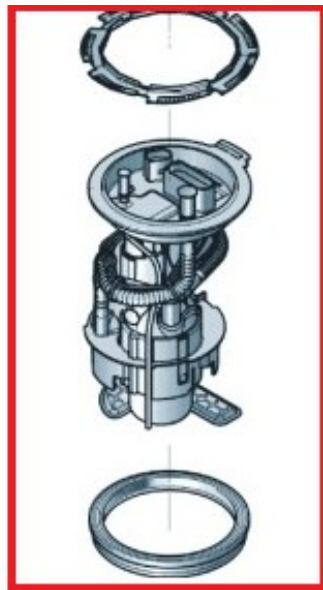
1) Referring to the example shown in Figure 1 - Check the actual pressure value

- In the event the fuel pressure actual value is above 450kPa the Fuel Delivery Module within the fuel tank (Figure 2) should be replaced

- In the event the fuel pressure actual value is above 475kPa (2023MY) the Fuel Delivery Module within the fuel tank (Figure 2) should be replaced

Engine rpm	639.5	1/min
Normed load value	13.725490449999999	%
Vehicle speed	0	km/h
Coolant temperature	82	°C
Intake air temperature	42	°C
Ambient air pressure	1000	mbar
Voltage terminal 30	12.4	V
Dynamic environmental data	20 96 28 11 CE 11 94 11 C8 12 80 11 C9	
	F8 41 11 A4 26 66 12 8AAA 15 9F 66 60	
	15 A0 66 64	
Unlearning counter according OBD	40	
Low fuel pressure, specified value	450.0	kPa
Fuel low pressure, actual value	501.3	kPa
Fuel pump adaptation	-198.3	kPa
Fuel pump, specified value	14.99939	%
Fuel temperature	79.5	°C
Fuel high-pressure, actual value	13.104	MPa
Fuel pressure rail 2	13.106	MPa
