Technical Service Bulletin

Transaction No.:
2065664/5

Bentayga V8 Kovomo - Engine MIL light on - DTC "O2 Sensor Signals Swapped Bank 1 Sensor 2/ Bank 2 Sensor 2

Release date: Dec
10, 2025

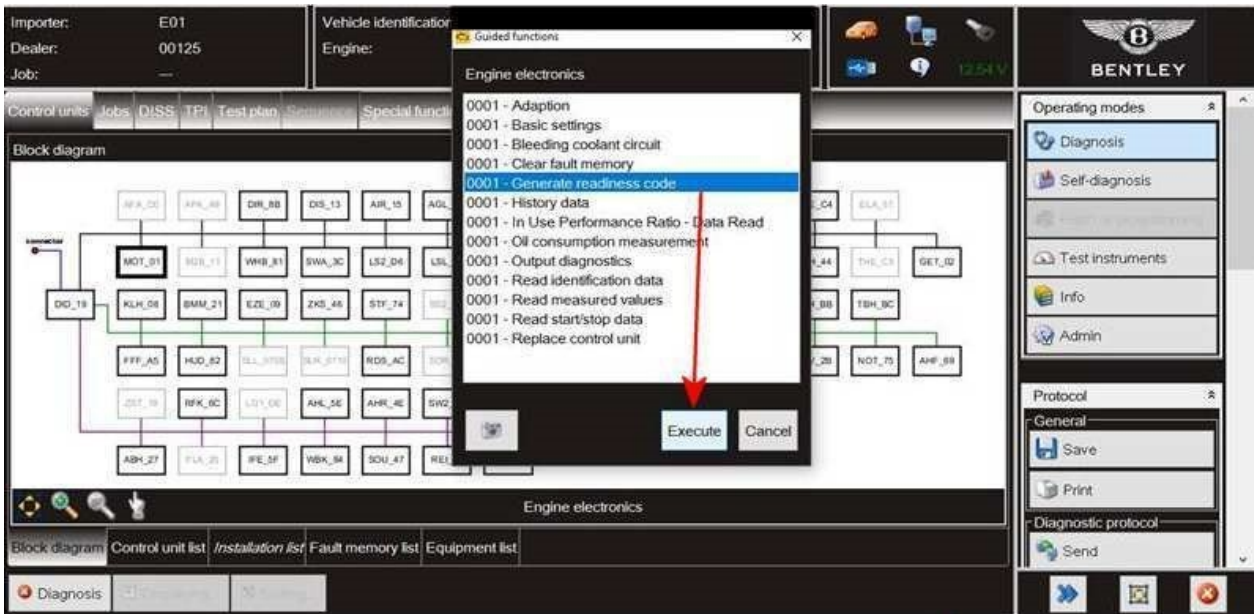
DTC P004100: "O2 Sensor Signals Swapped Bank 1 Sensor 2/ Bank 2 Sensor 2 is evident within address 0001 (Engine control unit) and MIL light active after attempting to conduct a readiness test

- Referring to Figure 1 - Select Guided functions from 01 - Engine Control Module 1
- Select Generate readiness code
- Select Execute and follow the readiness code procedure to completion as per all on screen prompts
