Technical Service Bulletin

Topic	DTC P14AB00 and/or other related exhaust flap DTC's - Warning lamp evident within the DIP
Market area	Bentley: worldwide (2WBE),Hongkong-Macau (5HK)
Brand	Bentley
Transaction No.	2055664/3
Level	EH
Status	Released for publishing
Release date	Dec 10, 2025

Bentayga V8 Kovomo and Bentayga W12 TSI

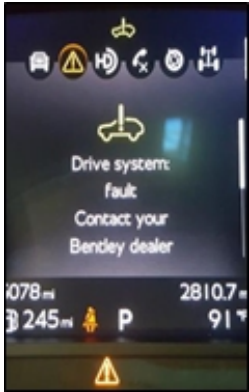
- Referring to Figure 1 - Warning lamp illuminated within the Drivers Information Panel (DIP)

- DTC P14AB00 and various DTC's evident within the Engine control modules 1 and/or 2 regarding exhaust control unit mechanical malfunctions
- Abnormal noises from the exhaust system
- This issue is applicable to both Standard and Sports exhaust systems

- The warning lamp and DTC's can be triggered by non-operation of the exhaust flap control unit/s

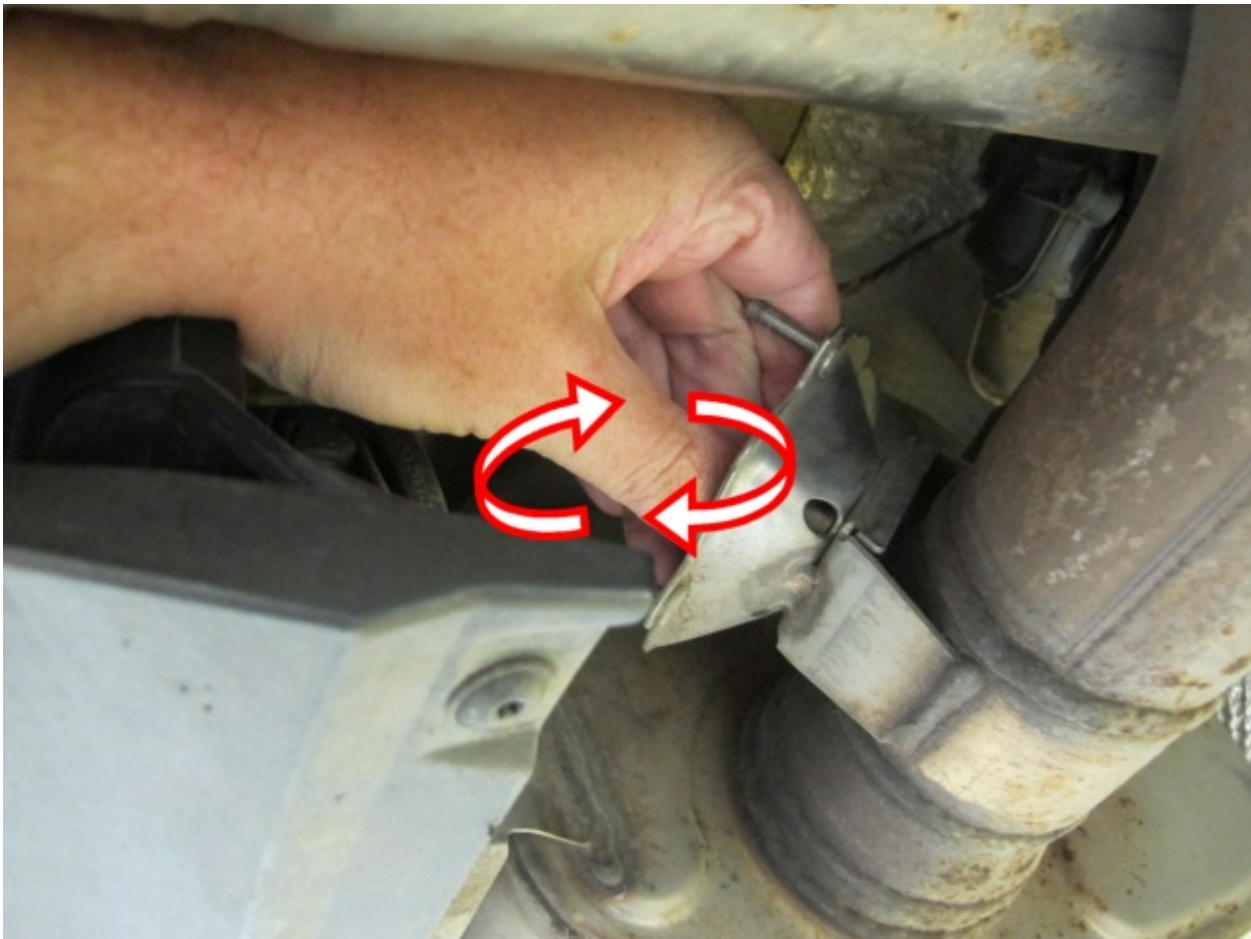
Figure 1

- Check and confirm the exhaust flap can be rotated by hand (clockwise and anti-clockwise) without the control unit fitted (Figure 1)

- Should no issue be evident with the exhaust flap and it can be freely rotated by hand - Replace the defective exhaust flap control unit Refer to Rep.Gr 26
