# Technical Service Bulletin

<b>Topic</b>	DTC P096C00 and / or P096F00 evident within the Engine Control Module
<b>Market area</b>	Bentley: worldwide (2WBE),China 796 VW Import Comp. Ltd (Vico), Beijing (6796)
<b>Brand</b>	Bentley
<b>Transaction No.</b>	2075941/3
<b>Level</b>	EH
<b>Status</b>	Released for publishing
<b>Release date</b>	Dec 10, 2025

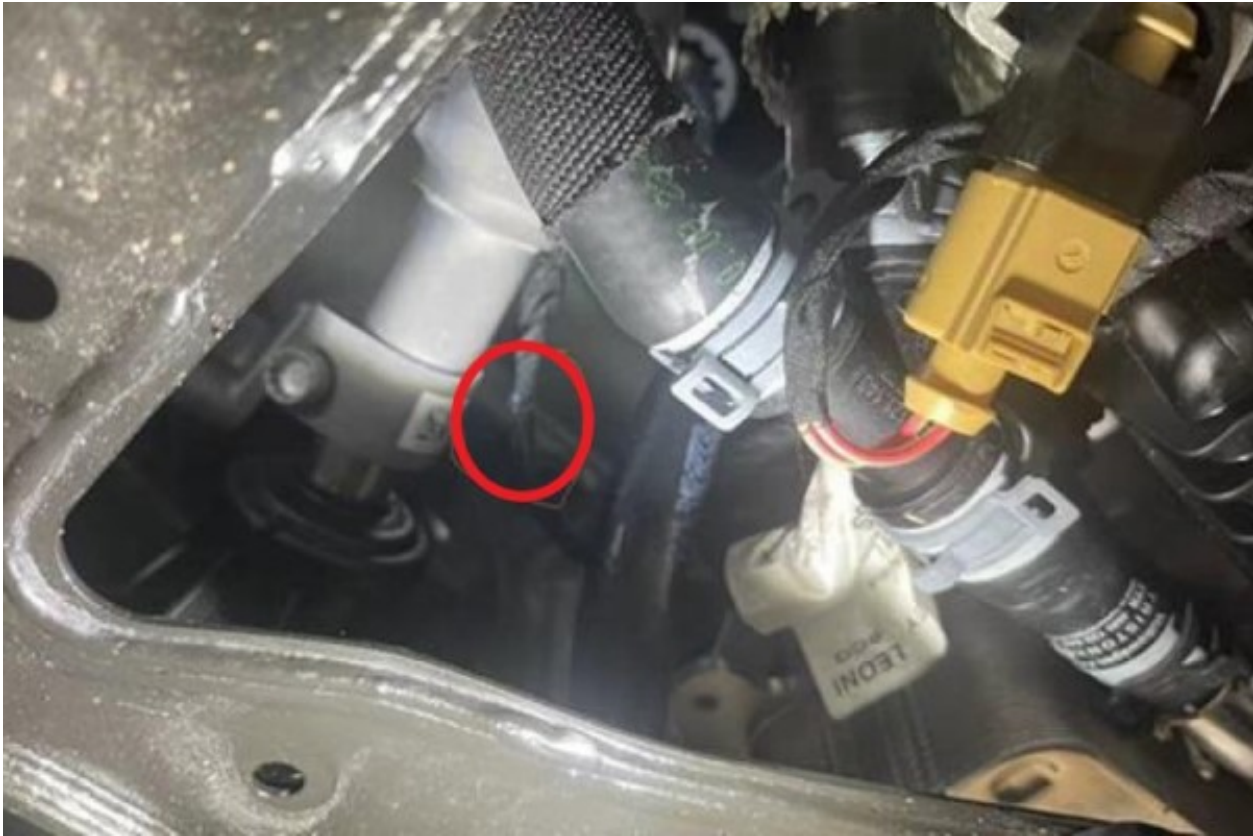
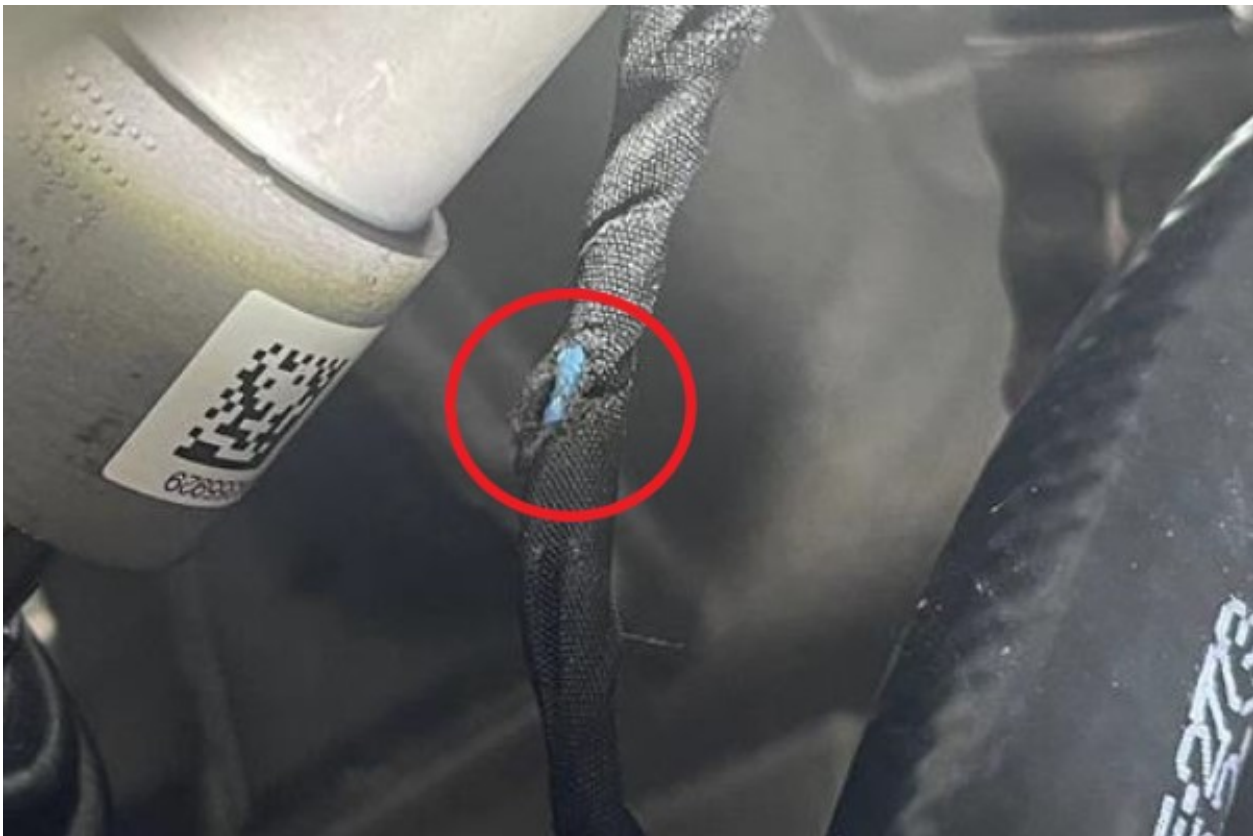
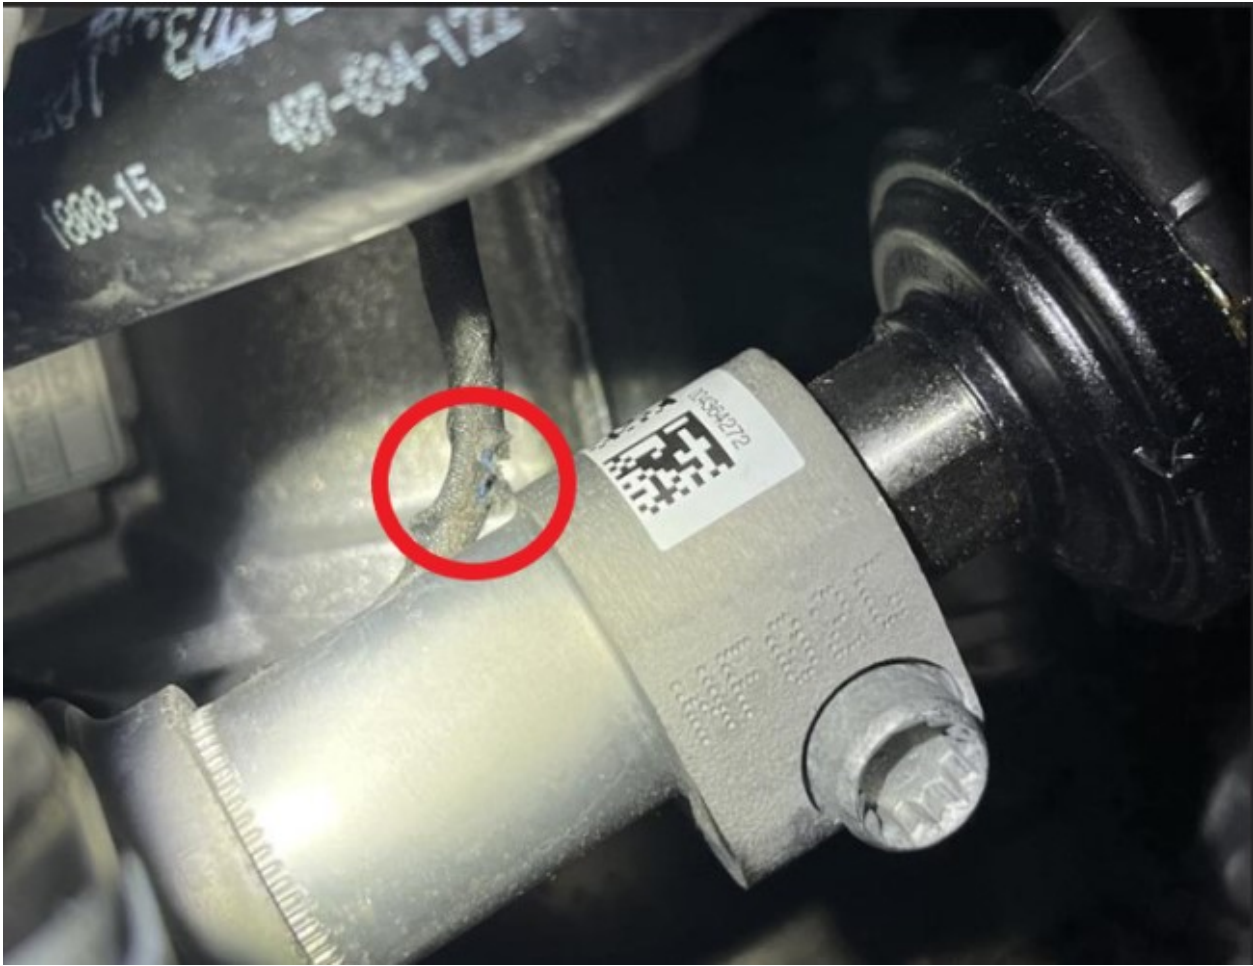
2) Referring to Figures 1, 2 and 3 - Conduct a visual inspection to confirm if the harness shown (CIRCLE) has any damage relating to contact with the steering shaft .

In the event the issue is as described the operative must conduct the remaining instructions (step 3 and 4) to completion and repair the damaged cable(s)

3) Referring to Rep.Gr 97 - Wiring harness repairs - Repair the damaged wiring using the VAS 1978B wiring repair kit
