Technical Journal

Rear roof cover with the molding line

REF NO: TJ 37644.1.1	ISSUING DEPARTMENT: Technical Service	CAR MARKET: United States and Canada	
PARTNER: 3 US 7515 Polestar		ISSUE DATE: 2025-12-01	STATUS DATE: 2025-12-11
FUNC GROUP: 8360	FUNC DESC: Roof hatch	Page 1 of 3

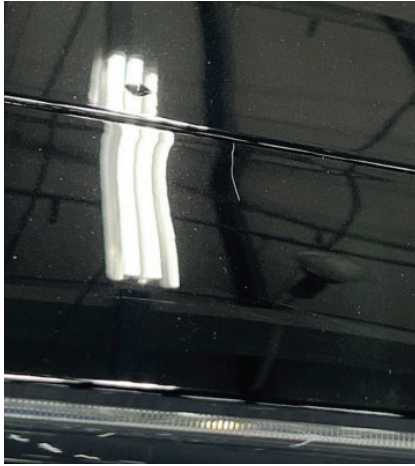
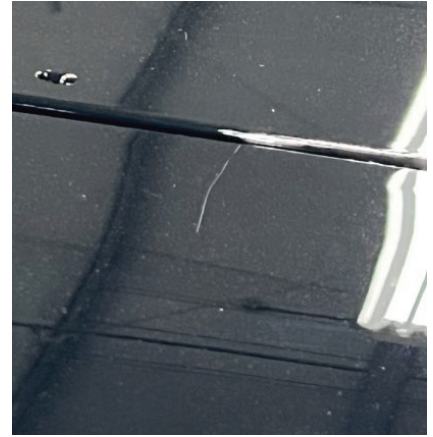
If customer complains that there is a visible on the rear roof cover follow advice under "Service".

Please, **Do not** replace any parts for the symptom described in this TJ. This is a molding line and **not** damage.
