**Door panel trim surface wavy on a specific angle**

<b>REF NO:</b> TJ 37643.1.1	<b>ISSUING DEPARTMENT:</b> Technical Service	<b>CAR MARKET:</b> United States and Canada	
<b>PARTNER:</b> 3 US 7515 Polestar		<b>ISSUE DATE:</b> 2025-12-01	<b>STATUS DATE:</b> 2025-12-11
<b>FUNC GROUP:</b> 8450	<b>FUNC DESC:</b> Sealing and protect. moulding for door	Page 1 of 3

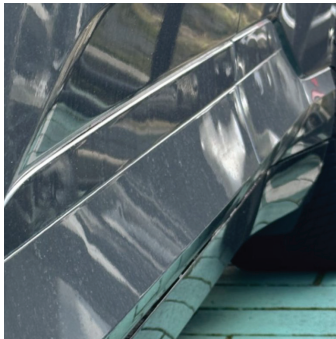
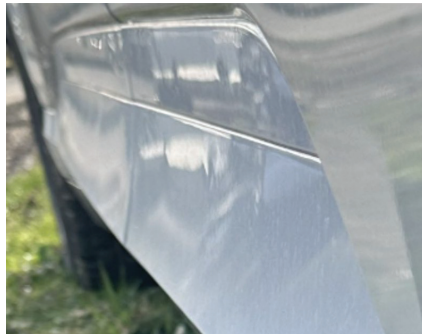
Part number in VIDA:

- 1) Front door: 80017171, 80013262, 80017170, 80013274
- 2) Rear door: 80017169, 80013288, 80017168, 80013304
