Volvo Car USA LLC

Technical Journal

Technical Journal Title Hood Hard to Close		Ref. No. TJ 36902.2.0	
Issuer (Dept.) Technical Service		Issue Date 12/10/25	Status Date 12/17/25
Car Market United States and Canada	Partner 3 US 7510 Volvo Car USA	Function Group 8213	
Function Description Catch		Page Page 1 of 6

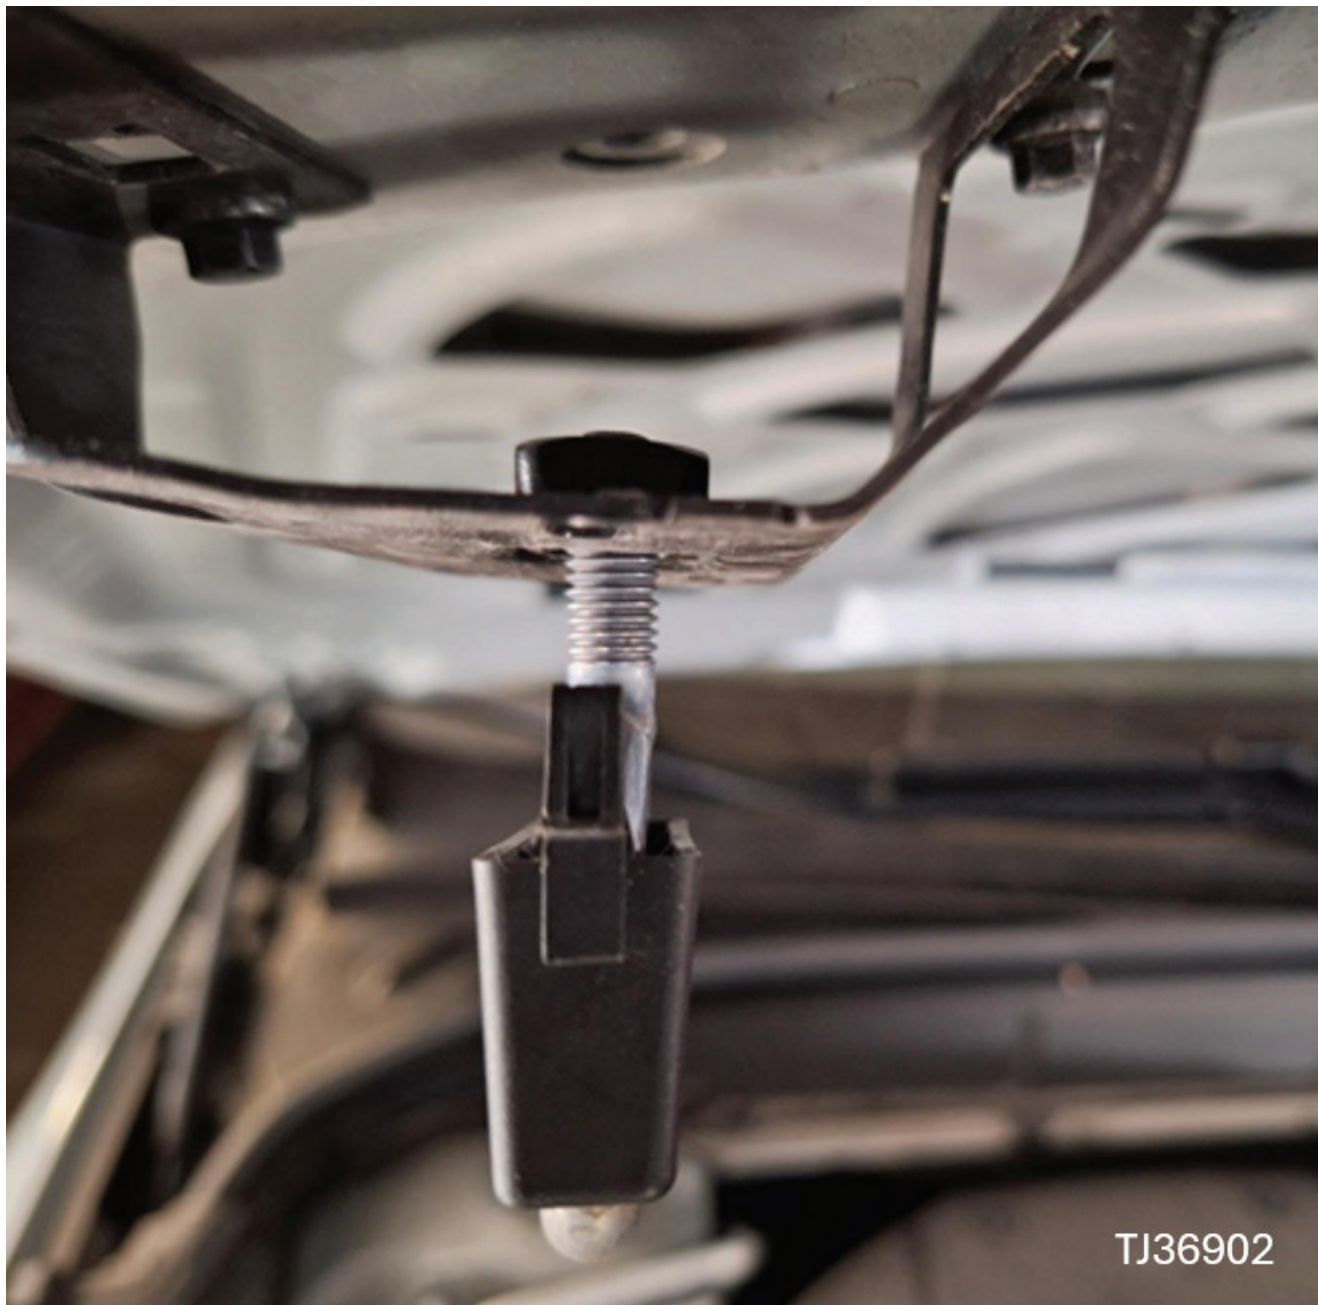
If customer complains of the hood being hard to close or "Open Hood" DIM message, please follow advice under "service".

1. Adjust the hood (see attachment TJ_36902_1.mp4).
2. Close and open a few times (2-3 attempts) to make sure the hood is properly latching. Make sure to check the bump stop after adjustment, so there is no gap between hood and bump stop (should have contact but not pressed against).
3. Check the latch of the hood after adjustment. As reference picture shows (TJ_36902_1.jpg), the screw should stick out on the other side.
4. If this doesn't solve the issue, replace the part.
