Maintenance Mode Horn Activation Correction

TSB-54-378-FTL

► 5th Generation Cascadia

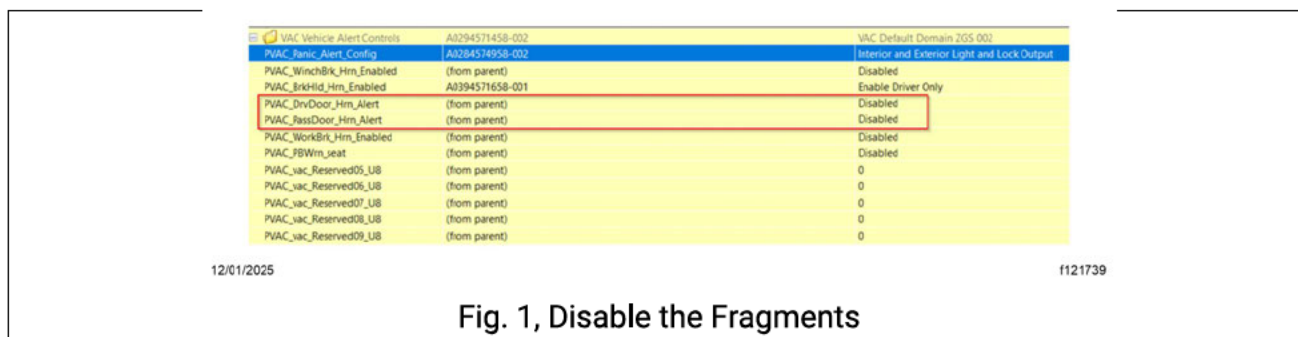
Fifth Generation Cascadia vehicles in maintenance mode may experience an issue where the rollaway mitigation horn sounds when the driver door is open or when the driver leaves the seat. The horn may also sound when the optional MSF ARA horn-disable switch is pressed. Follow the procedure below to correct this condition.

3. In the PVAC domain fragments, set both of the following to disabled. See Fig. 1.
 - PVAC_DrvDoor_Hrn_Alert (part number 045 457 27 58)
 - PVAC_PassDoor_Hrn_Alert (part number 040 457 33 58)
