**9YA/9YB - 'Tail Light Faulty' Warning in the Instrument Cluster**

Models	Model Year	Model Type	VIN Range	Vehicle-Specific Equipment
Cayenne	2024	9YA, 9YB	N/A	N/A

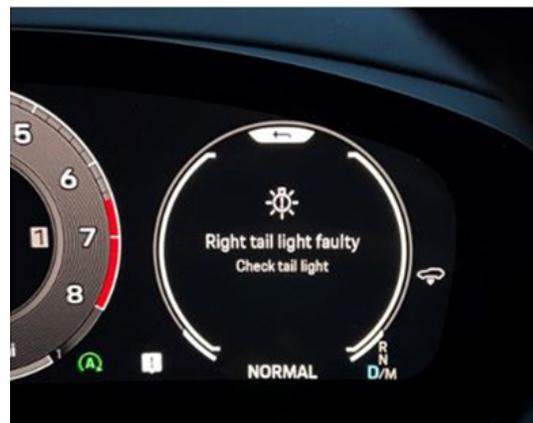
**Figure 1**

The customer receives a warning message in the instrument cluster indicating that a tail light is not working. (See Figure 1.)

Generally, however, the tail light does work as observed from outside the vehicle. The warning and faults are a false alarm.

Intermittently, the tail lights' internal communication can get stuck. This condition sends an unwanted failure message to the BCM2. The BCM2 interprets this as a possible loss of tail light function, consequently records a fault, and sends a warning to the instrument cluster.

1. Please create a VAL to document the occurrence of the fault.
2. Replace the rear tail light with the updated part number. Reference the table below.
