Considerable Dust Development in the Area of the Front Underbody When the Radiator Fan is On (107/25)

Model Line: **Macan (XAB)**

Model Year: **As of 2024**

Concerns: **Electric fan**

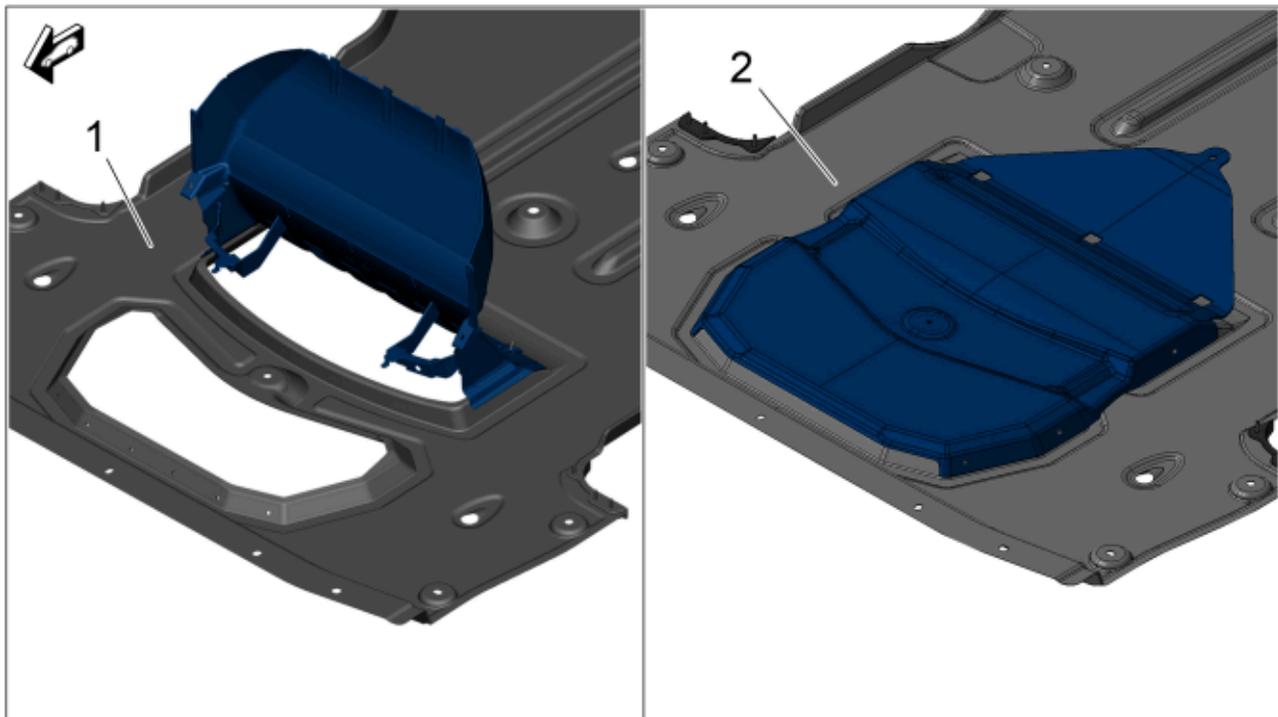
Underbody panelling (front cover)

- 1 – Underbody panelling with air guide
- 2 – Underbody panelling with closed cover

Action: In the event of a customer complaint, inform the customer about the concept-related discharge of the warm exhaust air of the cooling system to ensure the best possible cooling performance of the vehicle.
In the event of customer escalation, it is possible to install a newly developed, closed cover on the underbody panelling (front cover) instead of the previous air guide. This cover reduces the stirring up of road impurities.
