Technical Service Bulletin

Transaction No.:
2068946/11

Dynamic ride system warning visible - DTC P0B2500 logged within address 0021
(Battery Energy Control Module 2)

Release date: Dec
10, 2025

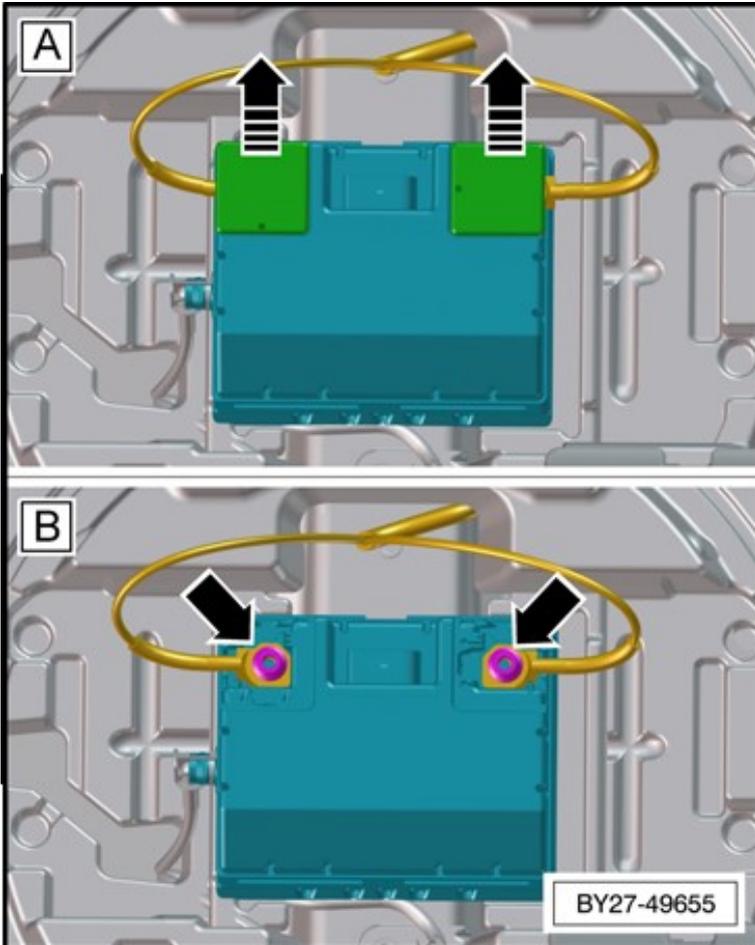
Figure 1

- 1) Referring to Rep.Gr 27 - Deactivate the 48 volt system - Refer to 48 volt system - To activate and deactivate
- 2) Referring to Rep.Gr 27 - Check the security of the super capacitor positive and negative terminals (Figure 1) as follows:
 - Remove the caps (A) from the terminals
 - Check the security of the positive and negative terminals (B) are as described within Rep.Gr 27

- In the event that one or both terminals were not tightened to the correct torque as Rep.Gr 27, the operative must tighten the terminal(s) to the correct torque as detailed within Rep.Gr 27 - Super capacitor

In the event one or both terminals required tightening to the correct torque (found to be not initially secure) the operative must feedback the findings via DISS

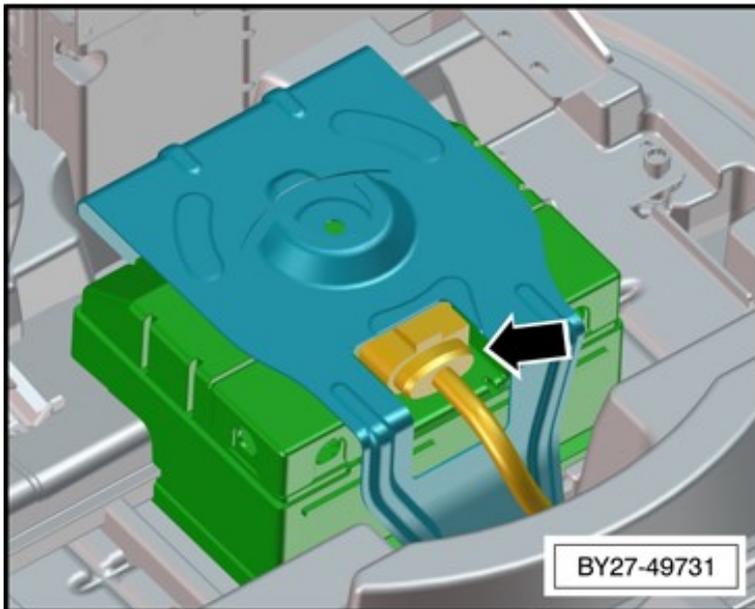
3) Referring to Figure 2 - Check the security of the harness connector

- In the event the harness connector is not secure the operative must secure the connector

Should an issue be identified with the connector or super capacitor which doesn't allow the connector to be secured the operative must feedback via DISS
