Field campaign

Topic	Software Update Window Short Drop Deletion Continental GT/GTC 26MY (SC25 /31)
Market area	Bentley: worldwide (2WBE),China 796 VW Import Comp. Ltd (Vico), Beijing (6796)
Brand	Bentley
Transaction No.	2078277/22
Campaign number	ED59
Note	
Type	
US code

Software Update | Window Short Drop Deletion | Continental GT/GTC | 26MY
(SC25/31)

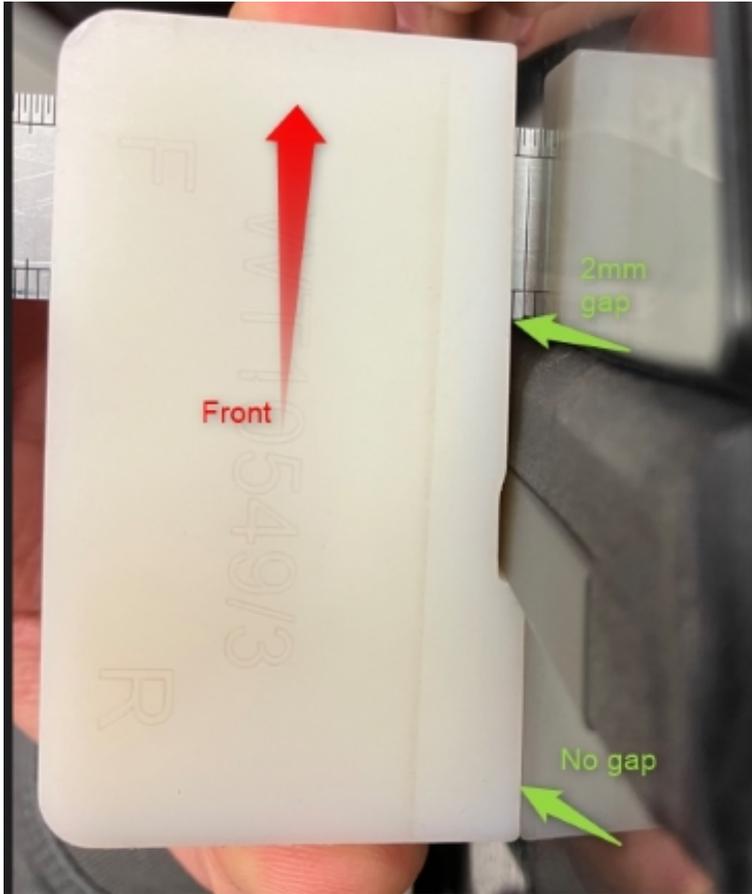
Figure 1

When the window is parallel take the 2mm step from the tool and minus the 2mm gap between front window and tool = -0mm (as shown in figure 1)

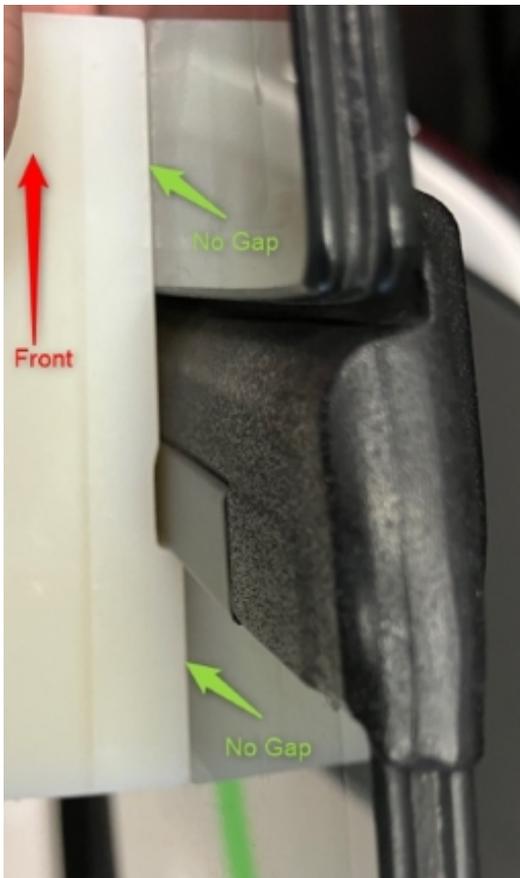
Figure 3

When the rear window is inboard and there is a 2mm step from the tool, when there is no gap between either window and tool (figure 3), the recorded measurement should be -2mm (figure 4)

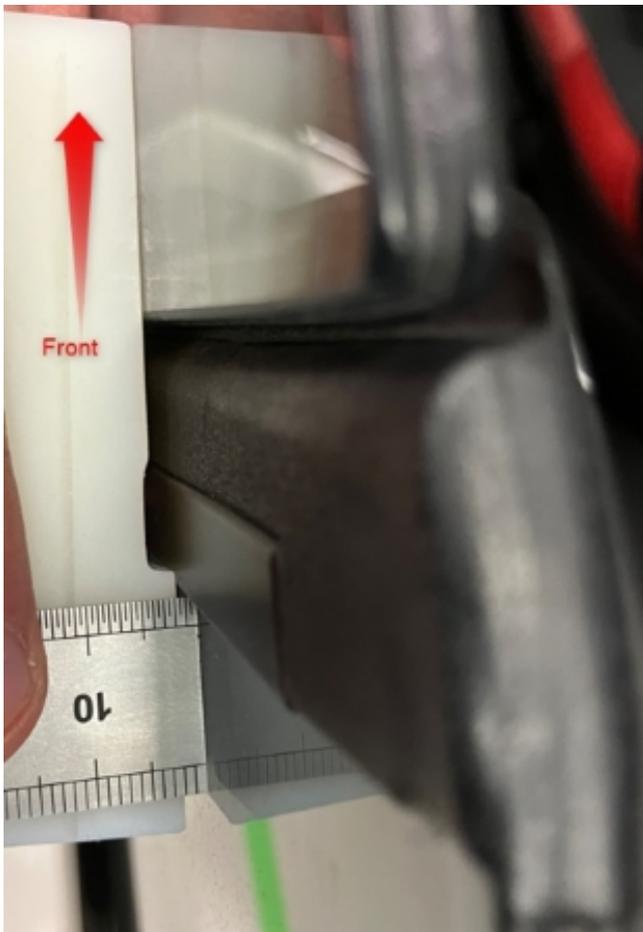
Figure 5

When the rear window is inboard and there is a 2mm step from the tool as well as an additional 1.5mm gap to the window (figure 5), the recorded measurement should be -3.5mm (figure 6).

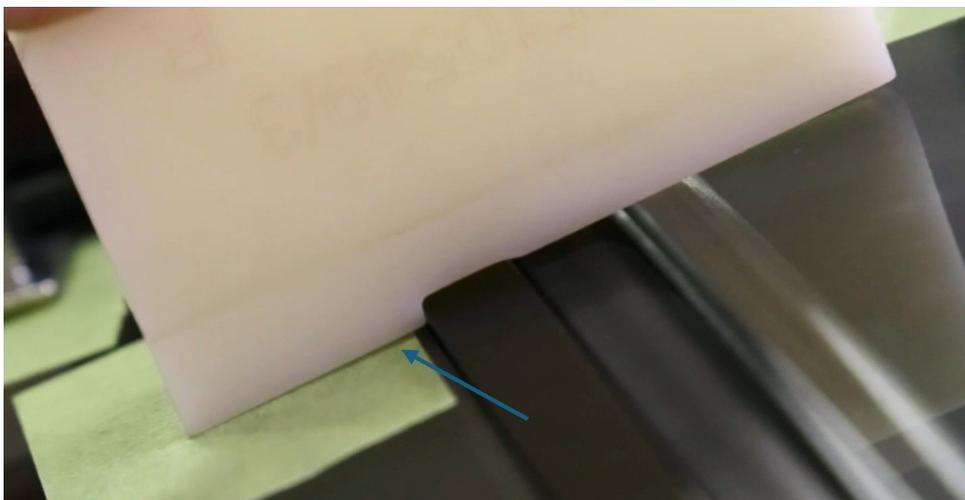
Figure 7

If the tool (WT10549/3) does not sit flush against the rear window then this shows rear window is more than 2mm inboard (more than -2mm), check this by holding the tool on the front window and measuring gap between the rear glass and the tool (as shown in figure 7)

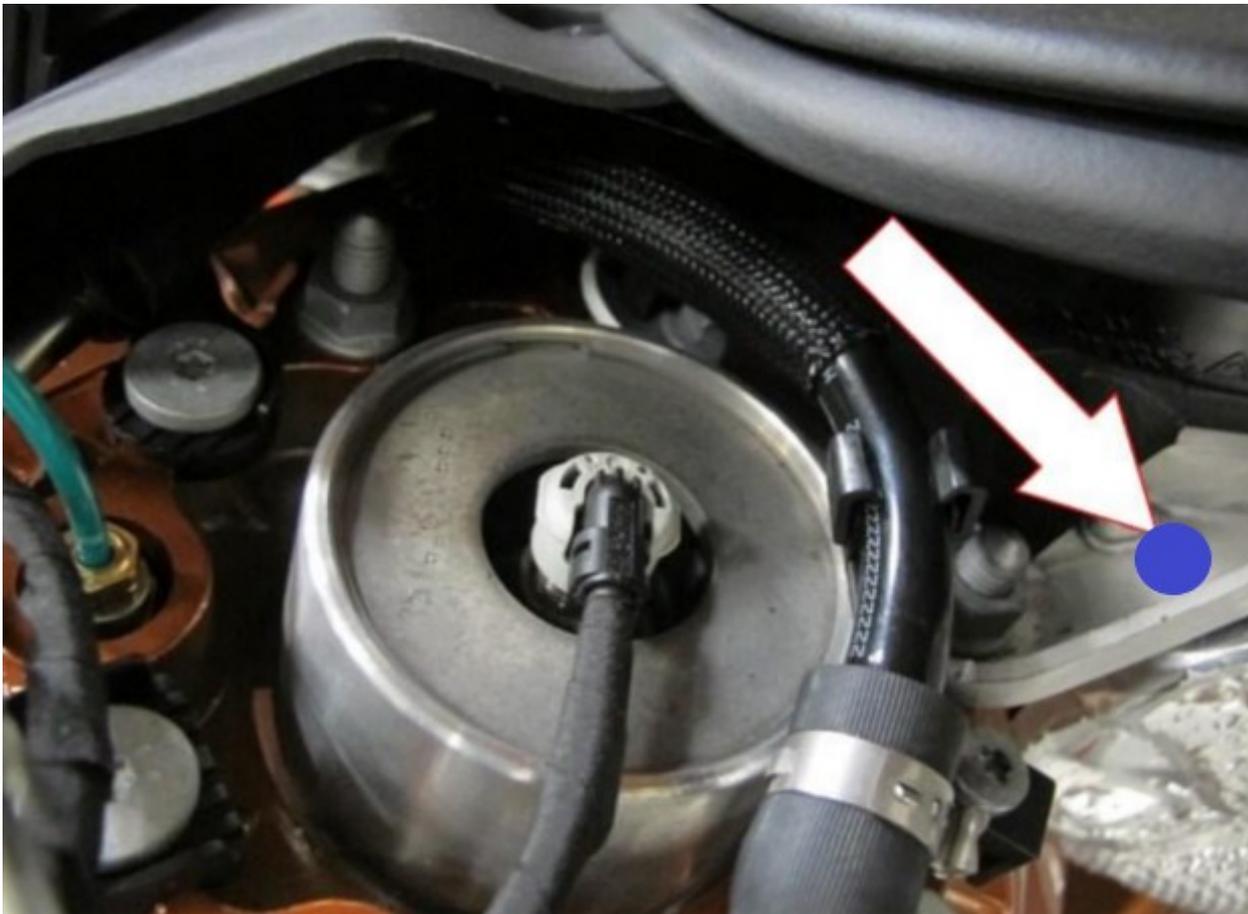
Figure 12

Blue paint completion mark on the engine partition brace

13) Referring to the Identification section - Apply a blue paint completion mark on the engine partition brace (Figure 12)
