Document ID: IK2600279

Title: Switch Pack Programming Troubleshooting Information

Applies To: Horizon Vehicles

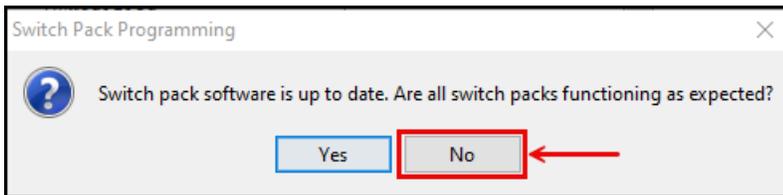
5. Once programming is successful and DLB asks you if all switch packs are working correctly, select "No". Selecting "No" is the only way to get to the next screen that allows you to change the switch pack's source address.

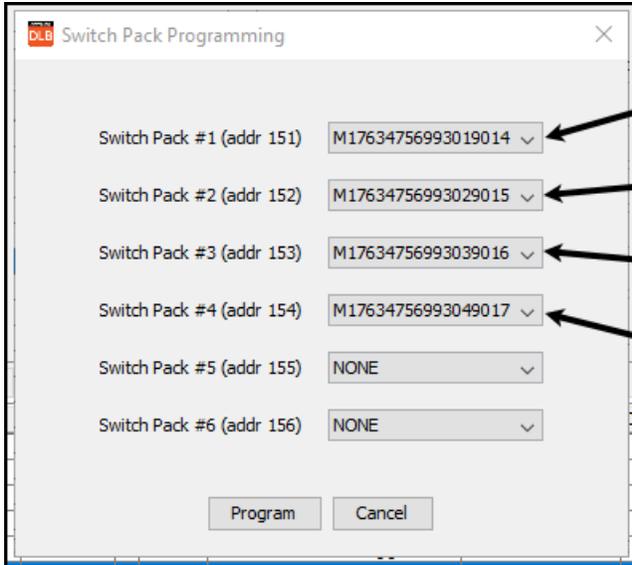
6. The next screen allows you to set the switch pack source addresses. The dropdown menu displays the serial number for all connected switch packs. Make sure you select the correct serial number on the correct line, then click the "Program" button.

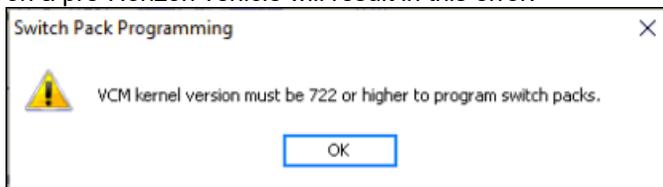
- When you hear the word "kernel", think "operating system". The kernel is the software that runs the switch pack's functionality.
- Only Horizon vehicles (LT, MV, HV, RH...) have programmable switch packs (switch packs that have their own operating system that can be updated with DLB).
- Pre-Horizon vehicles (Durastar, Prostar, Lonestar...) have switch packs, but they cannot be updated or programmed with DLB (because they do not have a kernel). Attempting to use DLB to program switch packs on a pre-Horizon vehicle will result in this error:
