Technical Service Bulletin: TSB250222

CM2450K System Control Module (SCM) Bootloader v2.4.7.3 Not Compatible with Accelera™ Diagnostics Electronic Service Tool

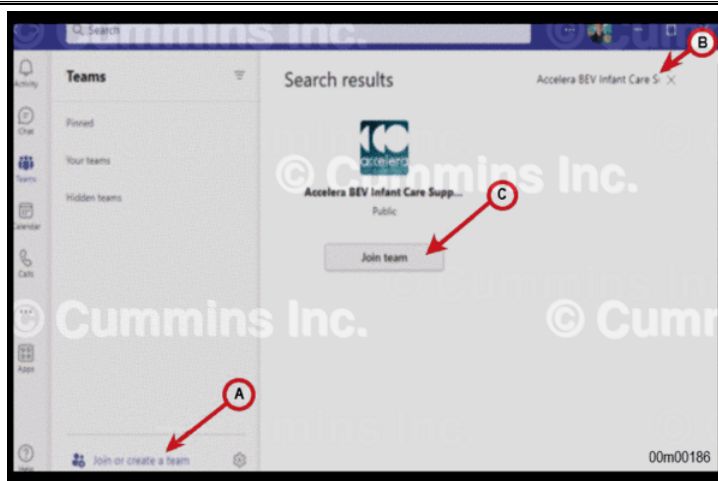
Figure 1, Gaining access to "Accelera BEV Infant Care Support Teams"

1. Navigate to Teams on Microsoft Teams.
2. In 'Accelera BEV Infant Care Support', select 'BES CM2450 EV101B'. To gain access:
  - 2a. Select 'Join or create a team.'
  - 2b. Search 'Accelera BEV Infant Care Support.'
  - 2c. Select 'Join team.'

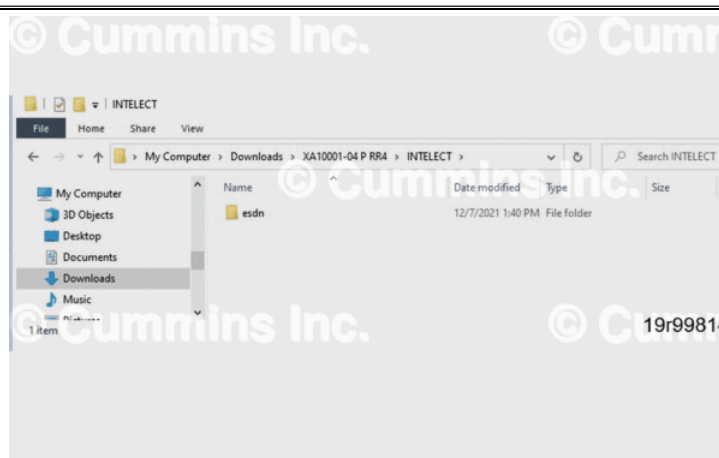
Figure 2, Unzipped File Containing Calibration

- After obtaining the SCM calibration, unzip the file if needed, open the “INTELECT” folder and verify there is an “esdn” folder within.

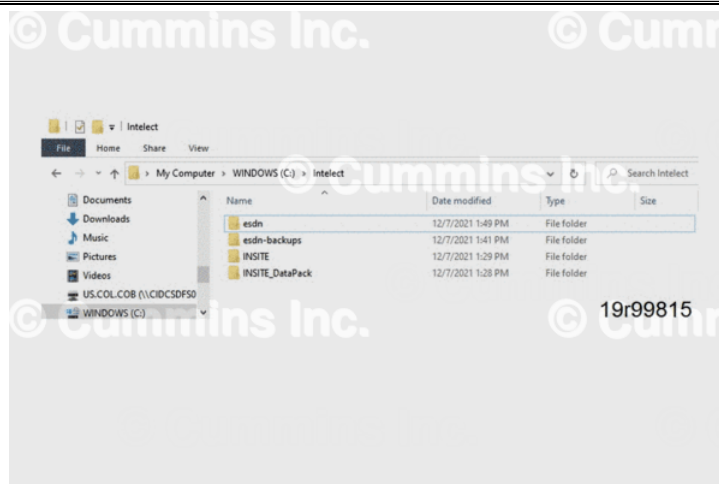
Figure 3, C:\Intelect directory containing existing “esdn” folder.

- Navigate to C:\Intelect to check for an existing “esdn” folder. If the “esdn” folder exists, delete/rename/move the “esdn” folder.

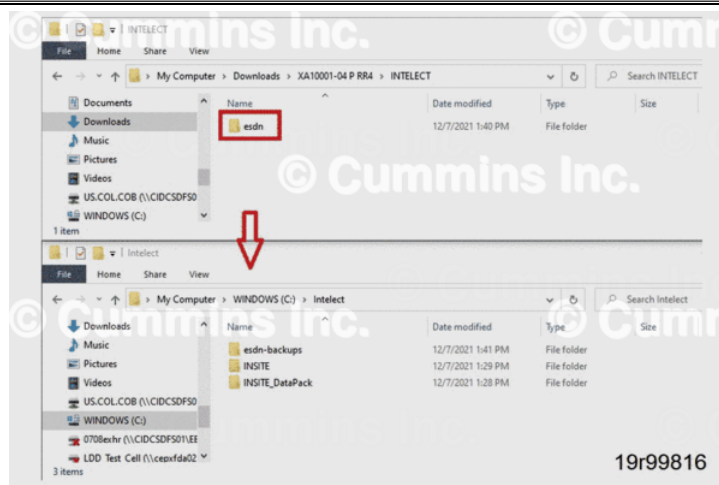
Figure 4, Copying Downloaded “esdn” Folder to “C:\Intelect”.

- Copy the “esdn” folder from the downloaded calibration folder to “C:\Intelect”.
