Technical Service Bulletin: TSB250223

CM2450K System Control Module (SCM) Bootloader v2.4.7.3 Not Compatible with Accelera™ Diagnostics Electronic Service Tool

- BES CM2450 EV109B

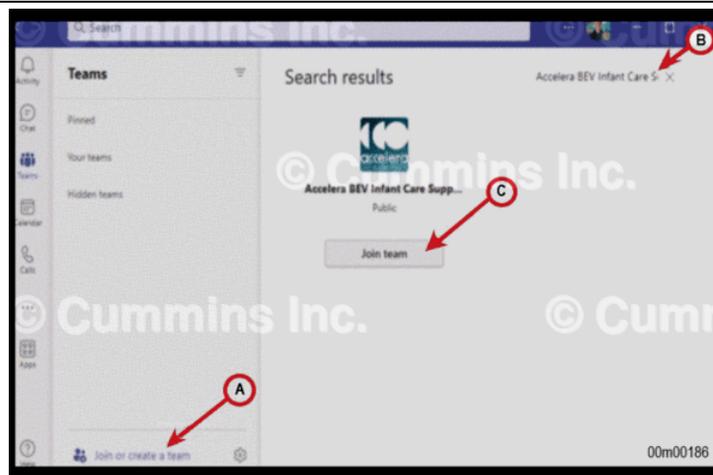
Figure 1, Gaining access to "Accelera BEV Infant Care Support Teams"

1. Navigate to Teams on Microsoft Teams.
2. In 'Accelera BEV Infant Care Support', select 'BES CM2450 EV109B'. To gain access:
  - 2a. Select 'Join or create a team.'
  - 2b. Search 'Accelera BEV Infant Care Support.'
  - 2c. Select 'Join team.'

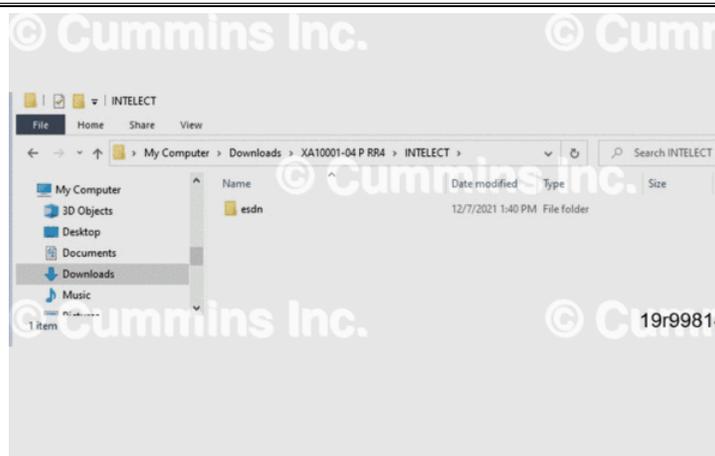
Figure 2, Unzipped File Containing Calibration.

- After obtaining the SCM calibration, unzip the file if needed, open the “INTELECT” folder and verify there is an “esdn” folder within.

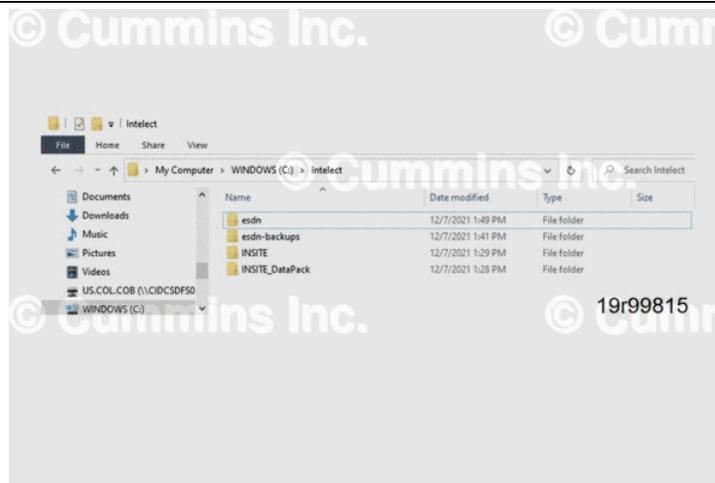
Figure 3, C:\Intelect directory containing existing “esdn” folder.

- Navigate to C:\Intelect to check for an existing “esdn” folder. If the “esdn” folder exists, delete/rename/move the “esdn” folder.

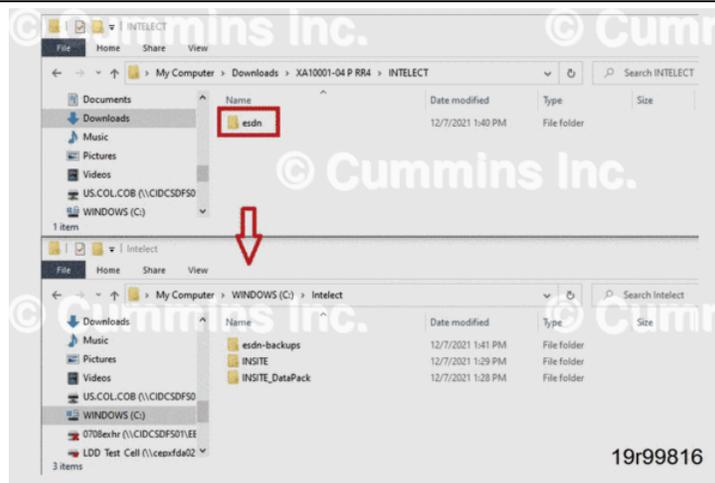
Figure 4, Copying Downloaded “esdn” Folder to “C:\Intelect”.

- Copy the “esdn” folder from the downloaded calibration folder to “C:\Intelect”.
