Technical Service Bulletin

Topic	Engine Overheating - Coolant Pump Leaking and Low Coolant Warning W12
Market area	Bentley: worldwide (2WBE)
Brand	Bentley
Transaction No.	2071239/5
Level	EH
Status	Released for publishing
Release date	Dec 4, 2025

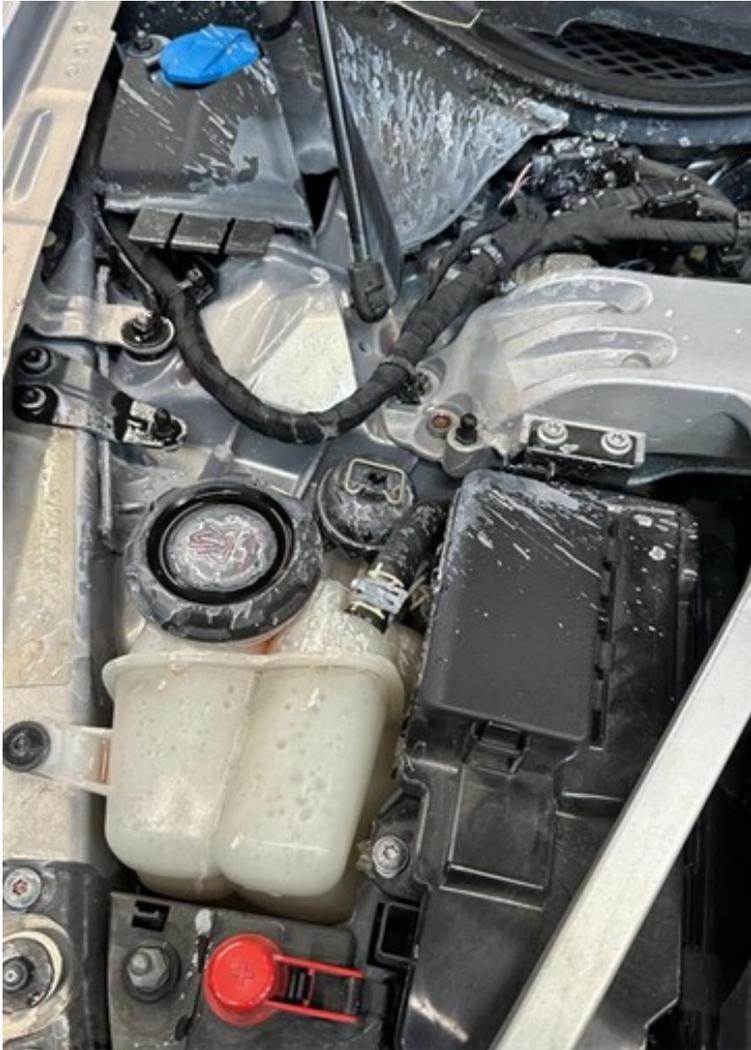
Figure 1

1) On receipt of the vehicle - Take a photograph of the coolant level within the coolant reservoir and inspect the engine bay for any coolant residue (figure 1).

If coolant residue is found in the engine bay, please raise a full technical DISS query and attach a photograph of the coolant residue and a photograph of the coolant level.

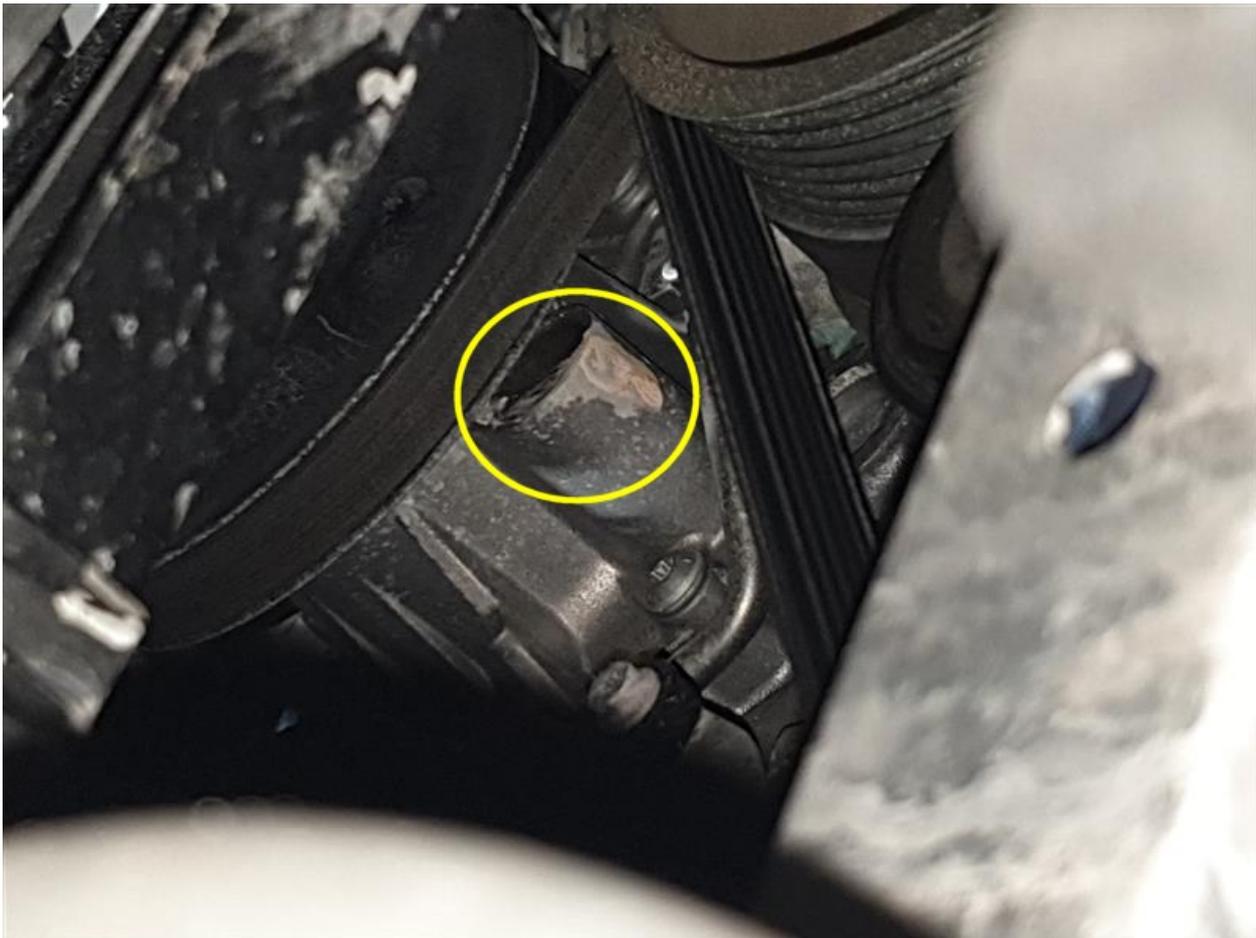
Figure 2

The video shows an example of a coolant pump with no leak, although a small coolant witness mark is evident (Figure 2). In this scenario the coolant witness mark should be cleaned off (using a suitable cleaning agent) to the condition shown in Figure 3

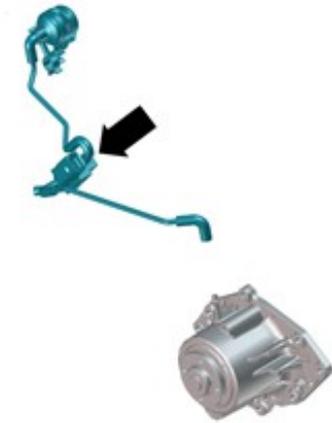
5) Referring to Figure 4 - Disconnect each vacuum hose with care from the Solenoid for coolant circuit N492 - visually monitor for any traces of coolant

VERY IMPORTANT: If traces of coolant are evident during disconnection, take clear photos or record a clear video of any coolant within the vacuum hoses or N492 and attach to a new or existing technical DISS query

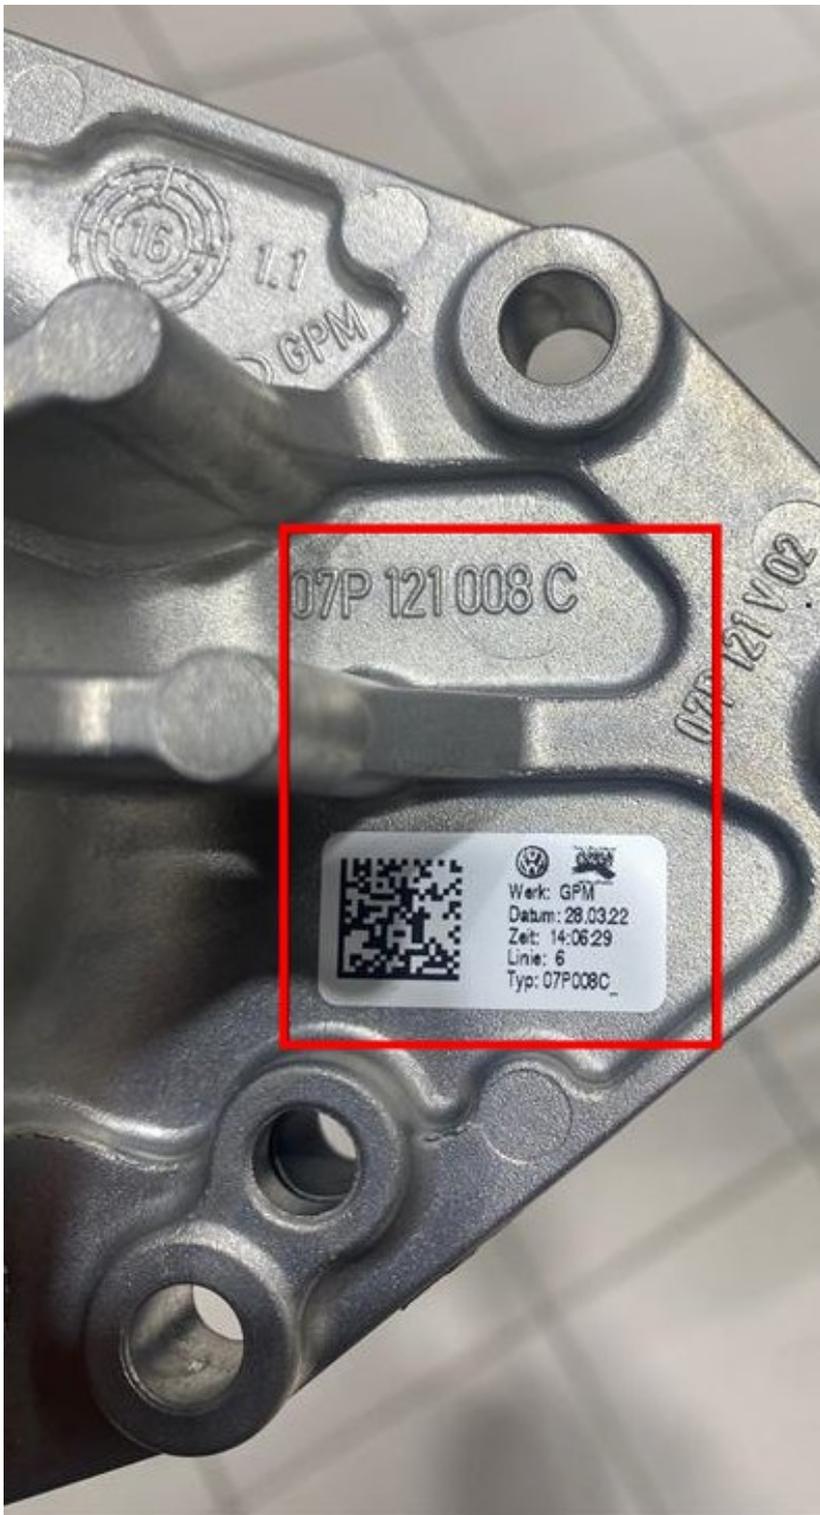
- Clear photo of the coolant level
- Clear photo of the original mechanical coolant pump part number **07P 121 008C** (Figure 5)
- Video of the coolant leak whilst carrying out the pressure test
- Current ODIS log
- Await feedback via DISS before replacing any parts

NOTE: The photo shown in Figure 5 is a C level coolant pump (shown removed from the vehicle for photographic purposes) a borescope may have to be used for photographs of the coolant pump when fitted

9) Replace the following

- Mechanical coolant pump - Rep.Gr 19
- Solenoid for coolant circuit N492 assembly - Rep.Gr 19
