Technical Service Bulletin

Topic	Engine Overheating - Warning in the DIP V8 Kovomo
Market area	Bentley: worldwide (2WBE),China 723 Volkswagen (Anhui) Automotive CO (6723),China 796 VW Import Comp. Ltd (Vico), Beijing (6796)
Brand	Bentley
Transaction No.	2061369/11
Level	EH
Status	Released for publishing
Release date	Dec 10, 2025

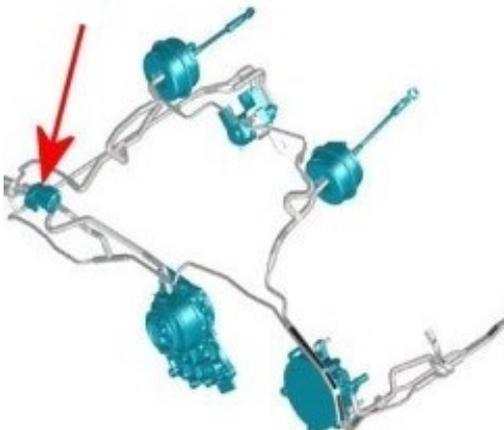
Figure 1

To allow the engine coolant to heat as quickly as possible (from cold start) coolant delivery from the mechanical coolant pump is interrupted by switch valve N649

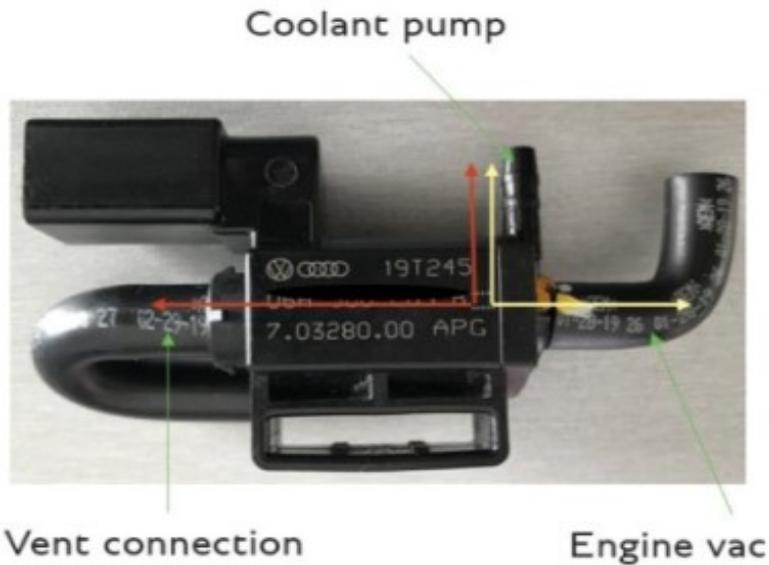
Figure 3

The correct operation of N649 (Figure 3) is as follows

Un-energised state (Ignition off) - Coolant pump connected to vent connection (red arrows)

Energised state (Ignition on) - Engine vacuum connection to coolant pump (yellow arrows)

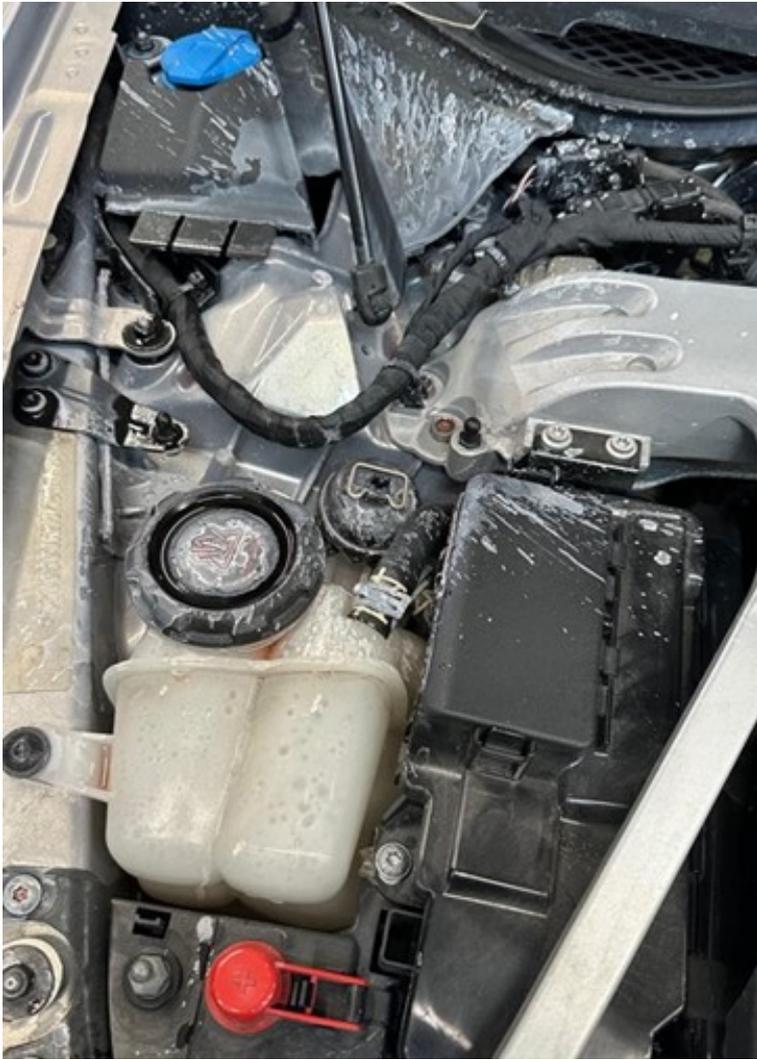
Figure 4

When inspecting the engine bay coolant residue can sometimes be seen around the reservoir when the engine has overheated (figure 4).

If this condition is found, the coolant may also be below the minimum level.

If coolant residue is found in the engine bay, please raise a full technical DISS query and attach a photograph of the coolant residue. If the coolant level is below the minimum level please also attach photographic evidence of this.
