Technical Service Bulletin

Topic	Exhaust Flap Control Unit - Various DTCs Bentley Series 17-25MY
Market area	Bentley: worldwide (2WBE),China 796 VW Import Comp. Ltd (Vico), Beijing (6796)
Brand	Bentley
Transaction No.	2077982/2
Level	EH
Status	Released for publishing
Release date	Dec 10, 2025

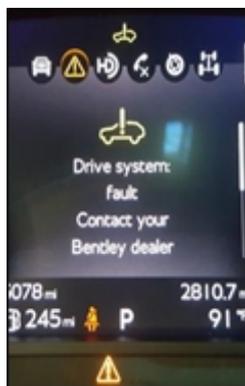
Figure 1

Warning lamp illuminated within the Driver Instrument Panel (DIP)

“Drive system fault. Contact your Bentley dealer” (Figure 1)

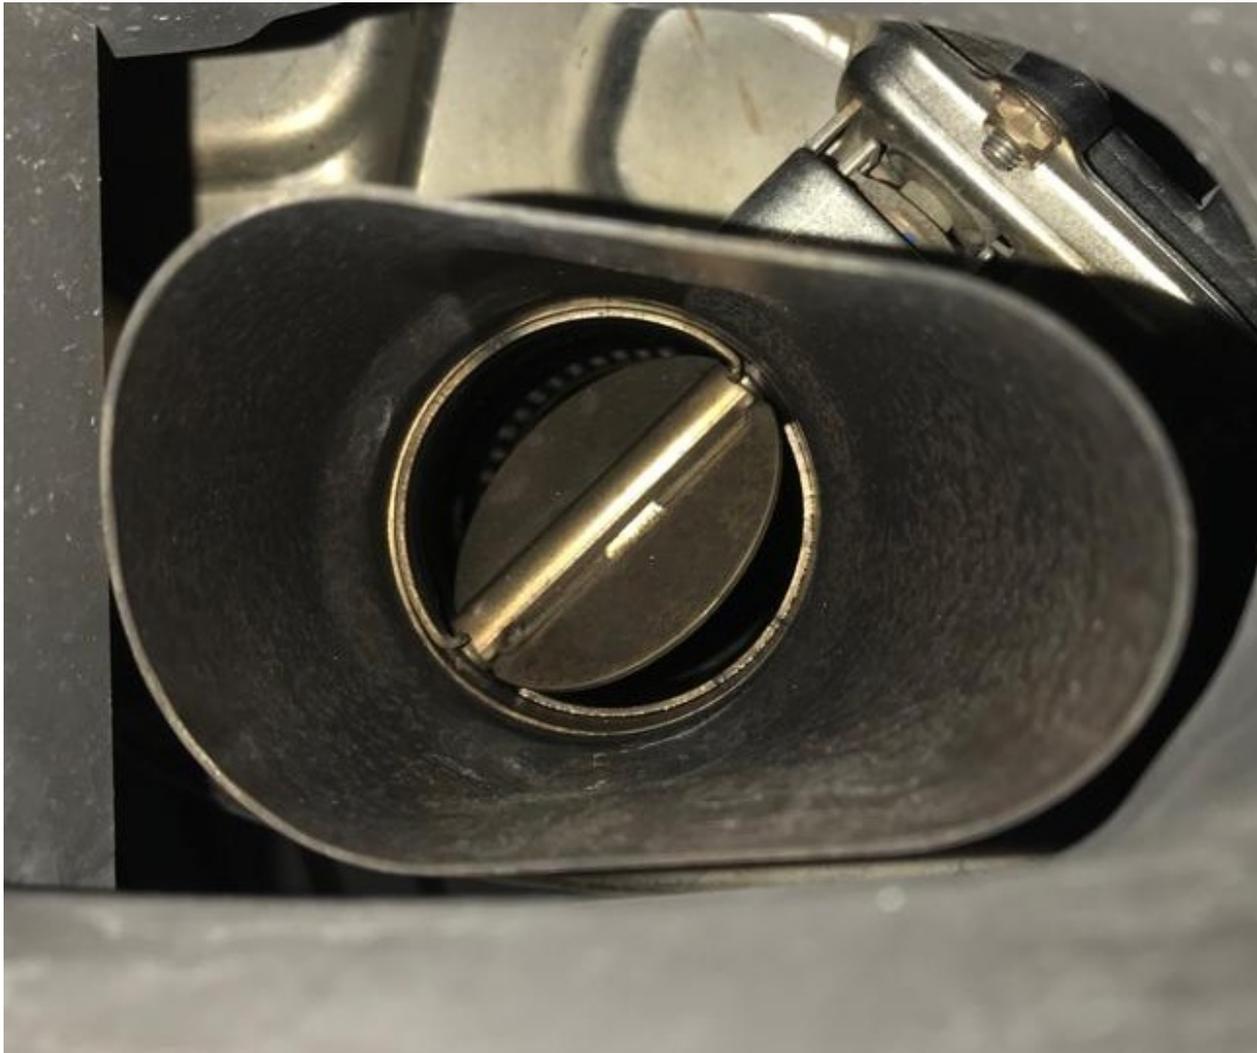
The root cause of Exhaust Flap Control Unit malfunction is electrical ‘shorting’ of the commutator segments, this is caused by an accumulation of “Sludge” within the exhaust flap control unit

If an Exhaust Flap is stuck in an open, closed, partially closed position or does not achieve a full range of motion continue to follow the instructions within this Technical Product Information (TPI) document - Figure 2

Remove the suspected Exhaust Flap Control Unit – Refer to ***Repair Group. 26 Exhaust system – Exhaust flap control unit – To remove and fit***

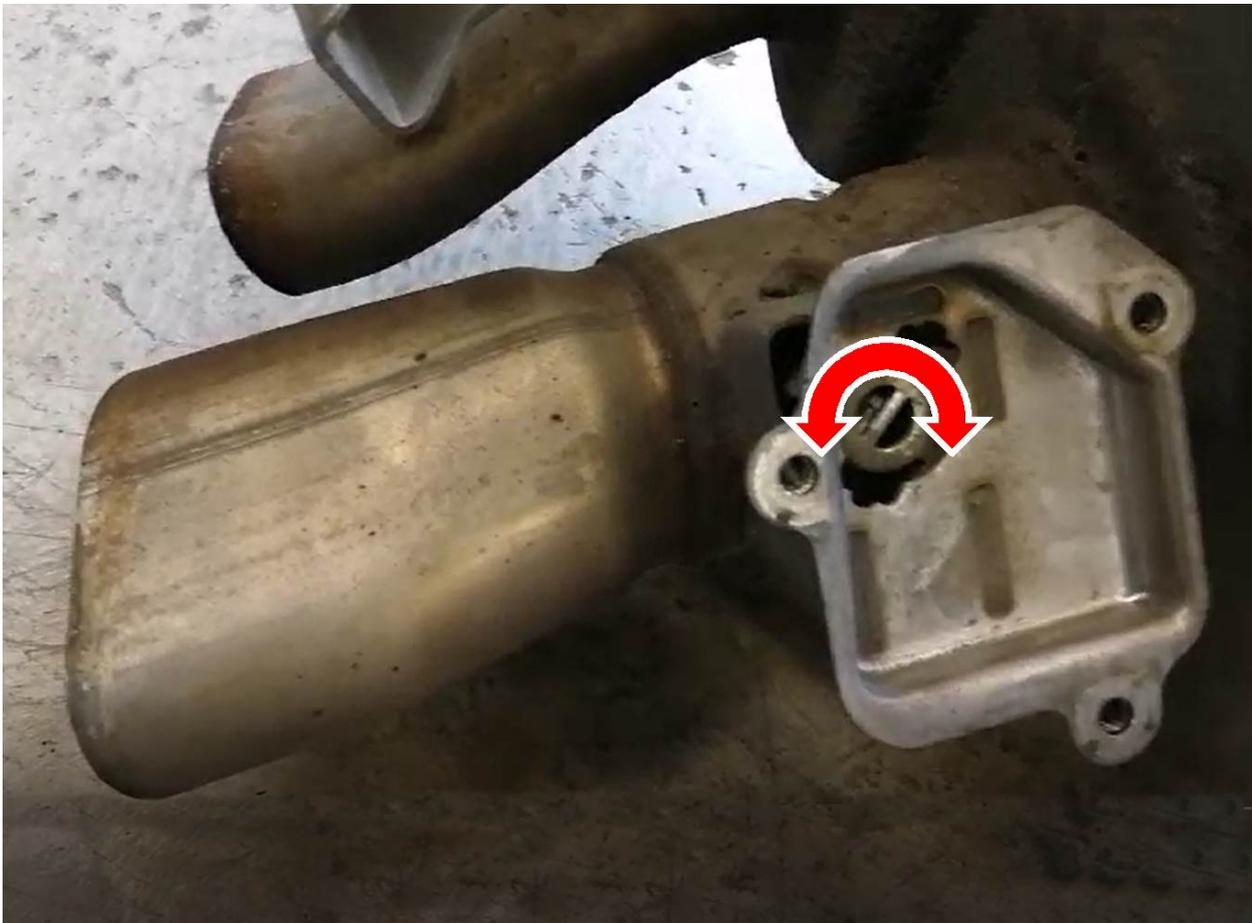
Check and confirm the Exhaust Flap spindle is free to open and close by hand - Figure 3

If no issue is evident and the Exhaust Flap oscillates freely by hand - replace the defective Exhaust Flap Control Unit, refer to *Repair Group. 26 Exhaust system - Exhaust flap control unit - To remove and fit*

If the Exhaust Flap does not oscillate freely by hand – replace the exhaust system. Refer to *Repair Group. 26 Exhaust system – Rear silencer and pipes – To remove and fit*
