Technical Service Bulletin

Topic	Front door clash with the rear door brightware Bentayga Series 21MY - 25MY
Market area	Bentley: worldwide (2WBE),China 723 Volkswagen (Anhui) Automotive CO (6723),China 796 VW Import Comp. Ltd (Vico), Beijing (6796)
Brand	Bentley
Transaction No.	2068064/5
Level	EH
Status	Released for publishing
Release date	Dec 10, 2025

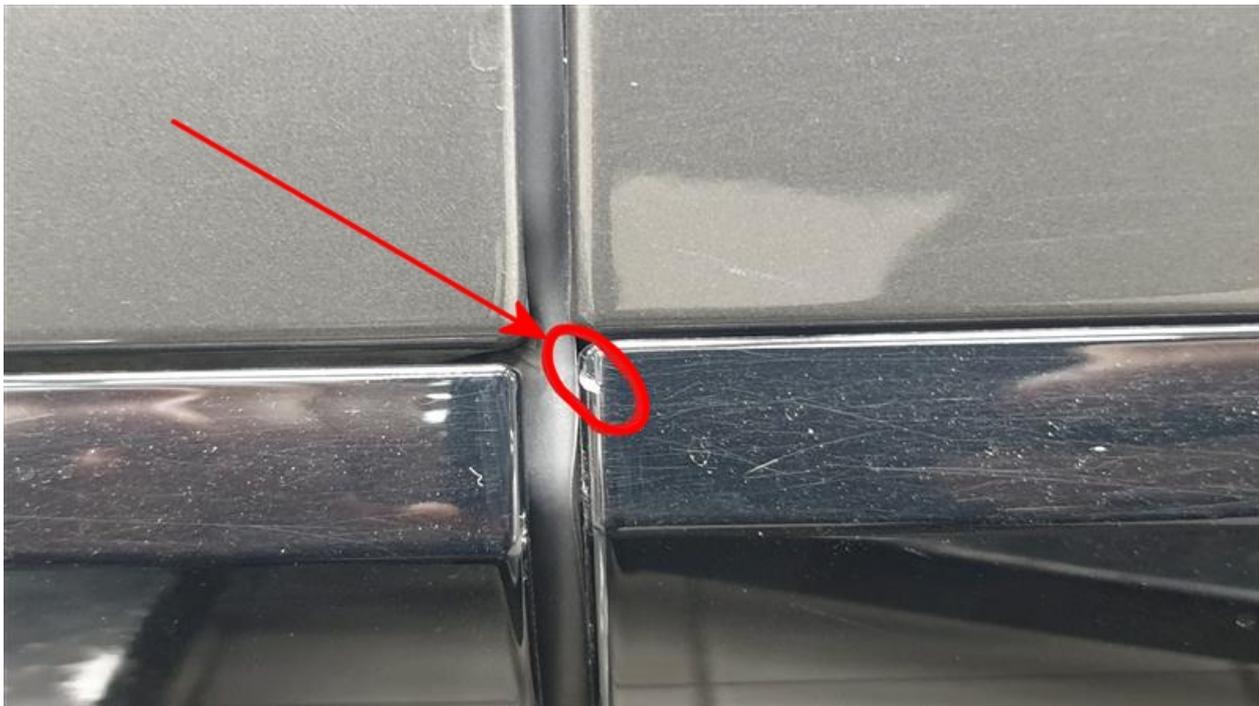
Figure 1

The front door inner panel hem is clashing with the rear door lower brightware (Figure 1) during the closing operation of the front door

1) With extreme care - Use a suitable "smooth cut hand file" to remove the raised inner door panel hem edge, until the hem edge is as shown in Figure 5

2) Once the protruding hem edge has been suitably reduced, close the front door to confirm the issue is resolved (No clash condition evident between the front door inner panel hem and the rear door lower brightware)

3) Conduct a paint repair to the applicable area **ensuring all approved paint repair guidelines are strictly followed to eliminate the risk of any paint and/or corrosion related issues**

4) Referring to Rep.Gr 66 - Replace the rear door lower brightware

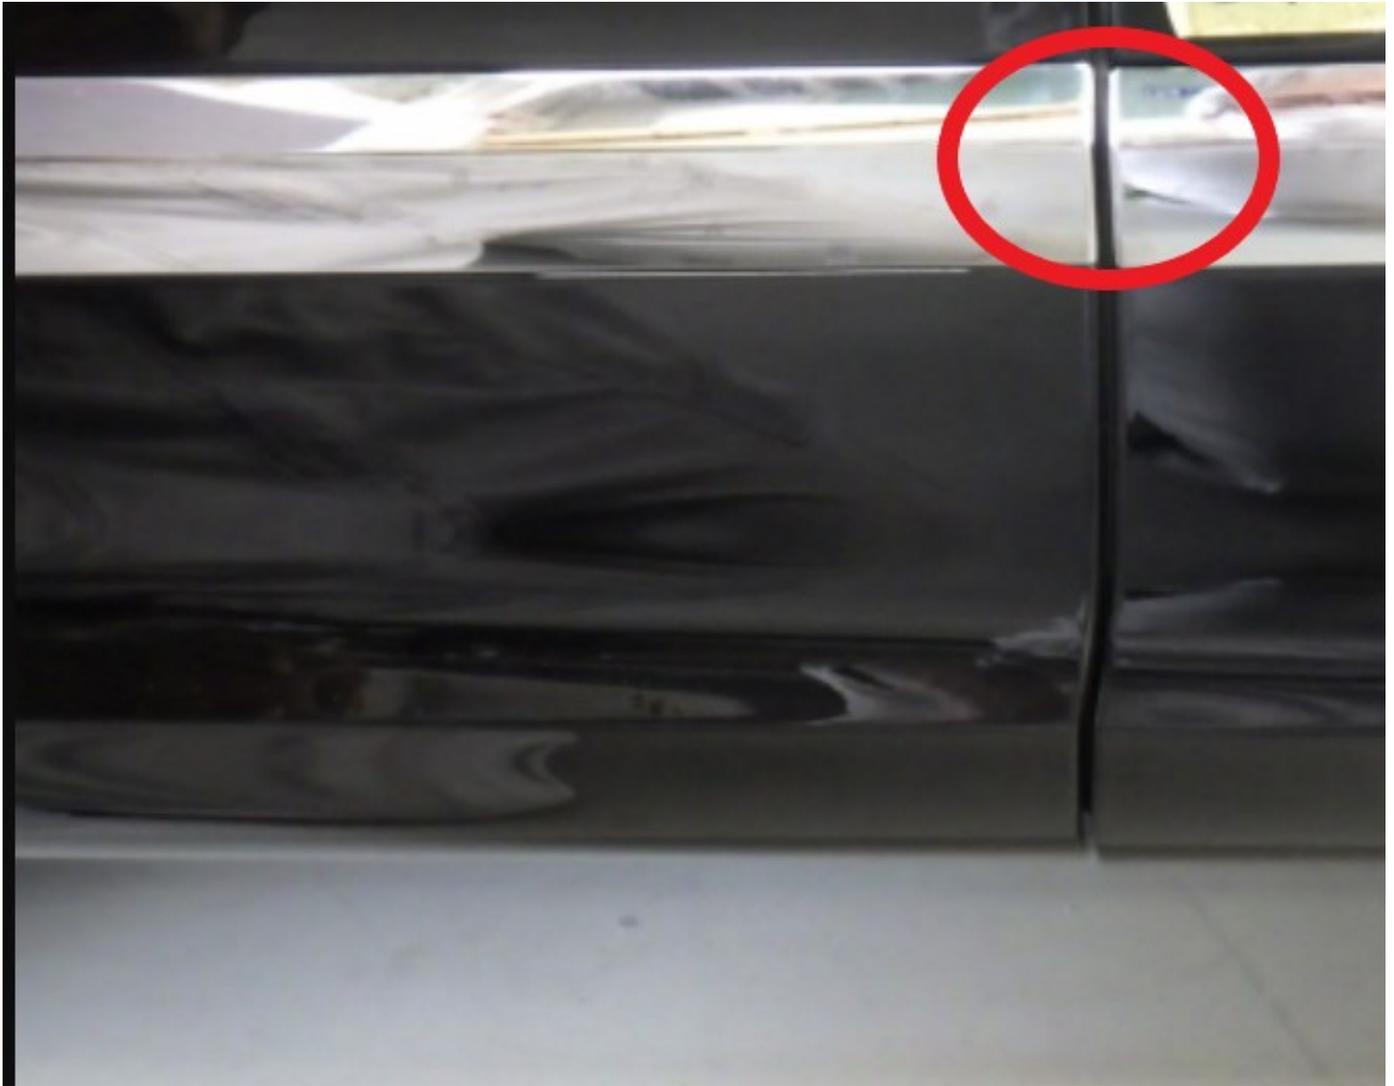
The rear door lower brightware is clashing with the front door brightware (Figure 2)

In the event the rear door lower brightware is clashing with the front door lower brightware as shown in Figure 2 the operative should conduct the instructions within the Measure section for (Scenario 2)

In the event the issue is as described and the clash condition is between the rear door lower brightware and the front door lower brightware the operative must refer to the instructions within Rep.Gr 66 - Door lower brightware – To remove and fit ensuring the following before refitting:

- If you are re-using the old part, replace the adhesive strips with "3M automotive acrylic tape" or similar, locally sourced
- Clean the bonding surface of the door with Cleaning solution 3M VHB before refitting the lower brightware

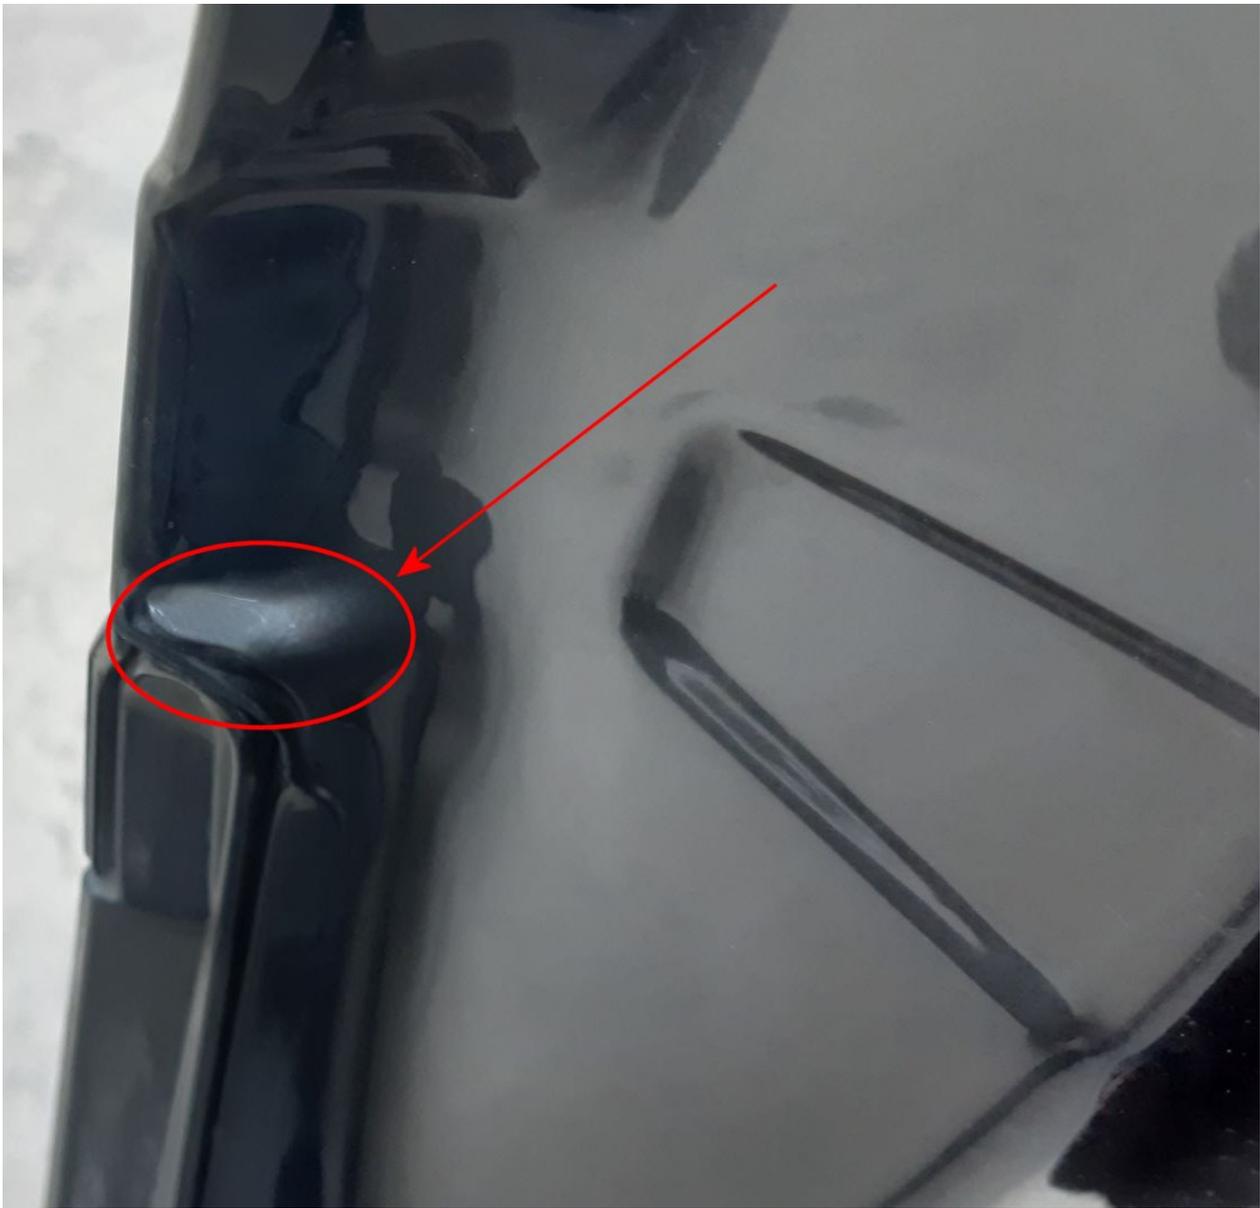
Figure 3

The issue is evident due to a clash condition between the front door inner panel hem (Figure 3) and the rear door lower brightware (Figure 4)
