Technical Service Bulletin

Topic	High pitched whistle from the engine - Warning light within the DIP - Engine not running smoothly - Numerous DTC's
Market area	Bentley: worldwide (2WBE),China 796 VW Import Comp. Ltd (Vico), Beijing (6796)
Brand	Bentley
Transaction No.	2075922/3
Level	EH
Status	Released for publishing
Release date	Dec 10, 2025

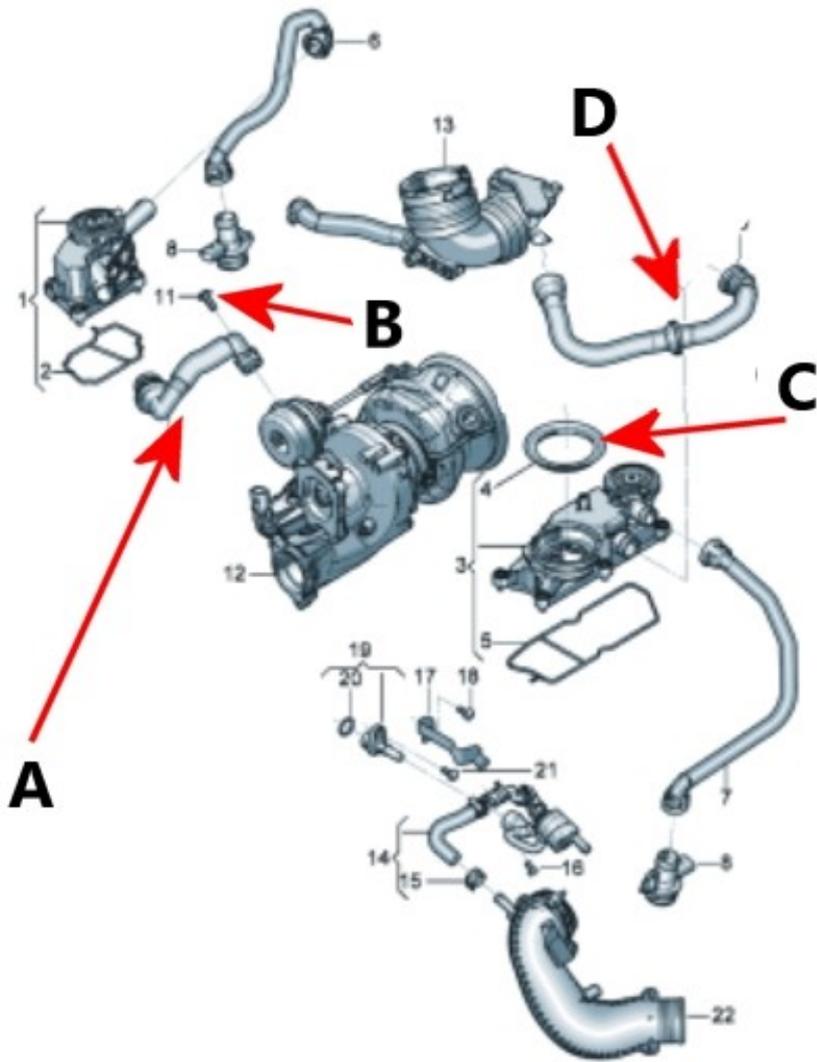
Air intake leak - Please refer to the instructions within the Measure section of this TPI

2) Referring to Figure 2 - Replace the following:

- Bank 1 Breather line (Point A) and fixing (Point B) - Refer to applicable sections from Rep.Gr 10 - Oil mist separator bank 1 - To remove and fit
- Replace the oil filler pipe seal to the Bank 2 oil separator (Point C)
- Replace the Bank 2 Breather line (Point D) - Refer to applicable sections from Rep.Gr 10 - Oil mist separator bank 1 - To remove and fit
