# Technical Service Bulletin

<b>Topic</b>	HVAC failing to cool   DTC B16A1F0 in diagnostic address 00C5   Bentayga Series (Hybrid)   23MY - 25MY
<b>Market area</b>	Australia E04 Bentley rest Asia and Australia (6E04),China 723 Volkswagen (Anhui) Automotive CO (6723),China 796 VW Import Comp. Ltd (Vico), Beijing (6796),Germany E02 Bentley rest Europe (6E02),Japan E03 Bentley Japan (6E03),Korea, (South) E08 Bentley South Korea (6E08),United Arab Emirates E06 Bentley Middle East and Africa (6E06),United Kingdom E01 Bentley UK (6E01),United States E05 Bentley USA and rest America (6E05)
<b>Brand</b>	Bentley
<b>Transaction No.</b>	2071190/3
<b>Level</b>	EH
<b>Status</b>	Released for publishing
<b>Release date</b>	Dec 10, 2025

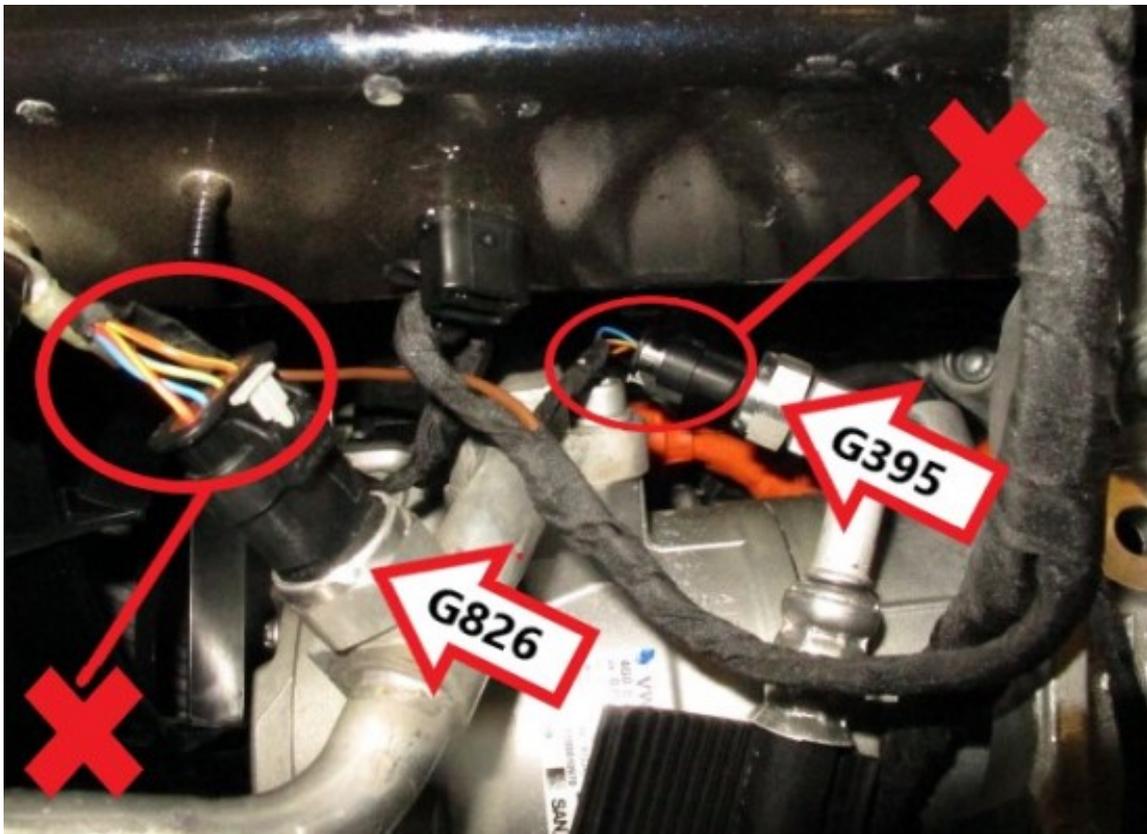
DTC B16A1F0 - Refrigerant shut-off valve Icing - water load too high, evident within diagnostic address 00C5

- 1) Referring to Rep.Gr 44 - Remove the left hand front wheel
- 2) Referring to Rep.Gr 66 - Remove the left hand front foremost wheel arch liner
- 3) Remove (x3) speaker box fixings (5Nm)
  - Disconnect the speaker box electrical connector
  - Remove the speaker box
- 4) Access can now be gained to the required connector plugs - Figure 1 shows G826 and G395 with the connector plugs fitted incorrectly
  - Low pressure sender G826 connector plug with 4 wires **(Incorrect)**
  - High pressure sender G395 connector plug with 3 wires **(Incorrect)**

In the event the pressure sender connector plugs are fitted incorrectly the plugs should be disconnected and refitted correctly as shown in Figures 2 and 3

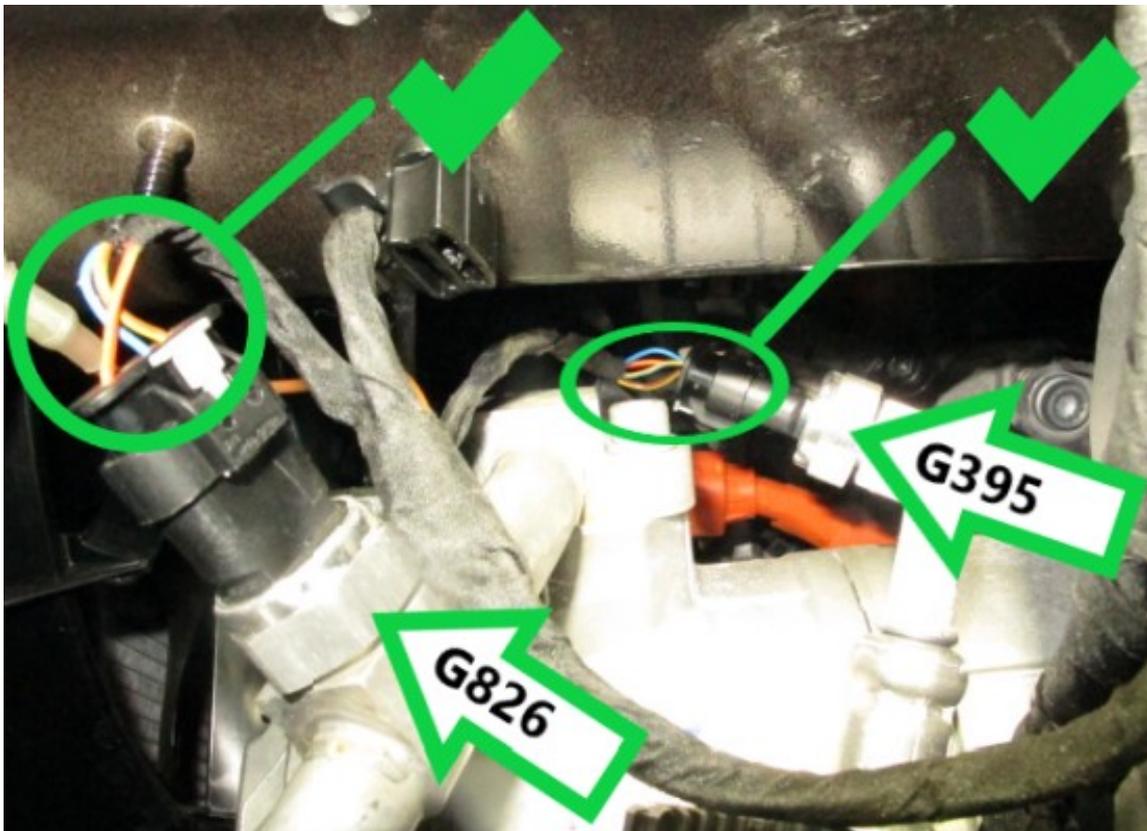
- Figure 2 shows G826 and G395 connector plugs fitted correctly
- Low pressure sender G826 connector plug with 3 wires (**Correct**)
- High pressure sender G395 connector plug with 4 wires (**Correct**)

5) Once the orientation of the connector plugs is correct - Refit all previously components

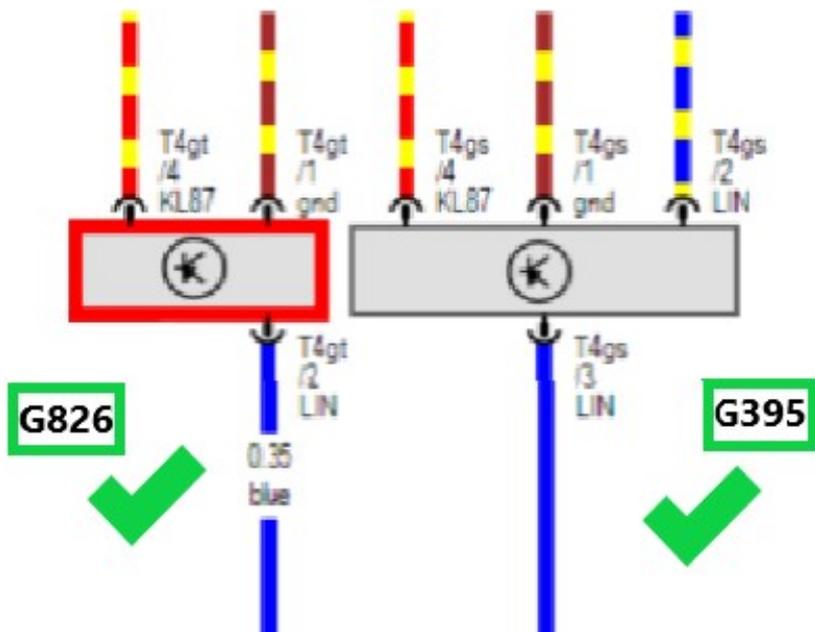
Hint: Figure 3 shows G826 and G395 as per the applicable Current Flow Diagram (Correct)
