# ABS Wheel Speed Sensor Faults

**Reference Documentation** Service Bulletin [TSB 42-080](#) publication date 5/10/24.

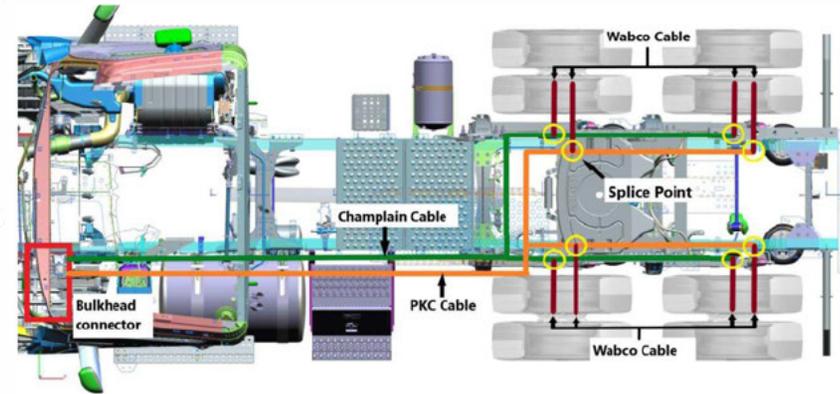
**Issue Description** Multitudes of ABS fault codes for rear drive axles, SA 791, 792, 793, and 794 FMI 1 air gap and/or FMI 7 tone wheel count.

- Status & Details**
- Inferior harness design. Lack of one twist per inch (spec)
  - Failure of over mold connector at wheel speed sensor end
  - Non-jacketed twisted pair
  - Moisture intrusion into engine wall connector BHB
  - Extensive harness length

**Field Action** Service Bulletin TSB 42-080 publication date 5/10/24.  
 WABCO jacketed harnesses on all drive axles exhibiting excessive codes.  
 Installation of YRR+ software.  
 Three phases of corrections that ultimately result in fully jacketed WABCO harnesses for all wheel speed sensors.
