CY2023 C/D DT12 Range Detent Pin

DT 12 Range Detent Pin

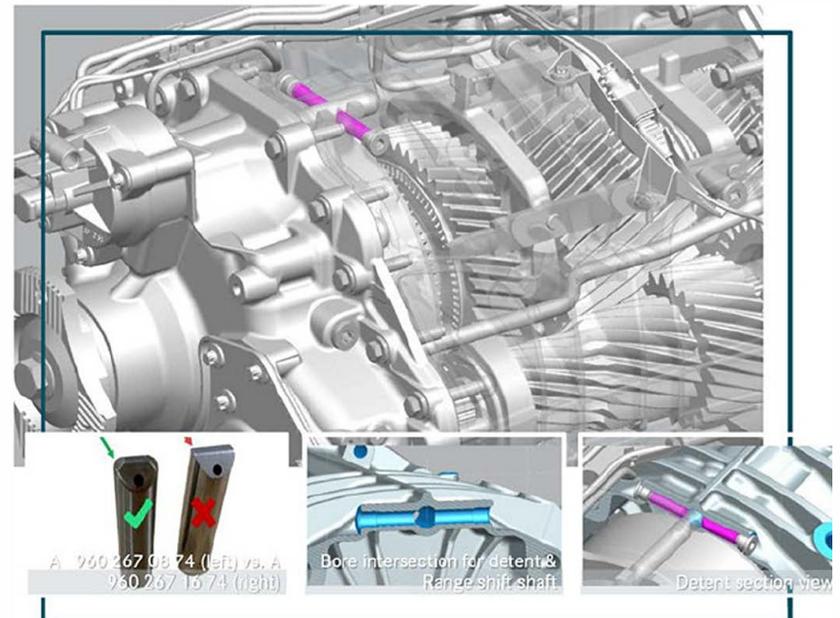
Issue Description 2023 built DT12 C/D transmissions range shift complaints (low mileage) – dropping to N, grinding during 6-7 shift, will not engage gear

Status & Details **Primary:** Burnishing at intersection of range shaft and detent bores insufficient, leaving burrs that hang the detent. **Secondary:** Range detent pin (without filleting) used for C/D transmission serials between 716350E0260359 and 716340E0267281 more susceptible to hanging up on a burr.

Field Action Production switched back to prior proven design of 0874 detent in 2023. Further refinements to detent in

Supplier corrected burnishing tool & path.

Additional Information Replacement detent part number A 960 267 08 74
