ECP (Electronic Control Pneumatic) Module Water Ingress

Issue Description Field failures of ECP device related to water/contaminants into solenoids through exhaust port

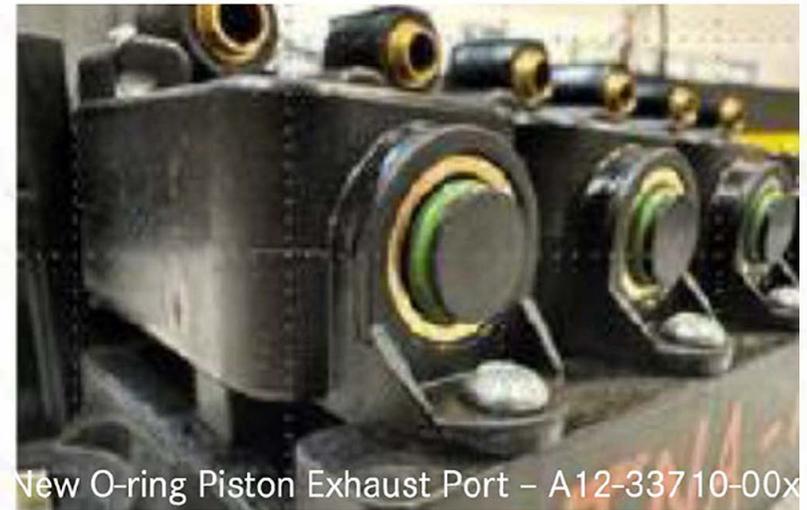
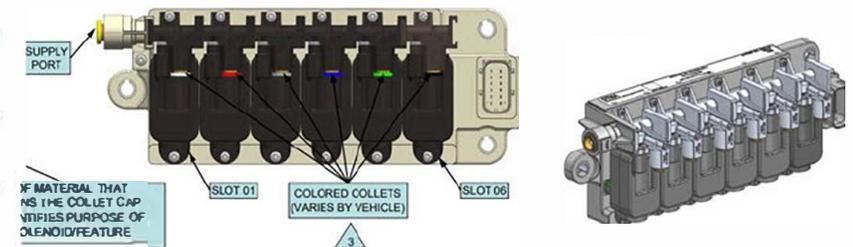
Status & Details Design of exhaust port (sintered nickel filter plug) was shown to be ineffective for protecting solenoid internals from contaminants and water, promoting rust which renders the solenoid ineffective (sticky) and losing function. Water and contaminant ingress through the exhaust port causing corrosion leading to the failure of the solenoid.

Additional Information Assembly: A12-33710-00x – New O-ring Solenoid

Field Action Troubleshoot and replace per TechLit instructions.
