Corrosion Protection/Glyptal Application

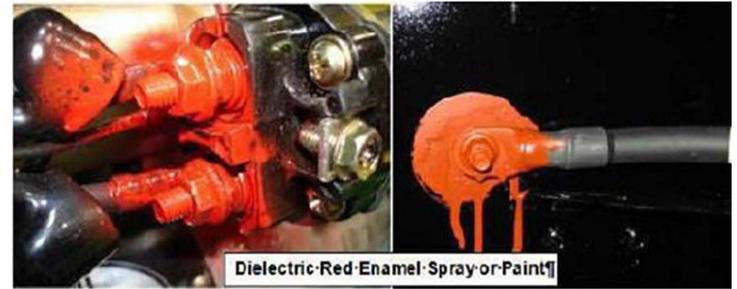
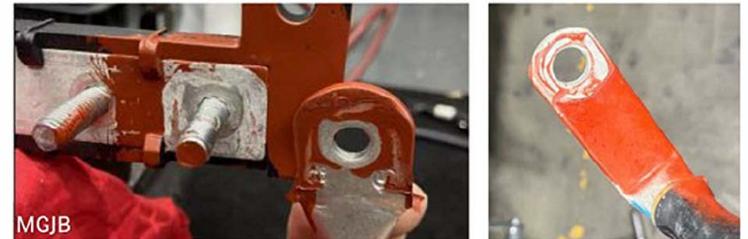
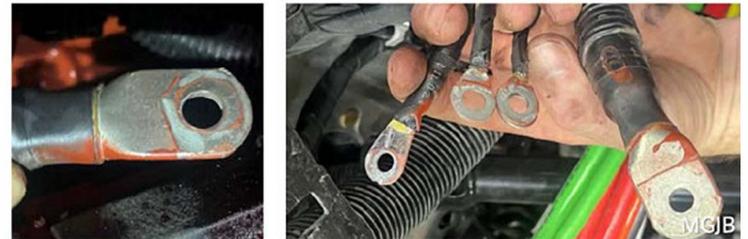
Issue Description Red Glyptal seepage into electrical connection joints causes open circuits and triggers ECU fault codes. Symptoms will be intermittent connections, grounding and other wiring related issues.

Status & Details Surface flatness around the studs of connections is inconsistent causing issues. Connection point attributes (flatness, hardware, torque, etc.), dielectric paint material, application method, and sequence of installation are still being investigated.

Excessive coating

Field Action Follow troubleshooting for any active faults.
For any suspected PowerNet issue, each terminal (particularly at MGJB, firewall, frame connections) must be removed and cleaned – simply checking torque is not sufficient.
