# Optimized Idle – Intermittent Hood Switch Interlock Preventing Start

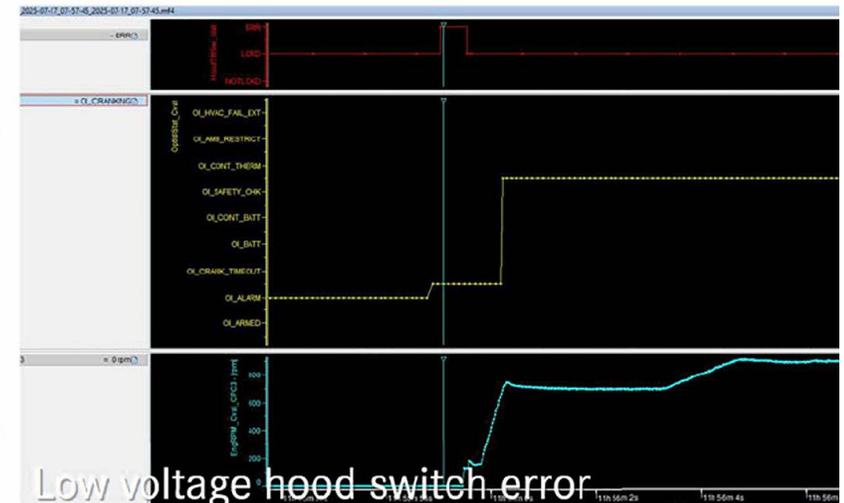
<b>Additional Information</b>	Resistive hood tilt switch 66-04116-000
