# Power Steering Reservoir – NTF Replacements

**Issue Description** NTF replacements of power steering reservoir due to regular misting

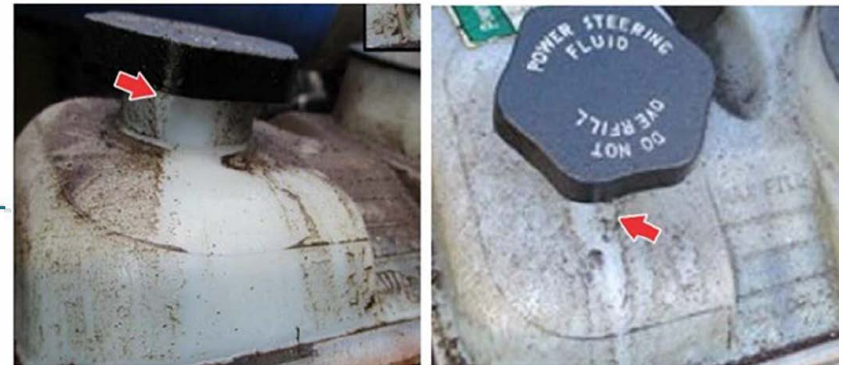
**Field Action** Normal venting operation can lead to a film of misted/vented power steering fluid on the exterior surface of the reservoir body. Depending on application, environmental conditions and maintenance practices, the amount of vented fluid film can vary. There are instances where fluid film buildup can pool along the reservoir body seam line. Certain applications/operating environments can lead to an excessive amount of debris accumulating on the vented fluid film.

Acceptable misting of power steering vent
