Gen 5 DD13 Turbocharger Oil Drain Tube Failure – Loose Mounting Bolts

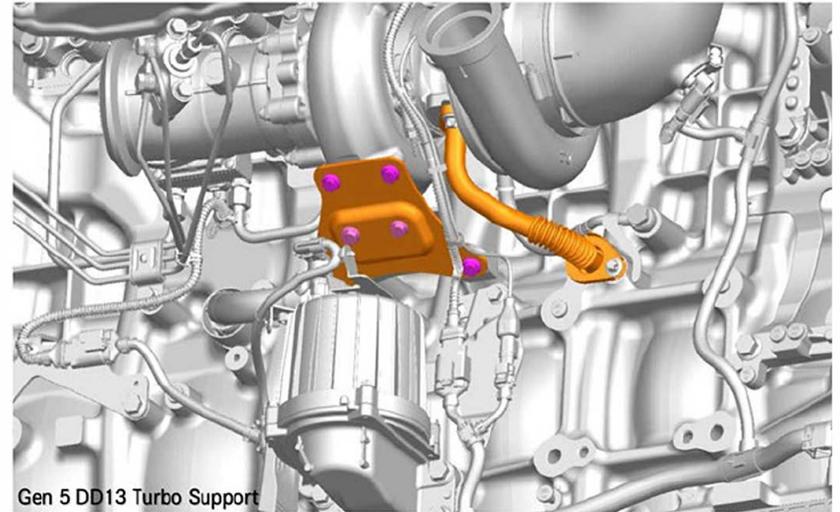
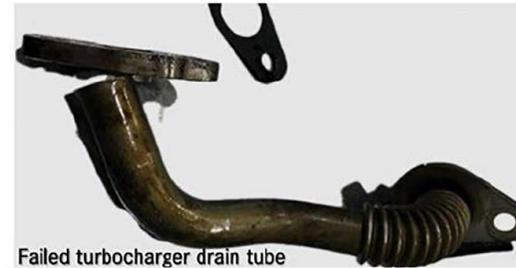
Issue Description Oil leak due to loose turbocharger mounting bolts; may lead to relative movement & fatigue of the oil drain line, repeat failure of turbocharger oil drain line

Status & Details Improperly torqued turbocharger mounting bracket bolts lead to movement of the turbocharger, resulting in excessive fatiguing of the oil drain line.

Field Action Consult TechLit/Workshop Manual for proper troubleshooting procedure.
