Special Service Message

SSM 76400 - 25.5MY onwards - Defender OCTA Rear Suspension Air Spring Positioning

Models : Defender/L663

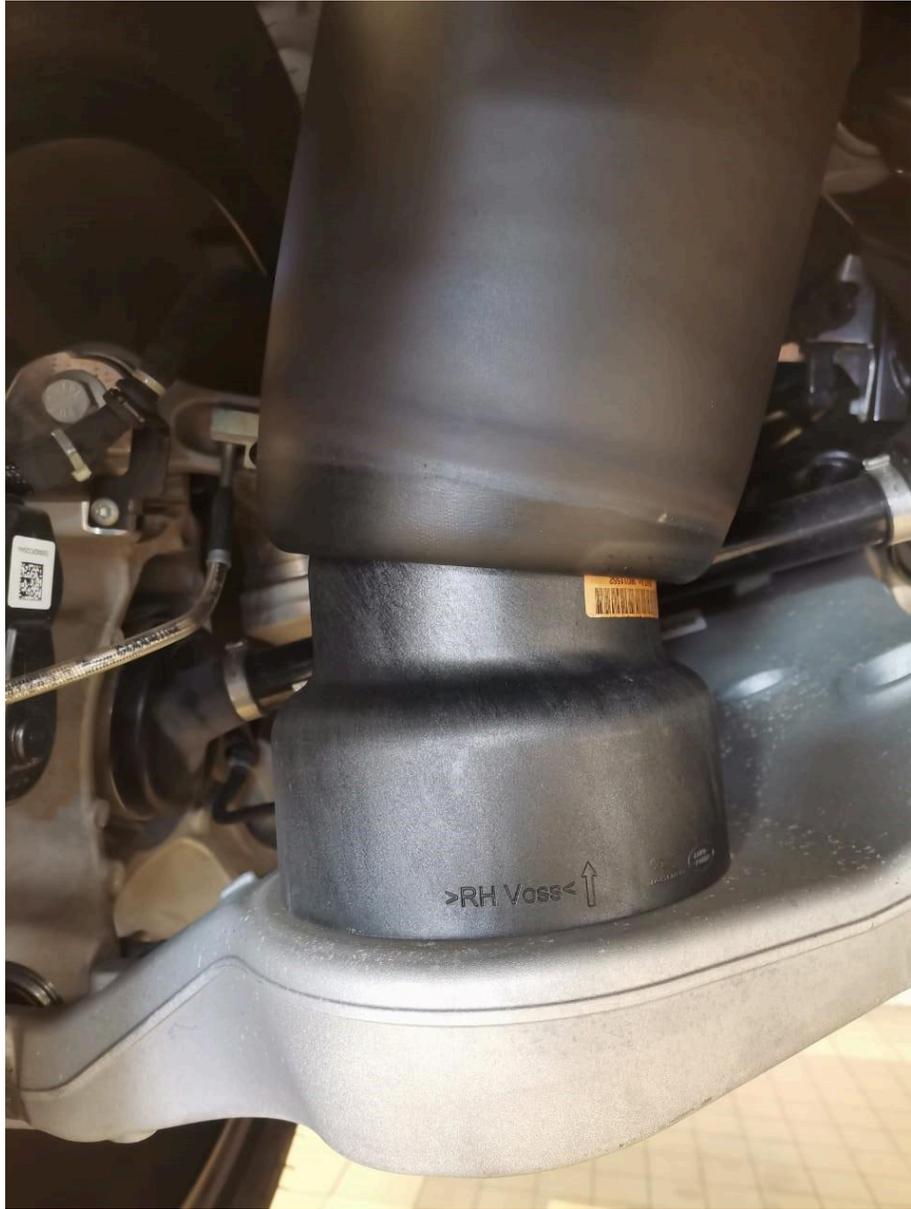
File : [Air Spring.jpeg](#)

JLR has received reports that the rear air spring lower cup is marked with "LH Voss" and "RH Voss" on opposing sides, when fitted this marking is showing at the rear of the cup and has led to questions whether the suspension air spring is fitted on the incorrect side of the vehicle.

The supplier of the air spring uses these markings to align the spring components with the air connection

No action needs to be taken, these are fitted correctly. See attached picture. It is fitted on the Left side, but shows "RH Voss" to the rear, the rearward lettering should be ignored.
