# McLaren Artura – Starter Motor Cable Inspection

<b>Bulletin type:</b>	Service Campaign
<b>Reference number:</b>	N/A
<b>Campaign reference:</b>	SCB 16 M 006
<b>Attention:</b>	Retailer Aftersales Managers, Retailer Service Managers, Retailer Service Advisors, Retailer Technicians, Retailer Parts Managers
<b>Affected vehicles:</b>	McLaren Artura
<b>Situation:</b>	Inspection of starter motor cable position
<b>Procedure:</b>	Action affected vehicles only during a service visit. Please refer to the information outlined in this document to complete the required work
<b>Date:</b>	05 December 2025

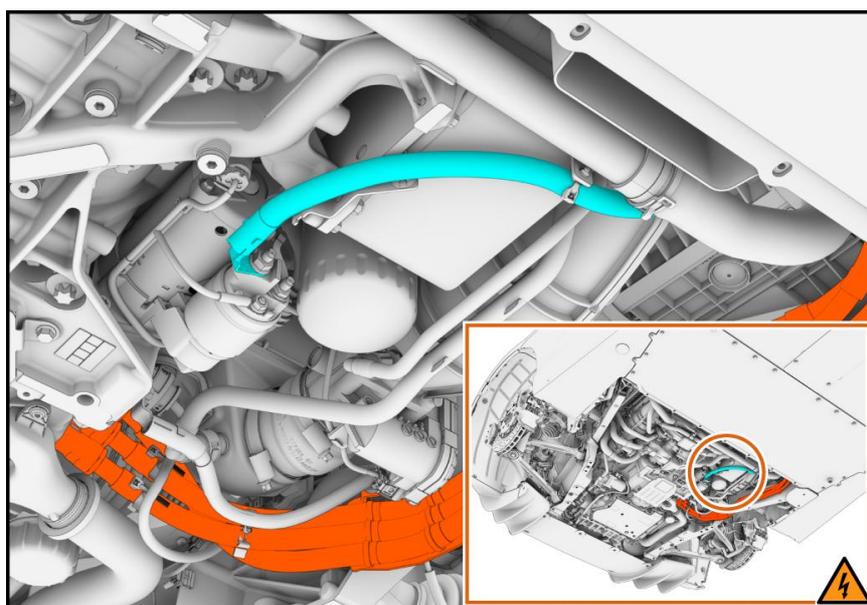
Through continuous product quality monitoring, McLaren Automotive has identified that in some McLaren Artura vehicles, the starter motor cable may not have been fitted as per specification.

Image 1: Overview of work area.

McLaren Automotive is instructing Retailers to inspect the condition of the starter motor cable and adjust the position as needed.

To carry out the required check for the Service Campaign, follow the work instruction in the McLaren Service Portal (MSP) D057122 for 'Check and Adjust Starter Motor Harness'.
