Location: Powertrain

Topic: McLaren Artura Oil Leak Diagnosis Guide - Rear of Engine

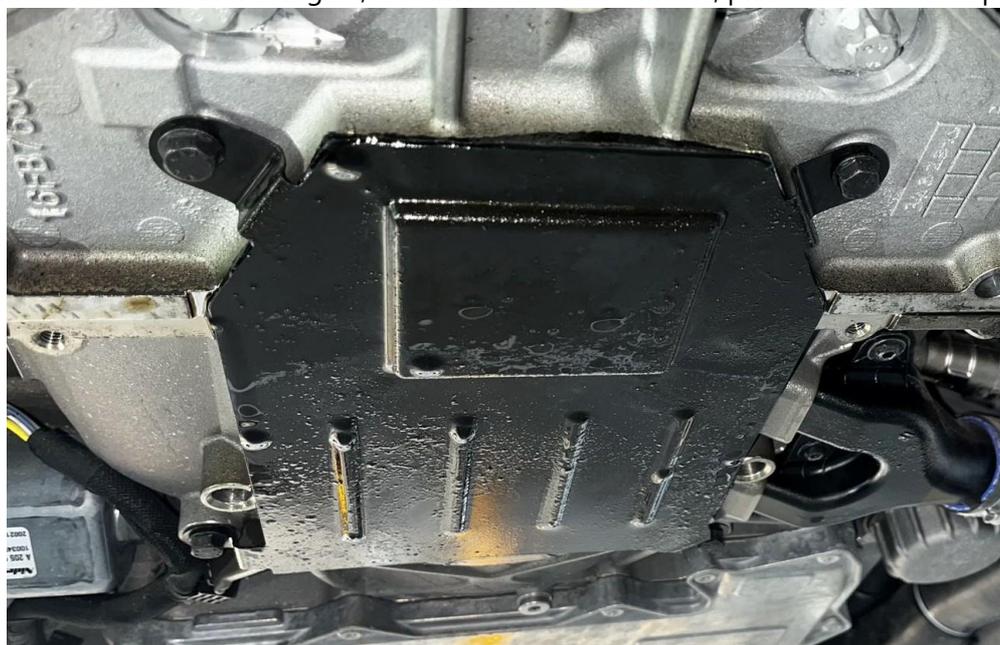
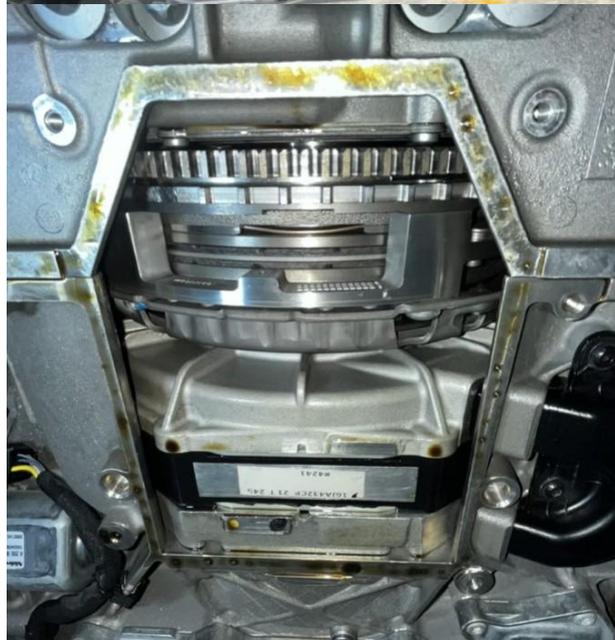
If an Artura is found to have oil traces on the underside of the powertrain at the rear, specifically the rear interface between the engine, transmission and e – motor, please follow the steps below

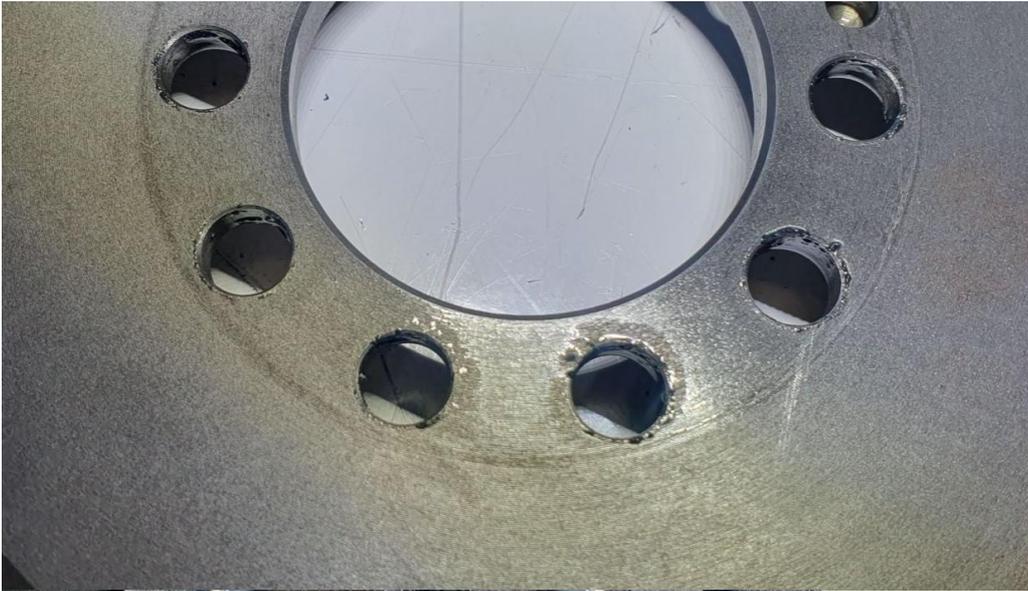
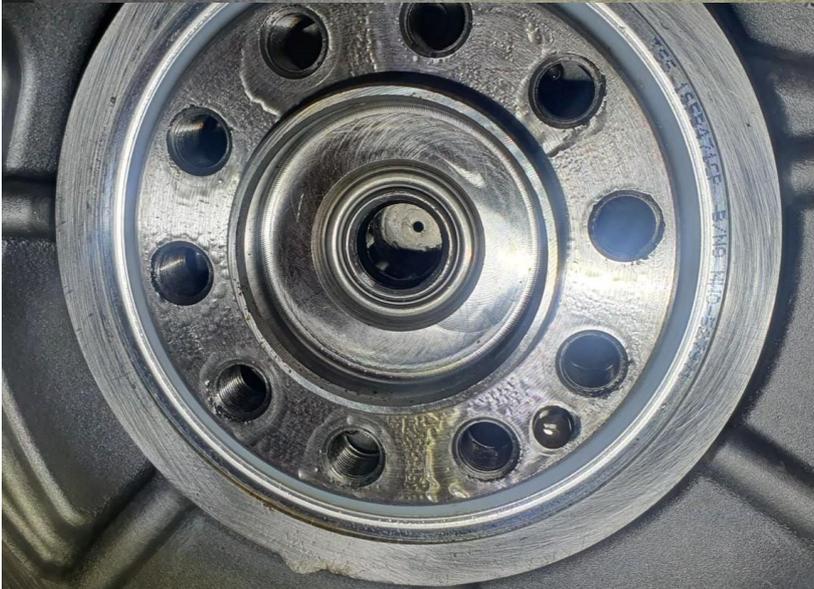
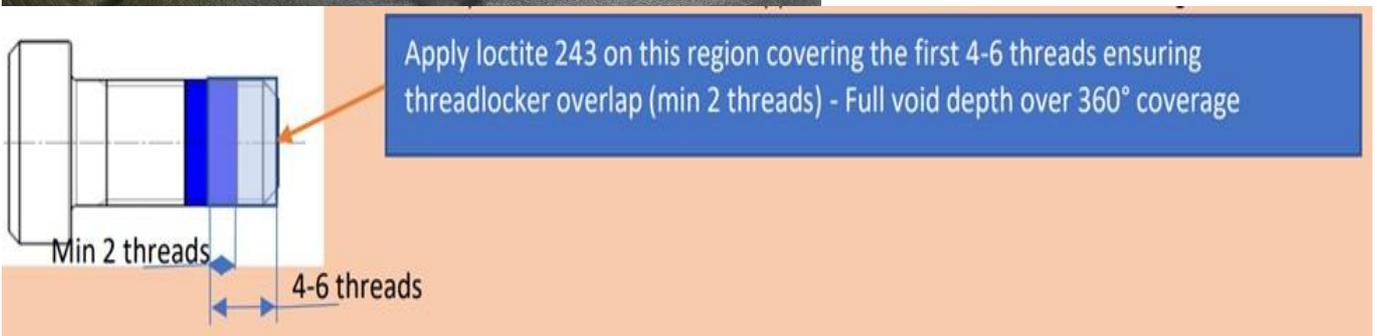
- Capture images immediately of the flywheel, label as “Flywheel Inspection” and inspect. If oil is centralized around the flywheel on the surface this indicates the flywheel bolts are potentially the cause of the leak and new flywheel bolts with added Loctite 243 to the top threads will rectify this

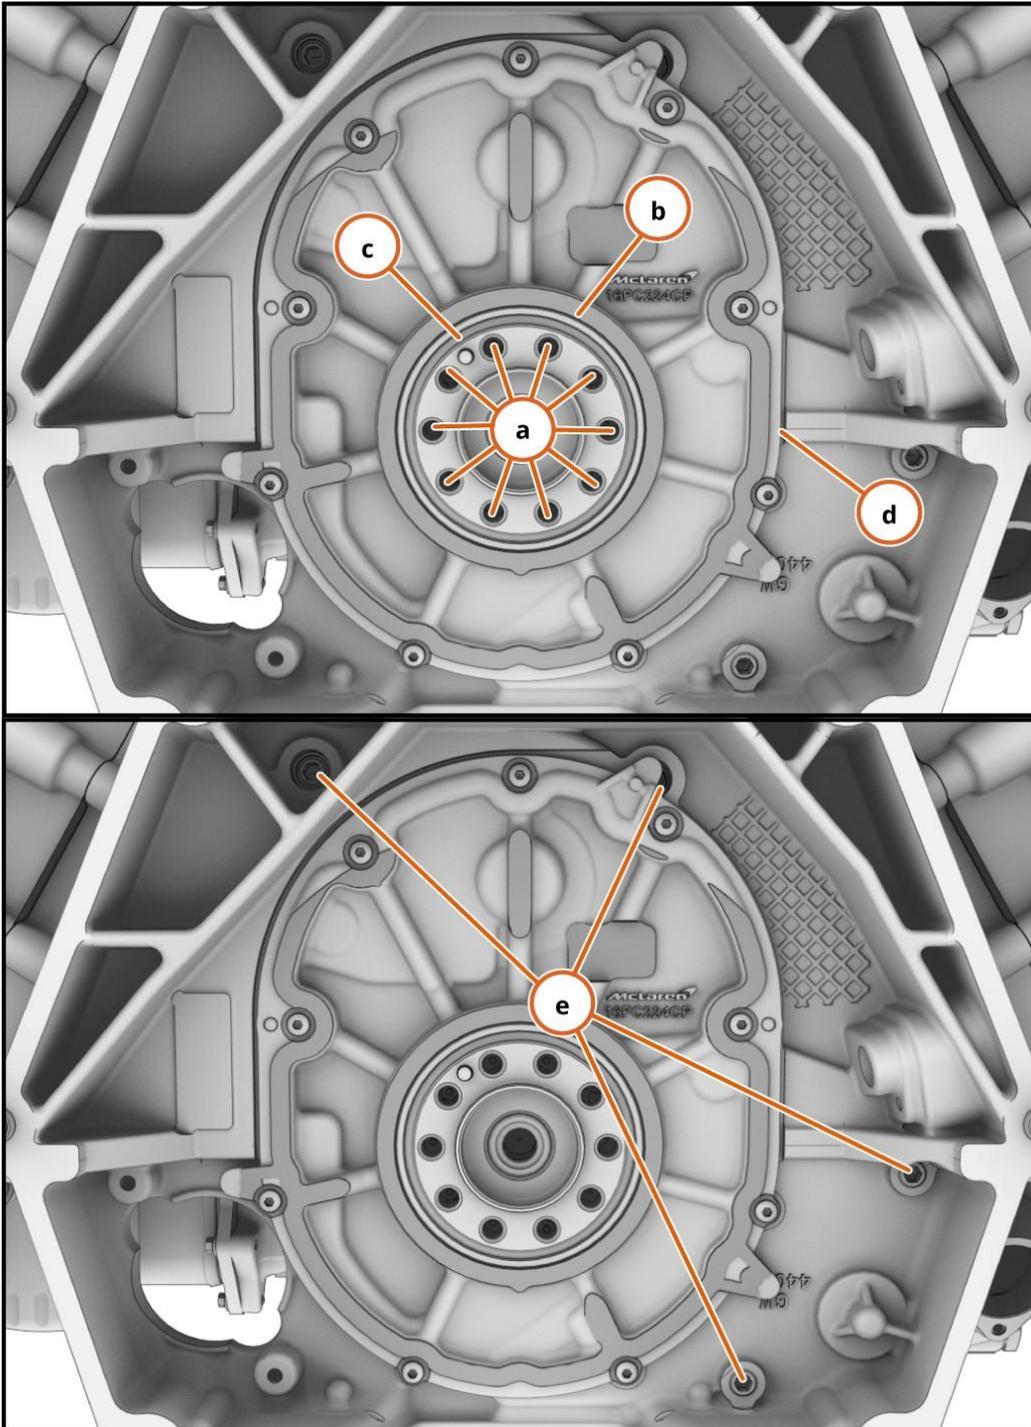
- Identify leaking area of the rear of the engine
 - a. Flywheel threaded bolt holes (crankshaft flange)
 - b. Rear crank seal OD
 - c. Rear crank seal ID

d. Rear cover (RTV Seal - identify exact location)

e. M14 Pins – Tensioner (escalate with images)

Care Point: Inner diameter of rear crank seal will exhibit a leak. This seal is a dynamic seal, the object of the leak test is to determine if another area at the rear of the engine is leaking also. If another area is found to be leaking this will likely be the root cause of the failure and this issue should be addressed

- If it is determined that the outer diameter of the crank seal or the RTV joint of the rear cover is leaking then replacement of the whole rear cover assembly with pre-fit rear seal is required

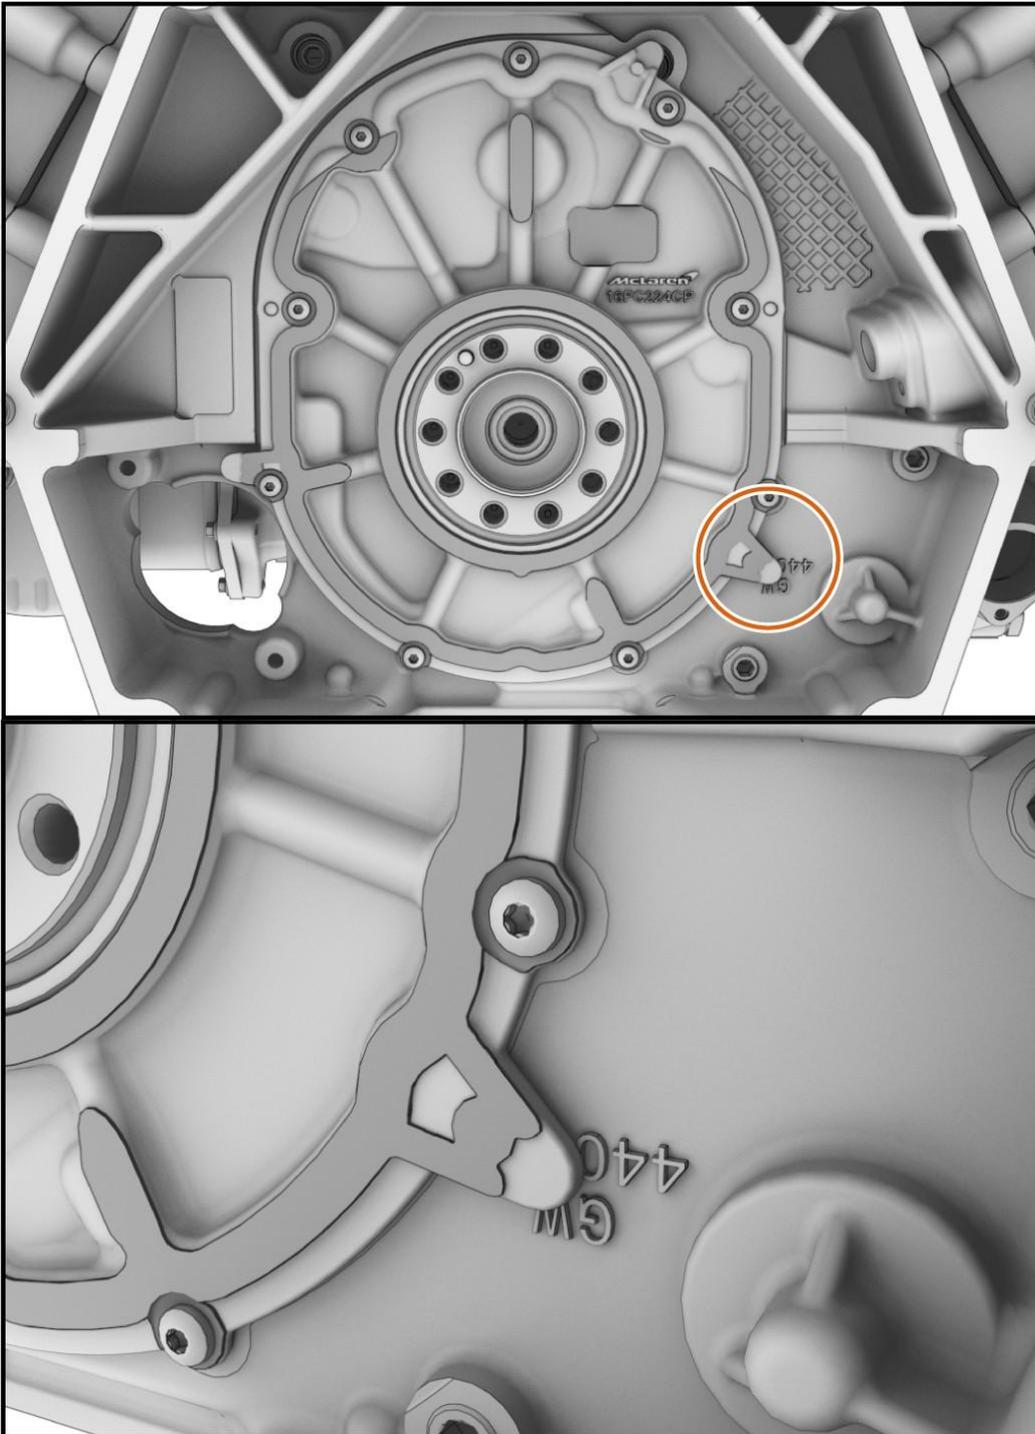
- Check if the rear cover has a tab that clashes with the cylinder block part marking

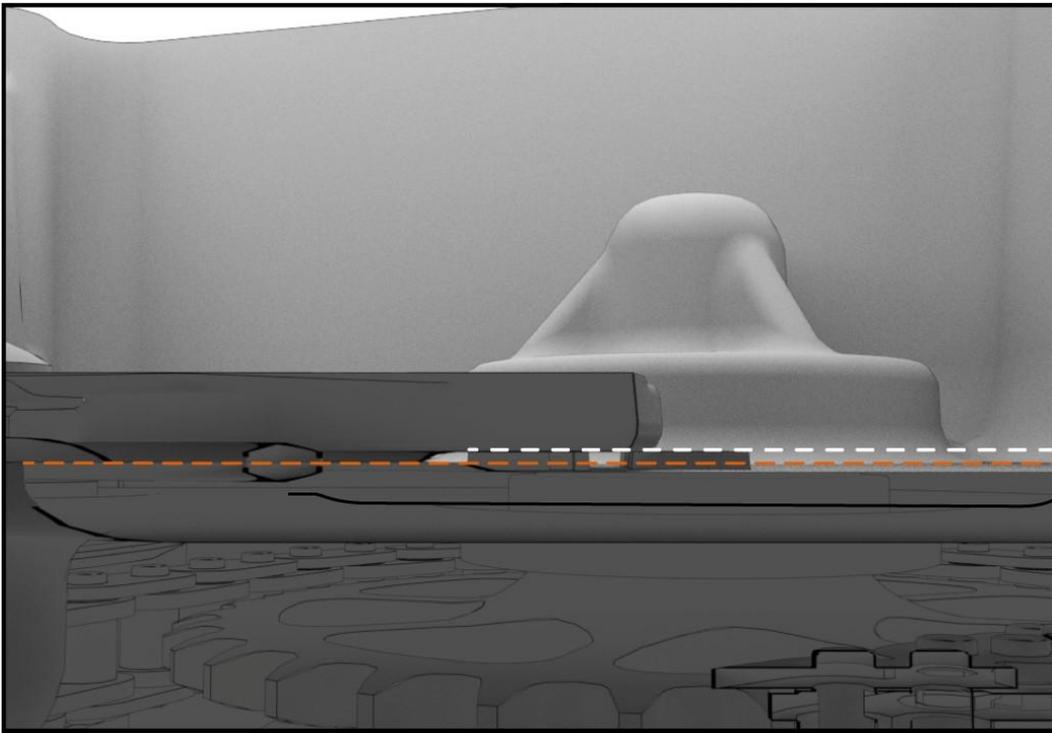
If the Part Marking on the Cylinder Block is present and not machined down, check if the top surface of the lettering is protruding the rear cover sealing surface on the cylinder block

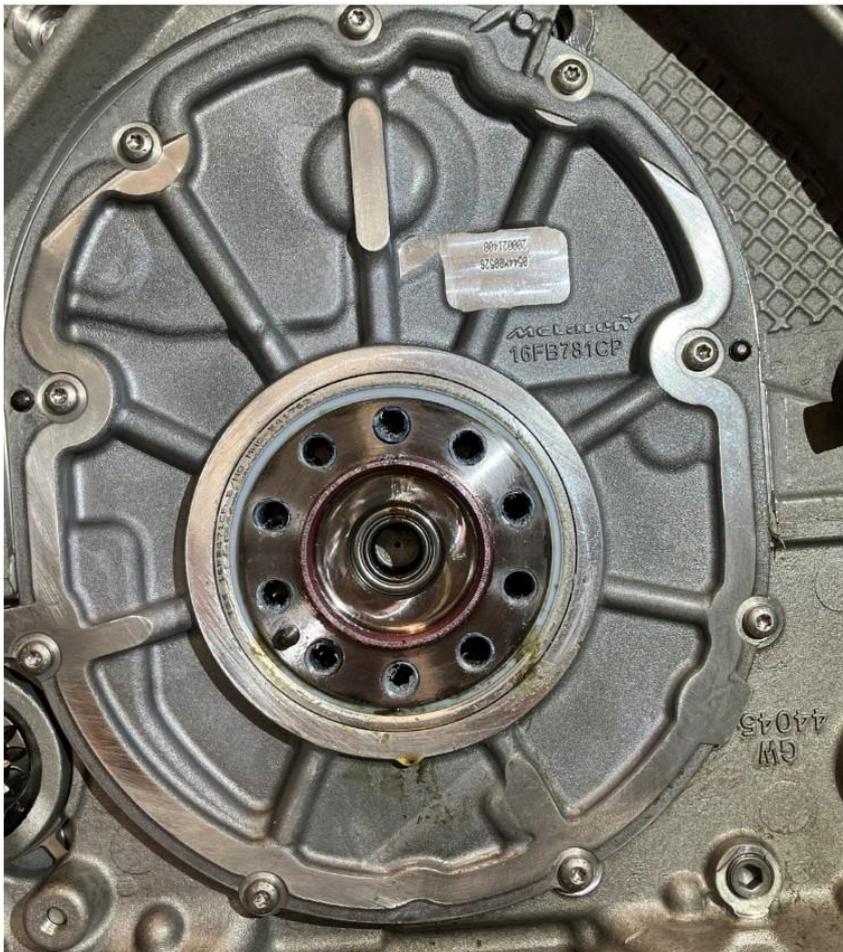
If the Part Marking protrudes, proceed with the tab removal to resolve the potential hard clash of the rear cover which would create a leak path
