Reference	SSM000013
Models	<p>Defender / L663 2020 → Onwards</p> <p>Discovery / L462 2021 → Onwards</p> <p>Discovery Sport / L550 2021 → Onwards</p> <p>E-PACE / X540 2021 → Onwards</p> <p>F-PACE / X761 2021 → Onwards</p> <p>I-PACE / X590 2021 → Onwards</p> <p>New Range Rover / L460 2022 → Onwards</p> <p>New Range Rover Evoque / L551 2021 → Onwards</p> <p>New Range Rover Sport / L461 2023 → Onwards</p> <p>XE / X760 2021 → Onwards</p> <p>XF / X260 2021 → Onwards</p>
Title	PIVI - Unable to log into InControl account in vehicle
Category	Electrical
Last modified	18-Dec-2025 08:14:00
Attachments	<p>Connectivity Settings 1.jpg (Connectivity Settings 1.jpg)</p> <p>Connectivity Settings 2.jpg (Connectivity Settings 2.jpg)</p> <p>overhead console.png (overhead console.png)</p>
Content	<p>SSM000013</p> <p>Defender (L663) 20MY onwards</p> <p>New Range Rover Sport (L461) 22MY onwards</p> <p>New Range Rover (L460) 22MY onwards (NAS 23MY onwards)</p> <p>New Range Rover Evoque (L551) 21MY onwards</p> <p>Discovery Sport (L550) 21MY onwards</p> <p>Discovery (L462) 21MY onwards</p> <p>E-Pace (X540) 21MY onwards</p> <p>F-Pace (X761) 21MY onwards</p> <p>I-Pace (X590) 21MY onwards</p> <p>XE (X760) 21MY

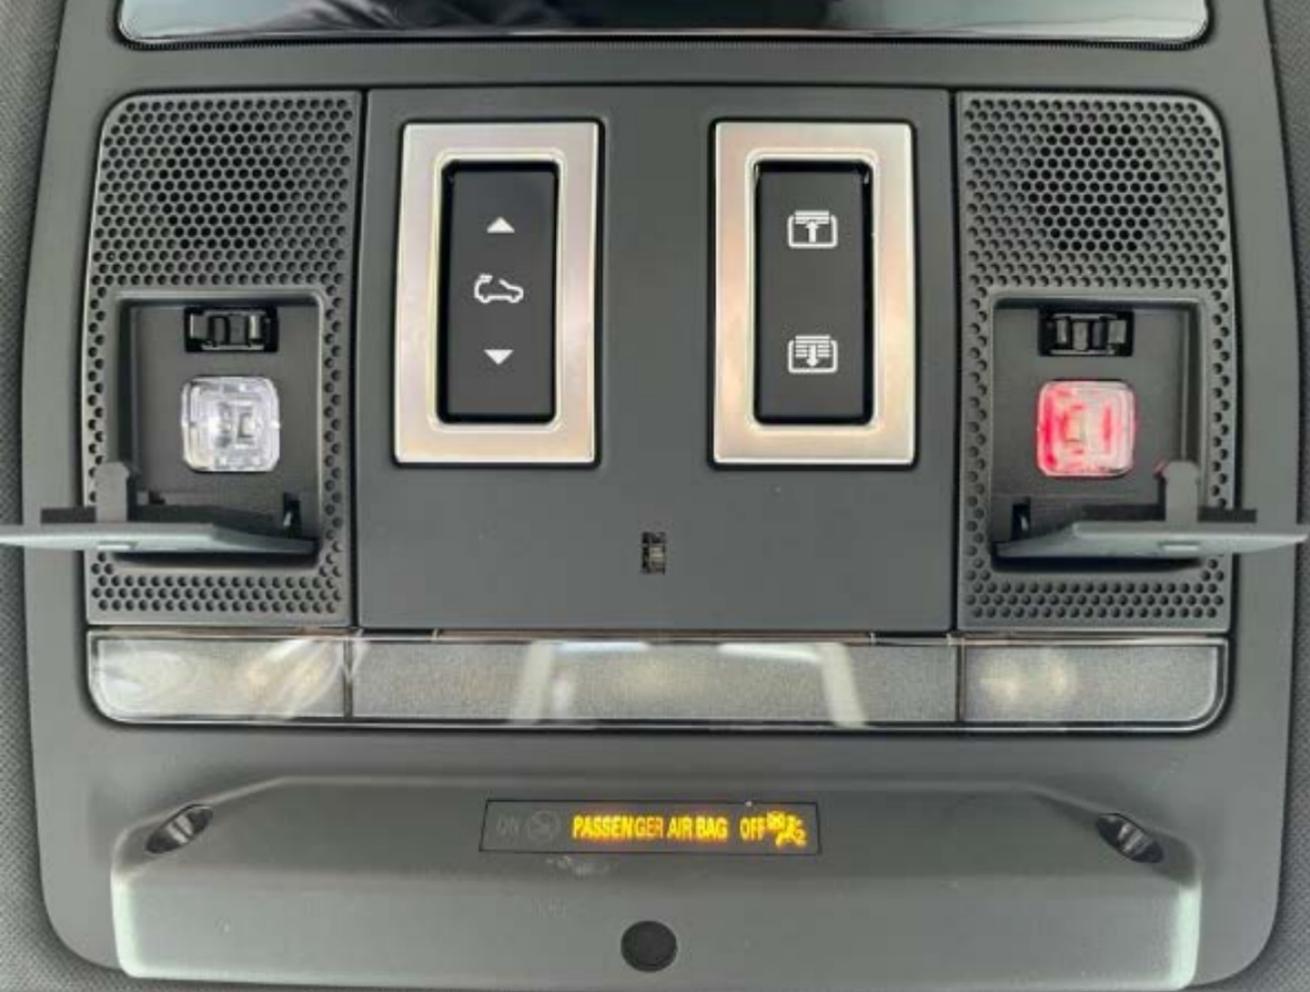
1. Exact time Long B-call press was initiated as part of the diagnostic steps above.
2. Photo of over-head console showing B-call and E-call light status, (see attached example).
3. Photo of the Connectivity Screen readout within Vehicle Setting menu in Touch Screen, (see attached example).
