Service Campaign Notification

Campaign #	Description	Check Area Around Integral Carrier and Front Axle Torsion Bar
2025120008	25P3390050

Service Campaign Bulletin

CAMPAIGN NO.	2025120008
CAMPAIGN DESC.	25P3390050
SUBJECT	Check Area Around Integral Carrier and Front Axle Torsion Bar
MODEL(S)	C-Class (206 platform)
MODEL YEAR(S)	2025
CAMPAIGN POPULATION	48

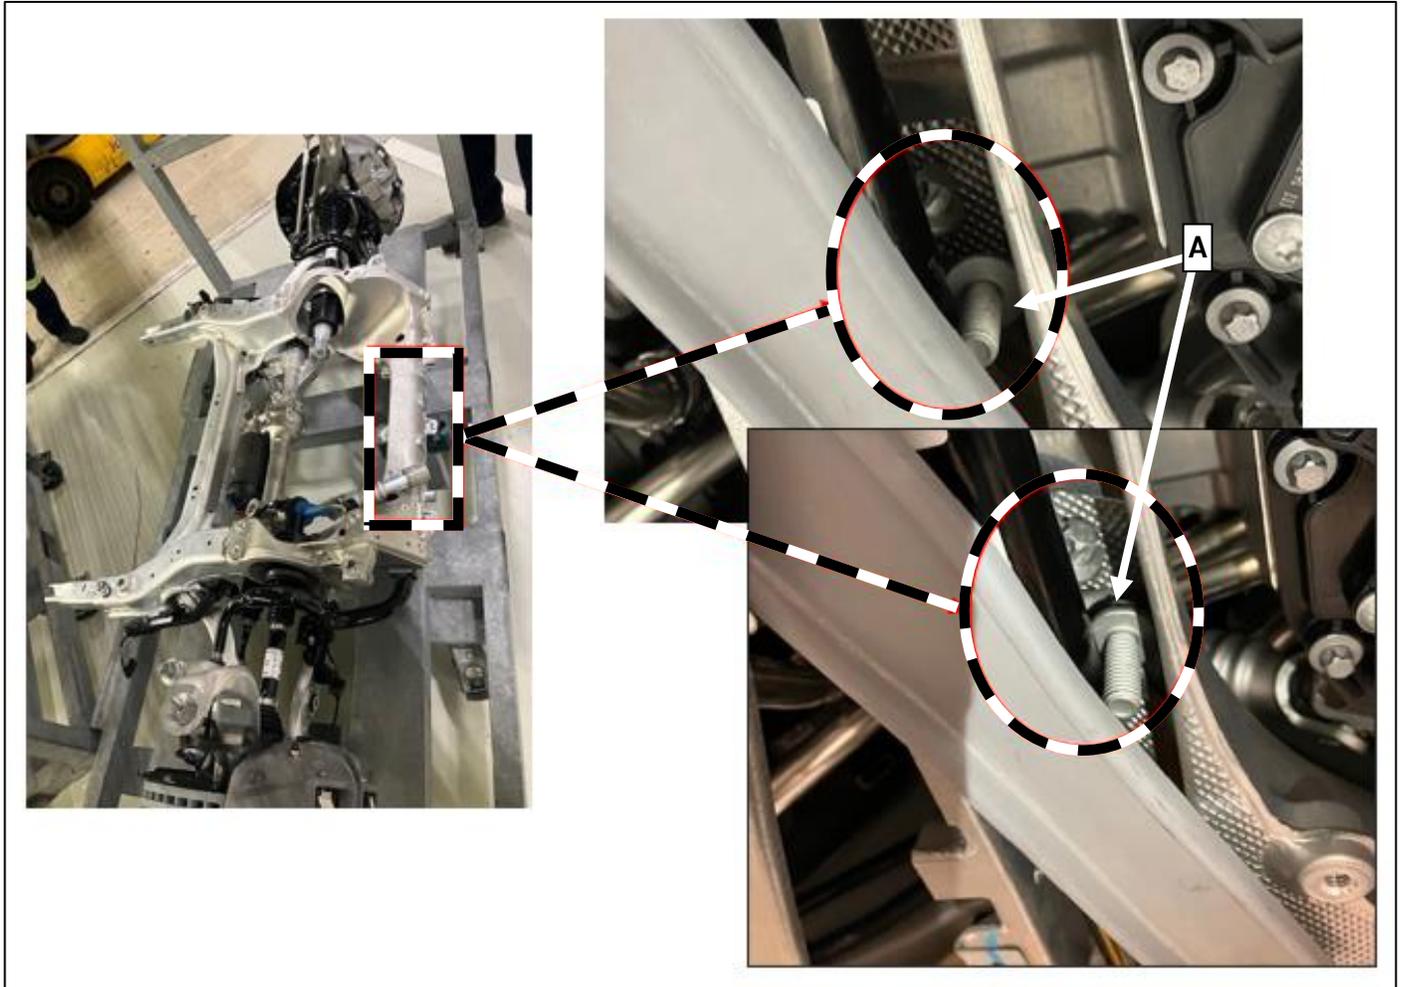
Figure 1

1. Remove center and rear engine compartment lining (AR61.20-P-1105WT).
2. Check area between torsion bar and integral carrier for presence of loose or jammed screw (Figure 1, A).

i Use mirror and flashlight to inspect area (Figure 1) between torsion bar and integral carrier.

- a. Loose or jammed screw is present: Perform Work Procedure
- b. If the loose or jammed screw is not present: End measure.

1. **Loose** screw is present: Remove screw.
2. **Jammed** screw is present: Loosen torsion bar on front axle **far enough on one side** until screw can be removed.

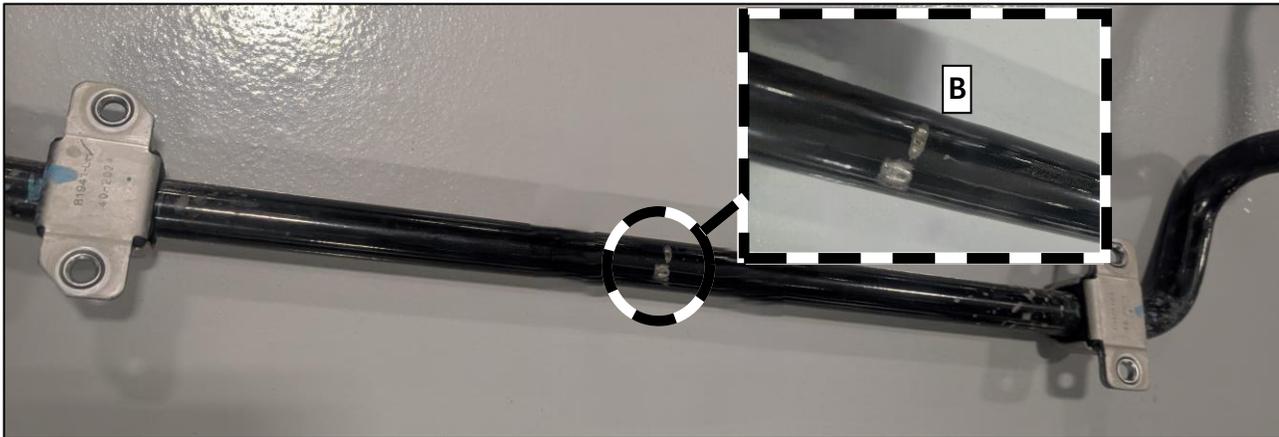
Figure 2

i Check the contact area of the removed screw for any surface damage (**Figure 2, B**) and if necessary, rework with a touch-up paint pen.

3. Assemble in reverse order.
