TECHNICAL SERVICE BULLETIN

Rattle From The Right Loadspace Trim Panel At High Audio System Volumes

25-2625

Ford 2021-2024 Bronco	Equipped with factory subwoofer
---------------------------------	---------------------------------

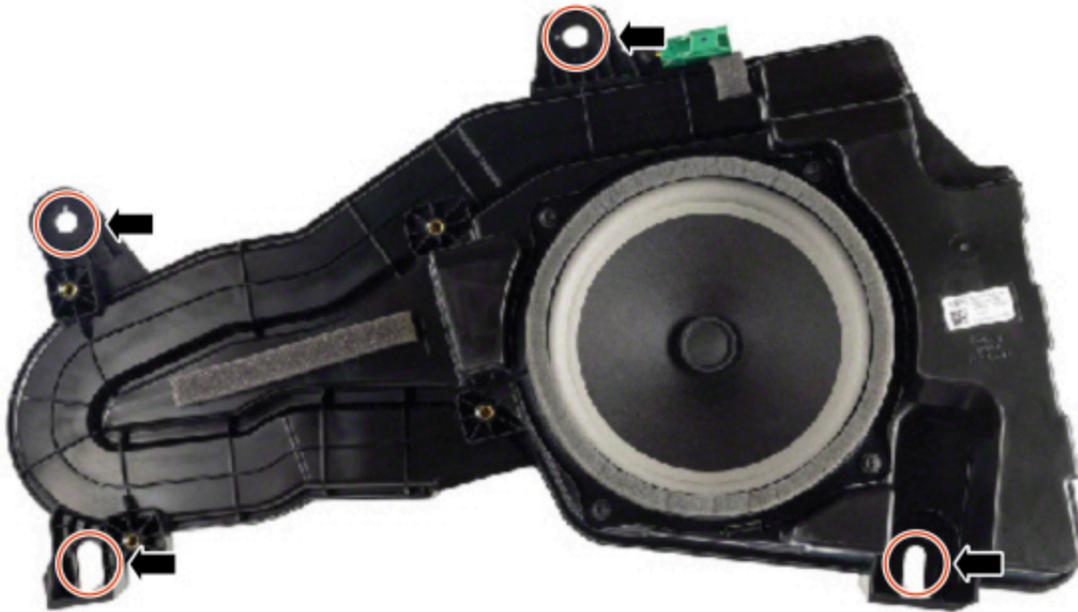
Figure 5

4. Remove the subwoofer and inspect the subwoofer for broken plastic mounting tabs. Refer to the WSM, Section 415-00 Information and Entertainment System. (Figure 5)

1. Yes - replace the subwoofer. Proceed to Step 6.
2. No - proceed to Step 6.

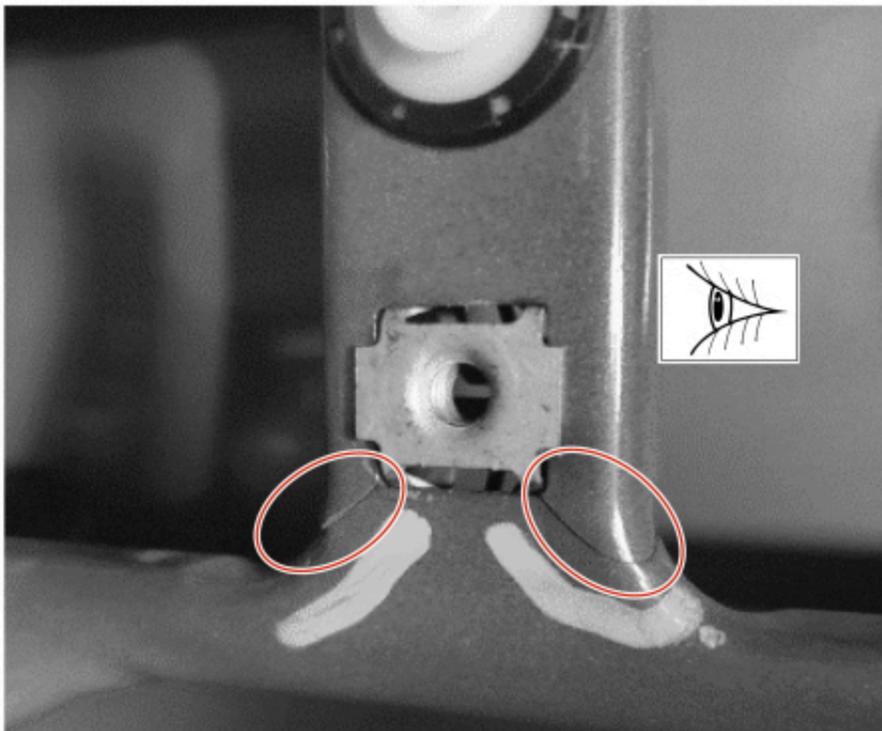
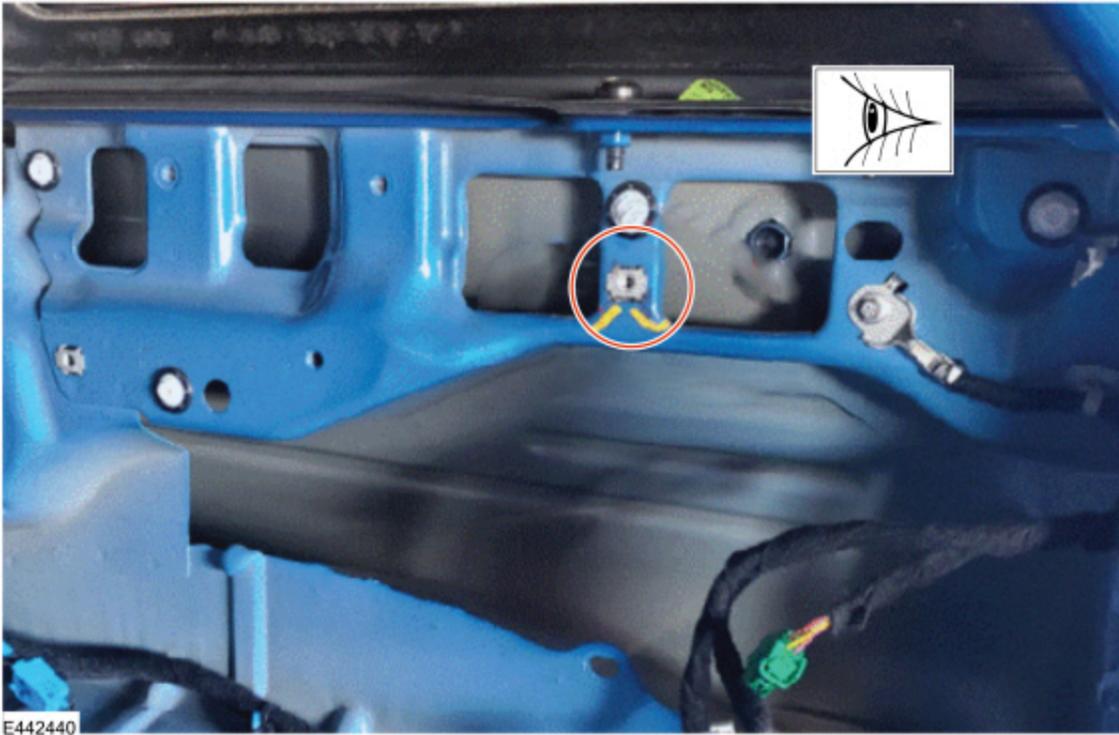
Figure 6

6. Inspect the top mounting point of the subwoofer for a crack in the metal, as seen in Figure 6. Is the metal mounting point cracked? (Figures 6-7)

7. Repair the mounting point using the subwoofer reinforcement kit, following the installation instructions included in the kit. Proceed to Step 9.

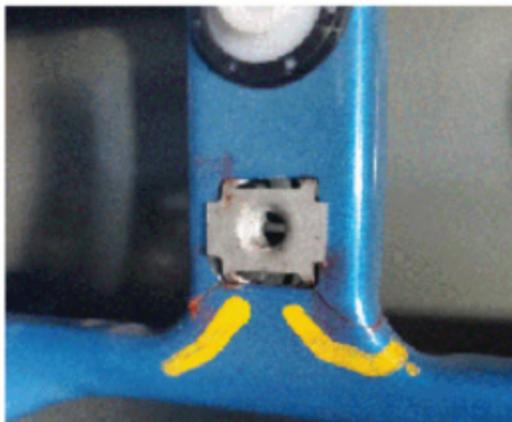
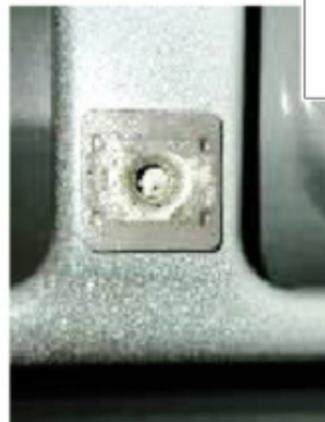
8. Is the retaining nut in the metal bracket rubber? (Figure 8)

Figure 8 - Left image shows metal retaining nut, right image shows rubber insulated retaining nut

1. Yes - proceed to Step 9.
2. No - replace the retaining nut with the updated rubber version.
