Service Bulletin

Bulletin No.: PIC6566B

Subject: Image Processing Module/Video Processing Module Reset Instructions

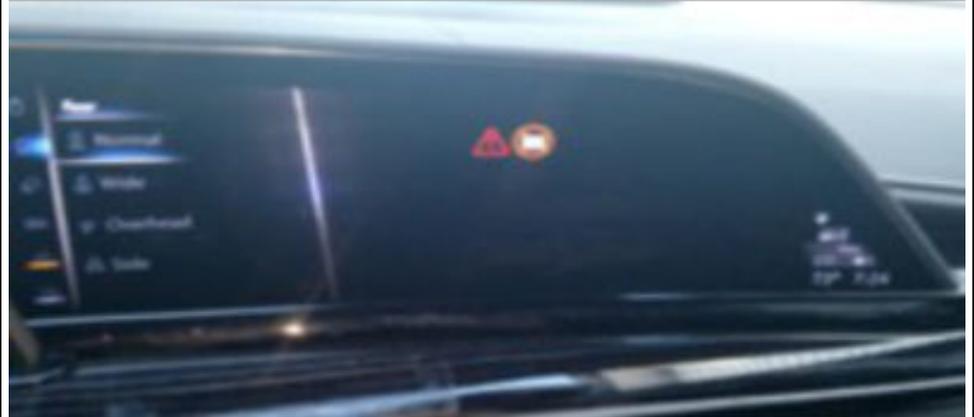
6713886

Involved Region or Country	United States, Canada, Mexico, Europe, Kazakhstan, Uzbekistan, Russia, Middle East, Iraq, Israel, Palestine, Argentina (Mercosur), Brazil (Mercosur), Chile (West), Colombia (West), Ecuador (West), Japan, Cadillac Korea (South Korea), Thailand (ASEAN), Singapore, Philippines, Australia/New Zealand, Caribbean, China
Condition	Some Customers may comment on a condition present on startup when shifting to reverse gear on the Radio Display where a black screen with a triangle and a camera with a slash through it is displayed. In addition, it may not be possible to launch the camera app from the Radio home screen.

The following DTC's may be present as Current DTC's:
DTC Set By DTC Description
U023C SYM00 CGM, EBCM Loss of Communication with VPM
B1596 SYM82 VCU/Radio VPM LVDS Coaxial Signal - Alive Sequence Counter Incorrect
B1596 SYM86 VCU/Radio VPM LVDS Coaxial Signal - Signal Invalid
B1A62 SYM82 CSM/Radio Rear Vision Camera Alive Sequence Counter Incorrect
B1A62 SYM86 CSM/Radio Rear Vision Camera Signal Invalid

Cause	This may be due to software anomalies that may be corrected by a reset of the module.
--------------	---

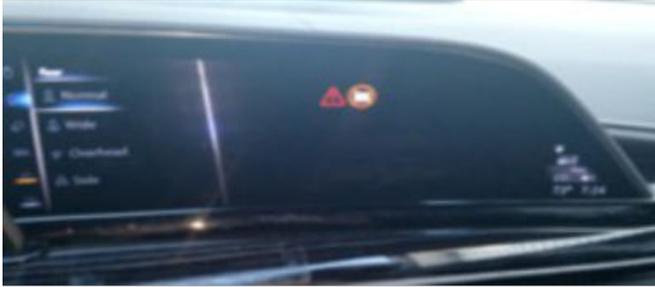
6713886

Shift to Reverse and verify RVC status. If the screen below appears, start with Step 1.

1. If U023C SYM00 is set as Current by the CGM or EBCM, then check if Warranty Labor Code 3459852 has previously been performed on this vehicle.

a. If this is a repeat visit for the same concern, Replace the VPM (Refer to SI Document: Video Processing Module Replacement).

b. If this is the first visit for this concern, refer to the chart below and perform fuse reset(s) based on option codes vehicle is equipped with.

c. After fuse pull, perform a 3-minute sleep cycle and then recheck for DTCs
