Service Bulletin

Bulletin No.: PIT6369B

Subject: Image Processing Module/Video Processing GEN2 Module Reset Instructions

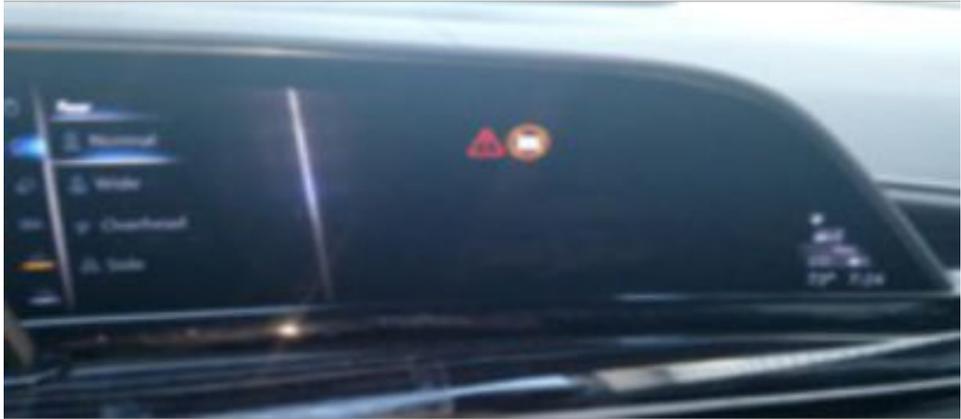
<p>Condition</p>	<p>Some customers may comment on a condition present when shifting to Reverse gear on the Radio Display where a black screen with a triangle and a camera with a slash through it is displayed.</p> <p>In addition, it may not be possible to launch the camera app from the Radio home screen.</p>

<p>Note: This PI only will apply to GEN2 Modules. Please make sure you are looking at the correct Model and Year of the vehicle that is being diagnosed.</p> <p>The following DTC's may be present as Current DTC's:</p>
<p>Cause</p>	<p>This may be due to software anomalies that may be corrected by a reset of the module.</p>

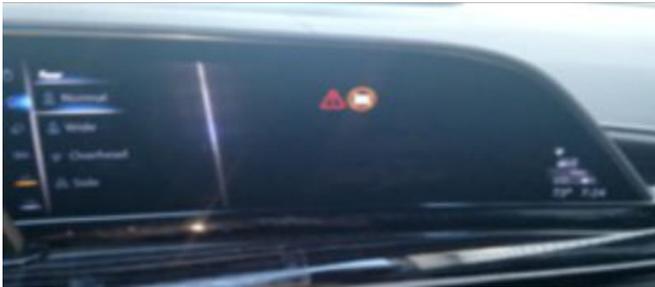
Shift to Reverse and verify RVC status. If the screen below appears, start with Step 1.

1. If U023C SYM00 is set as Current by the CGM or EBCM, then check if Warranty Labor Code 3459852 has previously been performed on this vehicle.

a. If this is a repeat visit for the same concern, Replace the VPM (Refer to SI Document: Video Processing Module Replacement).

b. If this is the first visit for this concern, refer to the chart below and perform fuse reset(s) based on option codes vehicle is equipped with.

c. After fuse pull, perform a 3-minute sleep cycle and then recheck for DTCs
