GROUP	MODEL
Subsequent Repair Action	2022-2024MY EV6, EV6 GT (CV)
NUMBER	DATE
SC327Y (Rev 1, 01/15/2026)	December 2024

ICCU AND FUSE REPLACEMENT (SC327Y)

P1A9096 - DC/DC Converter Input Voltage Sensor Fault

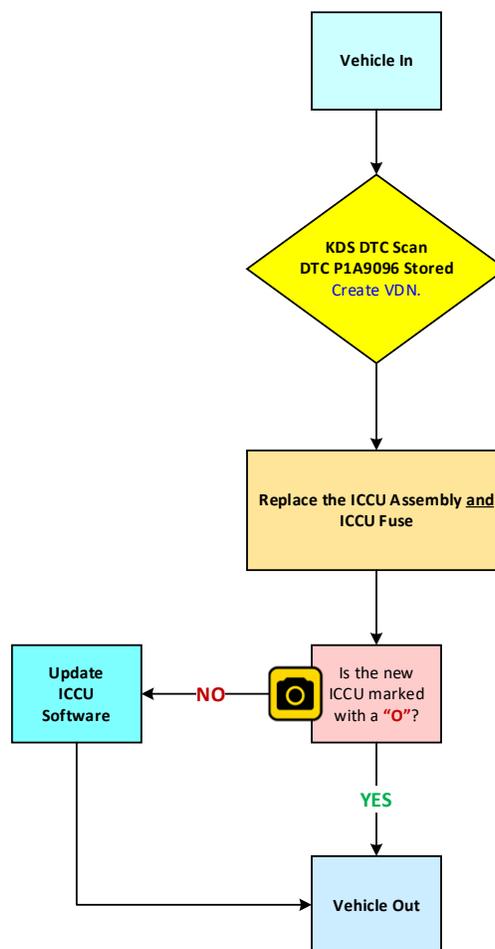
Flowchart:

'Vehicle In' with DTC P1A9096 (after completing SC327 with the latest software)

DTC P1A9096 Stored + ICCU Assembly and ICCU Fuse Replacement**Is the 'new' ICCU Assembly marked with a letter "O"?**

- If DTC is stored, replace the ICCU Assembly + ICCU Fuse (Page 5)

- No - Take a KDS Warranty Attachment photo of ICCU + Update the ICCU software (Pages 3-4)
- Yes - Vehicle OUT
