GROUP	MODEL
BOD	2025-2026MY EV9 (MV1a)
NUMBER	DATE
348	January 2026

TECHNICAL SERVICE BULLETIN

SUBJECT: **SERVICE ACTION: FRONT PASSENGER WALK-IN SEAT SWITCH INSPECTION, REPAIR & REPLACEMENT (SA636)**

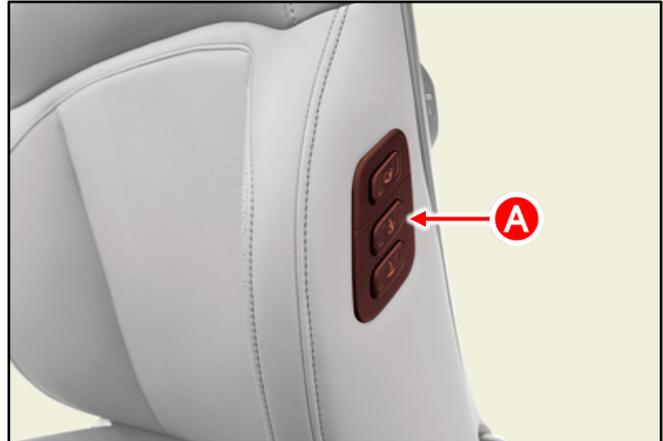
1. Locate front passenger seat walk-in switch (A).

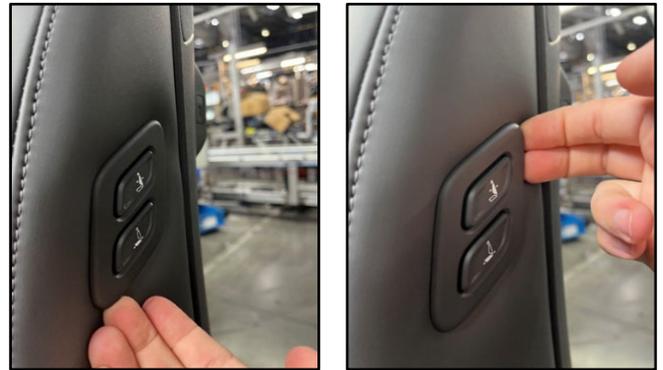
2. Use your fingers to gently pry around the edges of the front passenger seat walk-in switch (A) to check if it is loose. Inspect for any gaps that may indicate it is not fully seated.

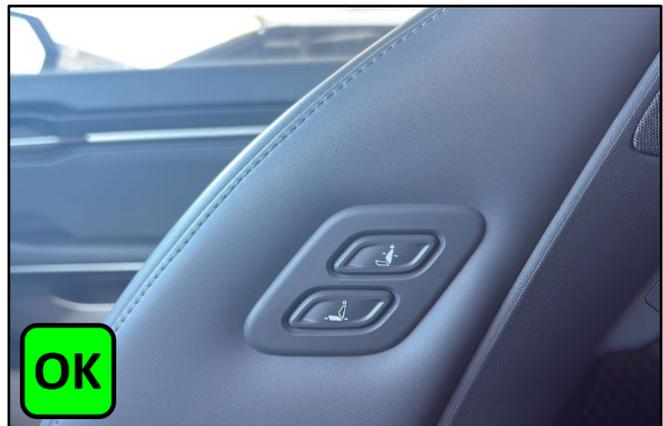
- If the front passenger seat walk-in switch (A) is properly secured (OK), then no further action required. Claim the inspection only op code 250A4810.

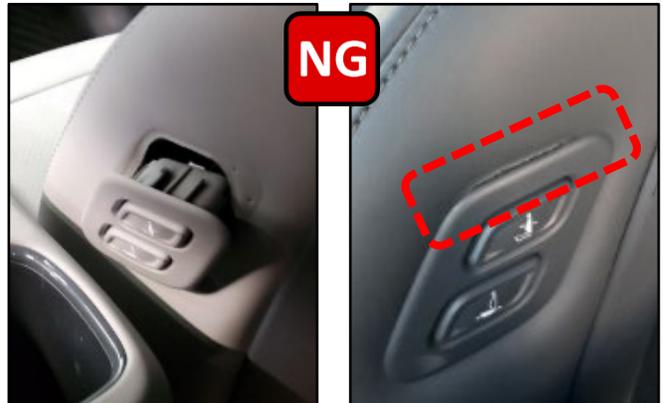
- If the front passenger seat walk-in switch (A) is loose or pops out (NG), replace the front passenger seat walk-in switch (A) and proceed to the 'Repair Procedure' on page 3.
